(11) **EP 1 808 263 B1**

(54) **Chordwidth restoration of a trailing edge of a turbine airfoil by laser clad**

(73) Proprietor: **United Technologies Corporation**
Hartford, CT 06101 (US)

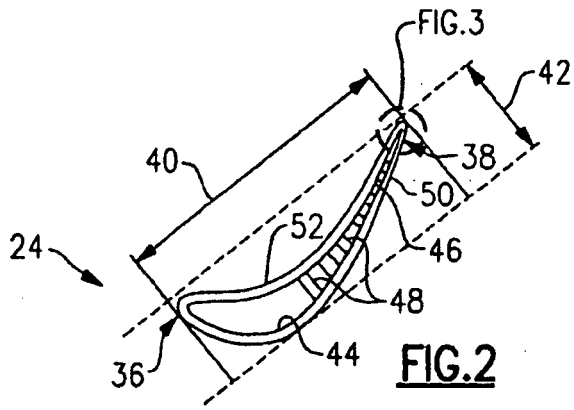
FIG. 2

Figure 2 shows an example cross-section of a turbine vane having a leading edge and a trailing edge.

[0014] Referring to the vane 24 cross section shown in Figure 2, the vane 24 includes a leading edge 36 and a trailing edge 38. The leading edge 36 is generally located toward the combustor section 14 and the trailing edge 38 is generally located toward the exhaust nozzle 20 in the combustion engine 10 (Figure 1).

[0015] The leading edge 36 and the trailing edge 38 define a chordwidth 40 of the vane 24. A thickness dimension 42 is transverse to the chordwidth 40. In the illustrated example, an aspect ratio of the chordwidth 40 to the thickness 42 at least partially determines an aerodynamic efficiency of the vane 24. That is, a relatively larger aspect ratio corresponds to a greater aerodynamic efficiency, while a relatively smaller aspect ratio corresponds to a lesser aerodynamic efficiency.

[0016] The vane 24 includes an internal cavity 44 that extends towards the trailing edge 38 to define a slot 46. The slot 46 opens through the trailing edge 38. Pedestals 48 within the turbine vane 24 support a suction side 50 and a pressure side 52 of a vane 24. The internal cavity 44 and slot 46 reduce the weight of the vane 24 and allow internal cooling of the vane 24.

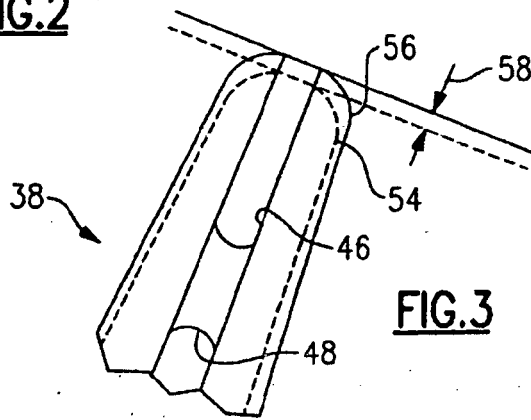
FIG. 3

Figure 3 shows an eroded surface and an original surface of the trailing edge of the vane of Figure 2.

[0017] Figure 3 shows a more detailed view of the section shown in Figure 2. In the illustrated example, the dotted line 54 represents an eroded surface of the trailing edge 38. In one example, the eroded surface 54 is the result of field operation of the combustion engine 10. A solid line 56 represents an original surface of the trailing edge 38. The original surface 56 refers to a shape and dimension of the trailing edge 38 before erosion. Thus, the original surface 56 may be the as-cast or as-forged condition of the trailing edge 38 of a newly manufactured vane 24. Alternatively, the original surface 56 is the as-designed dimension of the trailing edge 38 as found in a combustion engine 10 design manual.

[0018] Over time, the friction of hot gases 18 from the combustor section 14, soot, or particles in the hot gas flow 18 erode away the original surface 56 to produce the eroded surface 54. The erosion reduces the chordwidth 40 dimension by an amount 58, which reduces the aerodynamic efficiency of the vane 24 as described

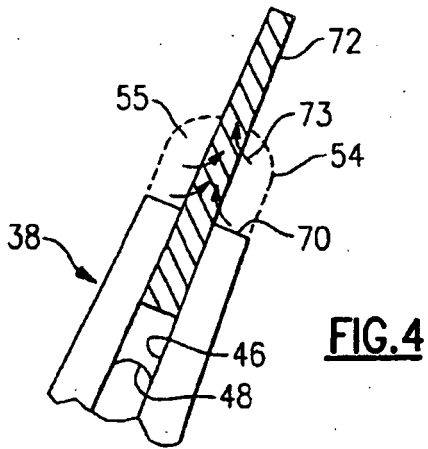
FIG. 4

Figure 4 shows removal of the eroded portion of the vane of Figure 3 and insertion of a barrier member into a slot through the trailing edge.

[0019] Referring to Figure 4, to repair the eroded surface 54 and restore the original chordwidth 40, a portion 55 of the trailing edge 38 is removed by machining, grinding, grit blasting, or other known removal method. In the illustrated example, the portion 55 is removed to produce a relatively flat surface 70, which will serve as a substrate surface for depositing a laser cladding portion to rebuild the trailing edge 38 as described below.

[0020] After removal of the portion 55, a laser cladding is deposited onto the relatively flat surface 70 to rebuild the trailing edge 38. Before laser cladding, a copper barrier member 72 is inserted into the slot 46 of the trailing edge 38. The copper barrier member 72 prevents filler material 74 (Figure 5) that is used to rebuild the trailing edge 38 during the laser cladding process from entering the slot 46. This provides the benefit of eliminating the need for machining the slot 46 after the laser cladding process to restore the slot 46 shape.

[0021] Additionally, the copper barrier member 72 serves as a heat sink to remove heat (as indicated by the arrows 73) from the trailing edge 38 during the laser cladding process. The removal of heat through the copper barrier member 72 minimizes the size of the heat affected zone of the trailing edge 38 and thus reduces heat distortion, which is a problem with prior art welding and brazing methods.

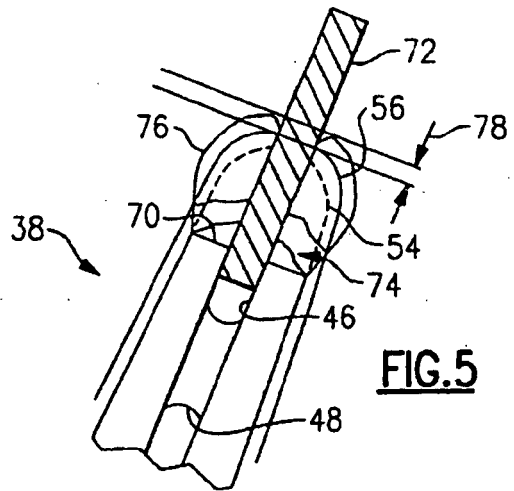
FIG. 5

Figure 5 shows rebuilding the trailing edge to produce an oversized cladded portion that is then machined down to produce a restored trailing edge having a chordwidth dimension near an original chordwidth dimension of the vane.

[0022] Referring to Figure 5, the filler material 74 is deposited onto the flat surface 70 in a known manner as a powder or other type of filler material to gradually build-up the trailing edge 38. In one example, the filler material is of a similar composition to the superalloy used to originally form the vane 24 to promote a strong bond between the cladding and the original superalloy of the vane 24. In another example, the filler material is a composition according to the standard set forth in AMS 5837.

[0023] A laser consolidates (i.e., melts and fuses) the deposited filler material 74 in a known manner. The melting and fusing of the filler material 74 is relatively rapid and accurate, which provides the benefit of a fast vane 24 repair cycle time and a high degree of repeatability. Furthermore, laser cladding melts and fuses a relatively small trailing edge 38 and filler material 74 volume to minimize the size of the heat affected zone of the trailing edge, which is a drawback of prior art brazing and welding that result in relatively large heat affected zones.

[0024] The consolidated filler material 74 builds-up on the trailing edge 38 to form an oversized cladded portion 76 that is bonded to the original superalloy material at the flat surface 70 of the vane 24. The oversized cladded portion 76 is larger than the original surface 56 in the chordwidth 40 dimension by an amount 78. This provides the benefit of ensuring that trailing edge 38 is built-up enough to completely restore the chordwidth 40 dimension to the original airfoil shape.

[0025] After the oversized cladded portion 76 is deposited on the trailing edge 38, the copper bearing member 72 is removed from the trailing edge 38. Next, the over-

sized clad portion 76 is machined to the chordwidth 40 dimension of the original surface 56. In one example, the machining includes known grinding, grit blasting, polishing, or other known machining method that provides a smooth transition area from the laser cladding to the original, non-repaired portions of the vane 24.
