(11) **EP 2 189 545 A1**

(71) Applicant: **Nippon Steel Corporation**
Chiyoda-ku
Tokyo
100-8071 (JP)

(54) **TAP HOLE STRUCTURE OF MELTING FURNACE AND METHOD OF REPAIRING SAME**

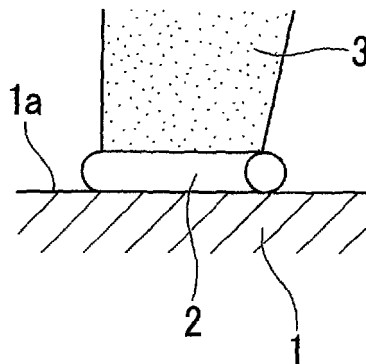
FIG. 1A

(57) A taphole structure of a melting furnace includes: a sleeve made of a fire-resistant brick, which is disposed inside a tapping hole provided in a furnace wall brick; and a ramming material which fills a gap between the sleeve and the tapping hole for fixing the sleeve. In addition, a repair method of the taphole which has expanded due to wear of a first ramming material during tapping, includes: forming a dismantled surface having a straight line shape by dismantling and removing a worn portion of the first ramming material in a straight line from an outer surface side toward an inner surface side of a furnace wall; and then filling a second ramming material into a gap between the dismantled surface having the straight line shape and a first sleeve for sealing.

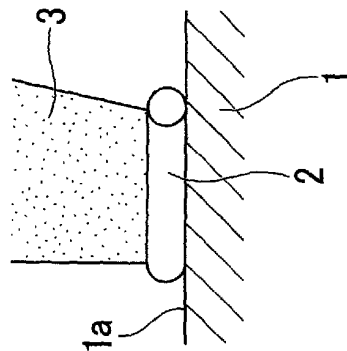
FIG 1A is a cross-sectional view schematically showing a repair method according to an embodiment of the present invention and an initial state.

In FIGS. 1A to 1D, reference numeral 1 denotes a furnace wall brick, reference numeral 1a denotes a tapping hole provided in the furnace wall brick 1, reference numeral 2 denotes a sleeve made of a fire-resistant brick, which is disposed inside the tapping hole 1a, and reference numeral 3 denotes a ramming material filled into a gap between a pipe and the tapping hole 1a.

[0021] A taphole of the present invention includes a structure in which, as shown in FIG. 1A, the sleeve 2 made of the fire-resistant brick is disposed inside the tapping hole 1a provided in the furnace wall brick 1 and the ramming material 3 is filled into the gap between the sleeve 2 and the tapping hole 1a.

FIGS. 1A to 1D schematically show a repair method according to this embodiment. FIG. 1A is a cross-sectional view schematically showing the repair method according to the embodiment and an initial state. FIG. 1B shows initial damage. FIG. 1C shows a state after a first repair. FIG. 1D shows a state after a second repair.

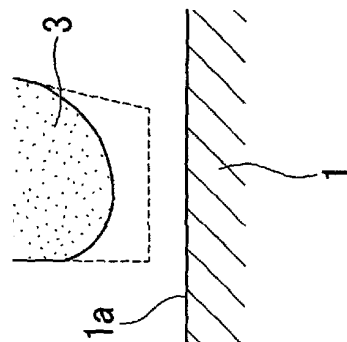
FIG. 1B is a cross-sectional view schematically showing the repair method and initial damage.

FIG. 1B is a view showing an initial damage state. With regard to the damage of the taphole, in addition to the sleeve 2, the ramming material 3 is significantly worn and has significant melting loss. In terms of the improvement of the durability of the sleeve 2, as described above, it was found that the improvement is exhibited to some extent by using the sleeve made of the fire-resistant brick. However, the repair for the wear and melting loss of the ramming material 3 can be performed by using only the existing heat pouring and the precast methods, and a repair method of satisfying all the factors such as durability, repair period, and costs did not exist. Furthermore, there is a concern that the wear and melting loss of the ramming material 3 causes the gas inside the melting furnace to be ejected from the furnace along with the hot metal, so that the development of a new ramming material repair method was required.

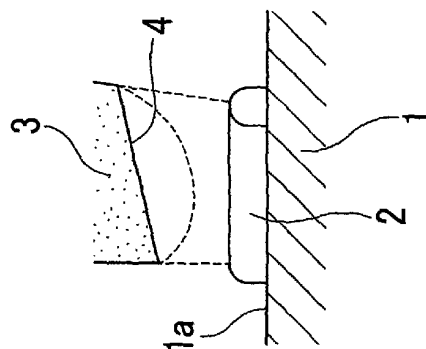
FIG. 1C is a cross-sectional view schematically showing the repair method and a state after a first repair.

[0025] Therefore, according to the embodiment, after dismantling and removing a worn portion of the ramming material 3 in a straight line from an outer surface side toward an inner surface side of the furnace wall as shown in FIG. 1C, a new ramming material 5 is filled into a gap between a dismantled surface 4 with the straight line shape and the sleeve 2 for sealing as shown in FIG. 1D. In addition, the above-mentioned dismantling performed in a straight line from the outer surface side toward the inner surface side of the furnace wall leaves a simple shape, so that a general dismantling heavy machine can be used, thereby achieving a reduction in work period. Furthermore, as shown in FIGS. 1C and 1D, the dismantled surface 4 is formed so that the gap between it and the tapping hole 1a is widened from an inside toward an outside of the furnace wall (in other words, is narrowed from the outside toward the inside of the furnace wall). As the gap is formed as described above, the ramming material 5 can be easily filled into the gap to an inward portion thereof.

With such a configuration described above, the ramming material 5 can be filled into the entire gap from the outside to the inside of the furnace wall, thereby restoring the initial state. Accordingly, there is no problem in that restoring of the inside of the furnace wall cannot be implemented like the hot pouring method, but a complete restoration is possible. Moreover, unlike the precast method, the repair can be performed in a short work period and at a low cost.

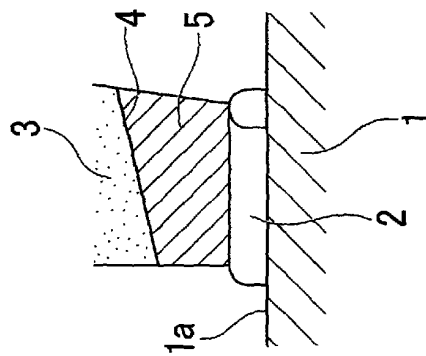
FIG. 1D is a cross-sectional view schematically showing the repair method and a state after a second repair.

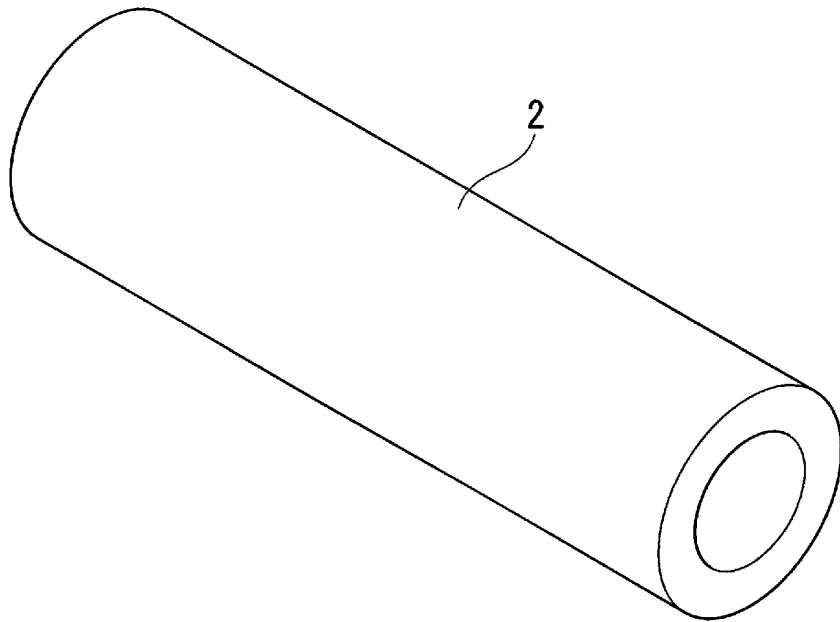
FIG. 2 is a perspective view showing a sleeve according to the embodiment.

[0023] As a shape of the sleeve 2 made of the fire-resistant brick, a cylindrical member as shown in FIG. 2 may be employed. In addition, a cylindrical member having an inclined portion 2a formed by obliquely cutting an end portion on the inward side of the furnace as shown in FIG. 3, or a open-tube-shaped half cylindrical member having a horizontal surface 2b formed by cutting a lower surface of a cylindrical member and an inclined portion 2a formed by obliquely cutting the end portion on the inward side of the furnace as shown in FIG. 4 may be employed.

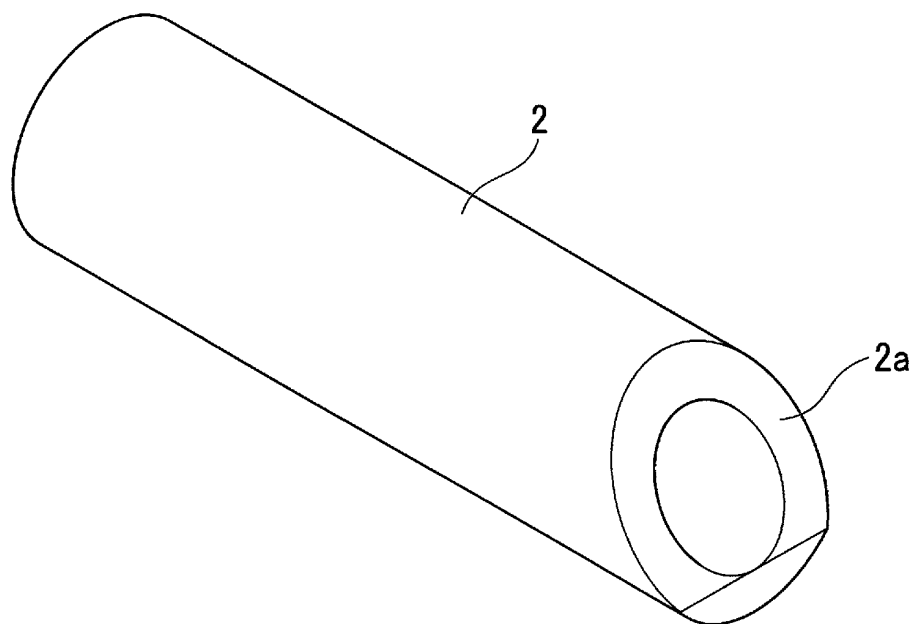
FIG. 3 is a perspective view showing a modified example of the sleeve.

As shown in FIGS. 3 and 4, in the structure having the inclined portion 2a formed by obliquely cutting the end portion on the inward side of the furnace, a front end side

thereof is sharpened, so that it can be easily inserted when disposed inside the tapping hole 1a, which is preferable.

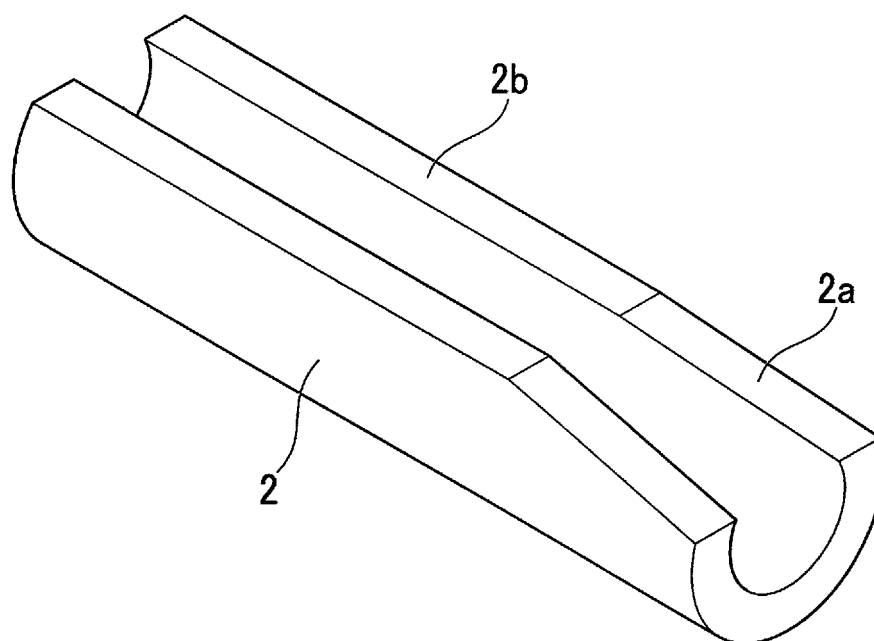
FIG. 4 is a perspective view showing another modified example of the sleeve.

[0026] In addition, during the dismantling, when a new sleeve 2 made of a fire-resistant brick, which has a half cylindrical shape formed by cutting a lower surface of a cylindrical member as shown in FIG. 4, is disposed instead of the worn and damaged old sleeve, although waste such as rubble remain in the space after the dismantling, the sleeve 2 is guided by the inclined portion

2a on the front end and properly inserted, so that the sleeve 2 can be easily mounted.

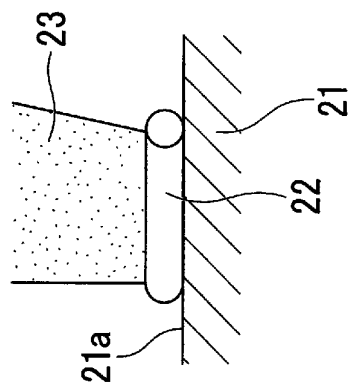
FIGS. 5A to 5D schematically show a repair method using the hot pouring method. FIG. 5A shows an initial state, FIG. 5B shows initial damage, FIG. 5C shows a state after a first repair, and FIG. 5D shows a state after a second repair. In FIGS. 5A to 5D, reference numeral 21 denotes a furnace wall brick, reference numeral 21a denotes a tapping hole provided in the furnace wall brick 21, reference numeral 22 denotes a pipe made of iron, which is disposed inside the tapping hole 21a, and reference numeral 23 denotes a ramming material filled into a gap between the pipe and the tapping hole 21a.

FIG. 5A is a cross-sectional view schematically showing a repair method using a hot pouring method and an initial state.

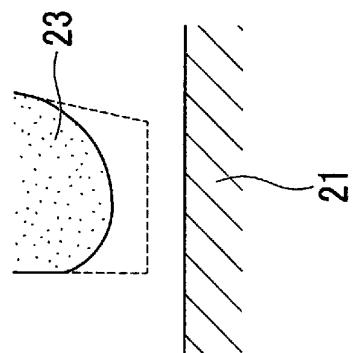
[0006] In the hot pouring method, as shown in FIG 5B, in a case where damage of the ramming material 23 occurs, a metal frame 24 for hot pouring is set outside of the furnace as shown in FIG 5C, and a pouring material 25 made of alumina and silicon carbide ceramics is injected for repair. However, since gas pressure is applied inside the furnace and scattered residuals after the dismantling remain, the pouring material 25 cannot reach the inner side, and correspondingly a space 26 is formed. Therefore, a complete restoration cannot be achieved. Furthermore, as shown in FIG. 5D, although the space 26 gradually increases, this cannot be prevented.

FIG. 5B is a cross-sectional view schematically showing the repair method and initial damage.

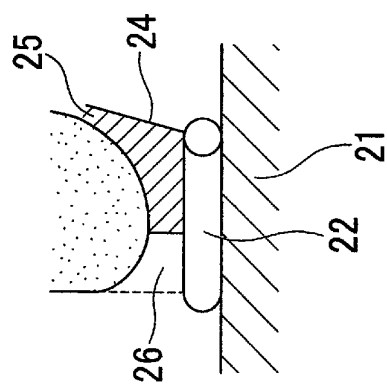
FIG. 5C is a cross-sectional view schematically showing the repair method and a state after a first repair.

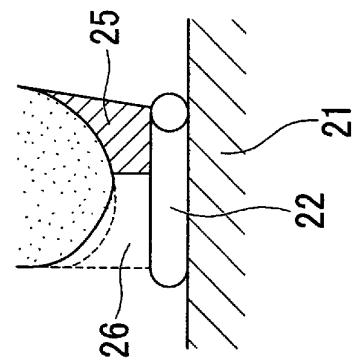
FIG. 5D is a cross-sectional view schematically showing the repair method and a state after a second repair.
