(11) EP 2 466 070 A2

(54) Method of repairing a transition piece of a gas turbine engine

(57) A method of weld repairing an air-cooled aft frame (26) of a transition piece (18) of a gas turbine engine (10). The transition piece (18) has an interior surface coated with a ceramic coating. The aft frame (26) has a surface (28) with cooling holes therein and from which cracks have propagated. The method includes removing the transition piece (18) from the engine (10) and, without

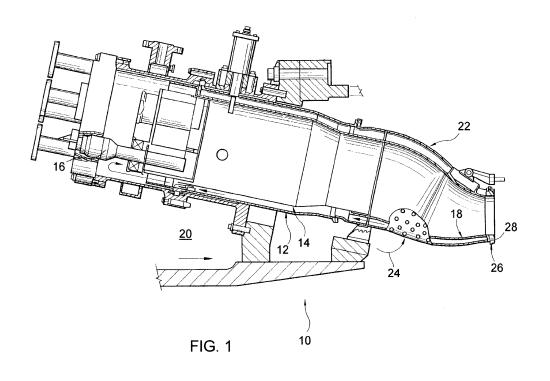
removing the ceramic coating or the aft frame (26) from the transition piece (18), weld repairing the cracks by performing a laser beam welding technique that deposits a filler material on the surface (28) but does not close the cooling holes in the surface (28). The surface (28) of the aft frame (26) can be machined to remove excess filler material prior to re-installing the transition piece (18) in a gas turbine engine (10).

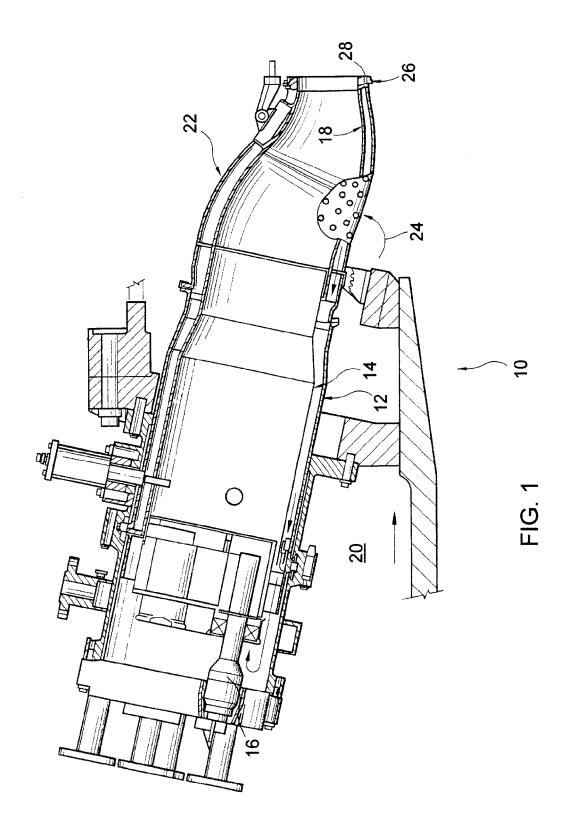
[0003] FIG. 1 schematically represents a cross-sectional view of a single annular combustor assembly of an industrial gas turbine engine 10. The combustor assembly is shown having a can-annular combustor 12, which is one of multiple combustors located about the periphery of the turbine engine 10. The combustor 12 has a cantype liner 14 whose interior defines a combustion chamber of the turbine 10. Multiple fuel nozzle assemblies 16 are located at the head end of the liner 14, while the aft end of the liner 14 is coupled to a transition piece 18. Hot combustion gases from the combustor 12 are conducted to the turbine section (not shown) of the engine through corresponding transition pieces 18. The combustors 12 and transition pieces 18 are disposed in a plenum 20 through which bleed air flows from the compressor section (not shown) of the engine 10. An impingement jacket (sleeve) 22 is represented as surrounding the transition piece 18, and bleed air 24 within the plenum 20 flows through the jacket 22 to impingement cool the outer surface of the transition piece 18. The transition piece 18 is equipped with a flange or frame 26 at its aft end, by which the transition piece 18 is connected to the turbine section. The aft frame 26 may also be cooled with bleed air, for example, by controlled bleed air leakage through a seal between mating seal lands of the frame 26 and turbine section, and/or cooling holes (not shown) that define openings at the seal land 28 of the frame 26 to allow bleed air to flow between the jacket 22 and transition piece 18 and then proceed through the frame 26 into a first stage nozzle section within the turbine section of the

engine. The frame 26 may be fabricated as a separate piece, and then subsequently welded to the aft end of the transition piece 18.

FIG. 1 is a partial cross-sectional view through a single annular combustor assembly of an industrial gas turbine engine. FIG. 2 schematically represents a portion of an aft frame of a transition piece, and cracks that have developed in a seal land of the aft frame that contains cooling holes.

[0014] The present invention will be described with reference to the transition piece 18 of the industrial gas turbine 10 discussed above in reference to FIG. 1. As such, an exemplary transition piece 18 has an exterior surface surrounded by an impingement jacket 22 that is attached to the transition piece 18, an interior surface coated with a TBC or other coating system suitable for thermally insulating the interior surfaces of the transition piece 18, and an air-cooled aft frame 26 adapted to attach the transition piece 18 to the first stage of a turbine section of a gas turbine engine. Furthermore, transition pieces of interest to the invention may be formed of a variety of materials, particular examples of which include nickel-based alloys such as Nimonic C263, Hastelloy X, Inconel 617 and Udimet 500. Finally, the invention is directed to performing a weld repair of cracks that have propagated from cooling holes in a seal land 28 of the aft frame 26, for example, as schematically represented in FIG. 2. Typical configurations for the cooling holes include centerto-center spacings of about 1.25 to about 15 millimeters and diameters of about 0.020 to about 0.080 inch (about 0.5 to about 2.0 mm). However, it should be understood that the invention is not limited to transition pieces having the specific configuration shown in FIGS. 1 through 3, but instead is applicable to other transition pieces adapted for use in a variety of combustor configurations.

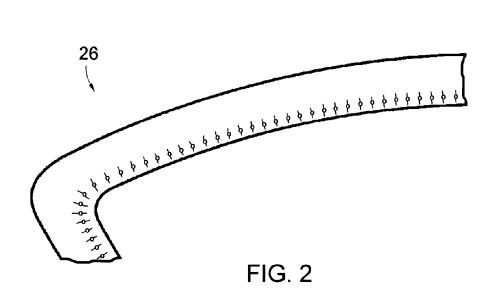
[0005] The aft frame 26 is subject to damage resulting from the combination of high temperatures and stresses that can lead to distortion and fatigue. Because the cooling holes act as stress concentrators, the material of the frame 26 surrounding the holes can be particularly susceptible to cracking due to thermo-mechanical fatigue (TMF). Close spacing between holes and small diameters of the holes (typically about 0.020 to about 0.080 inch (about 0.5 to about 2.0 mm)) tend to aggravate the cracking tendency. Steep temperature gradients are another factor that promotes cracking. The result is that multiple cracks may propagate from individual cooling holes, as seen in FIGS. 2 and 3, which show a transition piece that has seen service in an industrial gas turbine engine.

[0018] In an investigation leading to the invention, a transition piece was removed from service in an industrial gas turbine engine, and discovered to have cracks in its aft frame emanating from cooling holes in the seal land of the aft frame. The transition piece and the aft frame were formed of Nimonic C263, which has a composition of, by weight, 19-21% chromium, 19-21% cobalt,

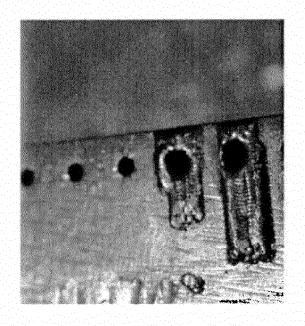
.IG. 3

FIG. 3 is a scanned image showing the result of weld repairing an aft frame of the type represented in FIGS. 1 and 2 using a welding process in accordance with the present invention, and FIG. 4 is a scanned image showing the result of removing excess weld material from the weld repair of FIG. 3.

[0019] Two of the resulting weldments are seen in FIG. 3, which evidences that a slight build-up of weldment occurred without any significant encroachment into the cooling holes. Furthermore, no melting or spalling of the TBC was observed. Additional cracks were welded in the aft frame in the same manner, after which the seal land was machined by hand blending using an abrasive wheel or belt to remove excess weldment projecting above the surrounding surface of the seal land. The results of this blending operation can be seen in FIG. 4. From these results, it was concluded that the pulsed laser beam welding technique successfully repaired the cracks without depositing excess filler material that would require redrilling the cooling holes. Furthermore, it was concluded that, because the low heat input of the welding technique did not melt or spall the TBC, stripping of the TBC prior to the weld repair was unnecessary. It was also concluded that the low heat input of the welding technique would eliminate the need to disassemble the impingement jacket from the transition piece, and eliminate the need to heat treat the transition piece following the weld repair. As such, the weld repair eliminates the need to reapply the TBC and reattach the impingement jacket. Consequently, the laser beam welding process performed on the transition piece was concluded to be less costly and time consuming than prior methods of repairing aft frames of transition pieces.
