**0 359 586 B1**

## EUROPEAN PATENT SPECIFICATION

(54) **Turbine blade repair.**

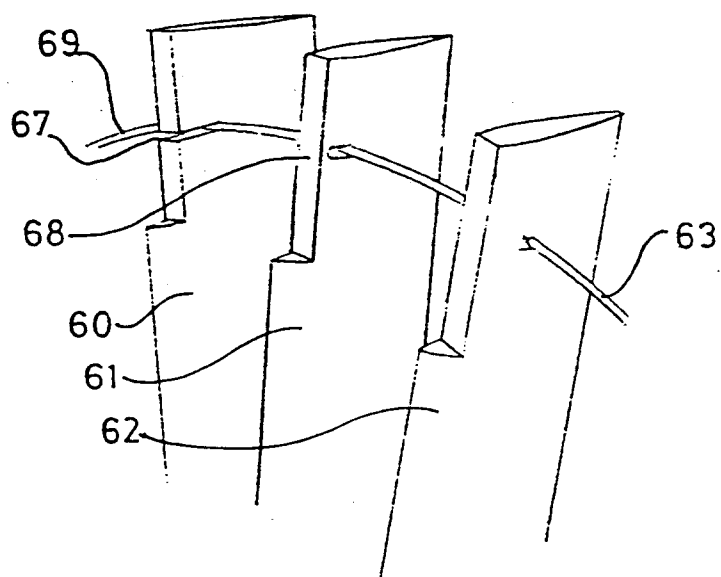
FIG 9

FIGURE 9 is a view of the blades shown in Figure 8 following the formation of slots into the blades to enable release of the lacing wire.

25 The replacement of an erosion shield, such as those shown at 64, 65 and 66 is a not infrequent repair and it is usual to cut out the piece of material of the blade carrying the shield since usually, not only the shield but also part of the blade surrounding the shield, is also eroded and Figure 9 illustrates the blades 60, 61 and 62 in which the erosion shields have been removed.
