54 **Near infrared polyethylene inspection system and method.**

## NEAR INFRARED POLYETHYLENE INSPECTION SYSTEM AND METHOD

This invention relates to an inspection system and the method of operating that system for inspecting polyethylene jacketed cable.

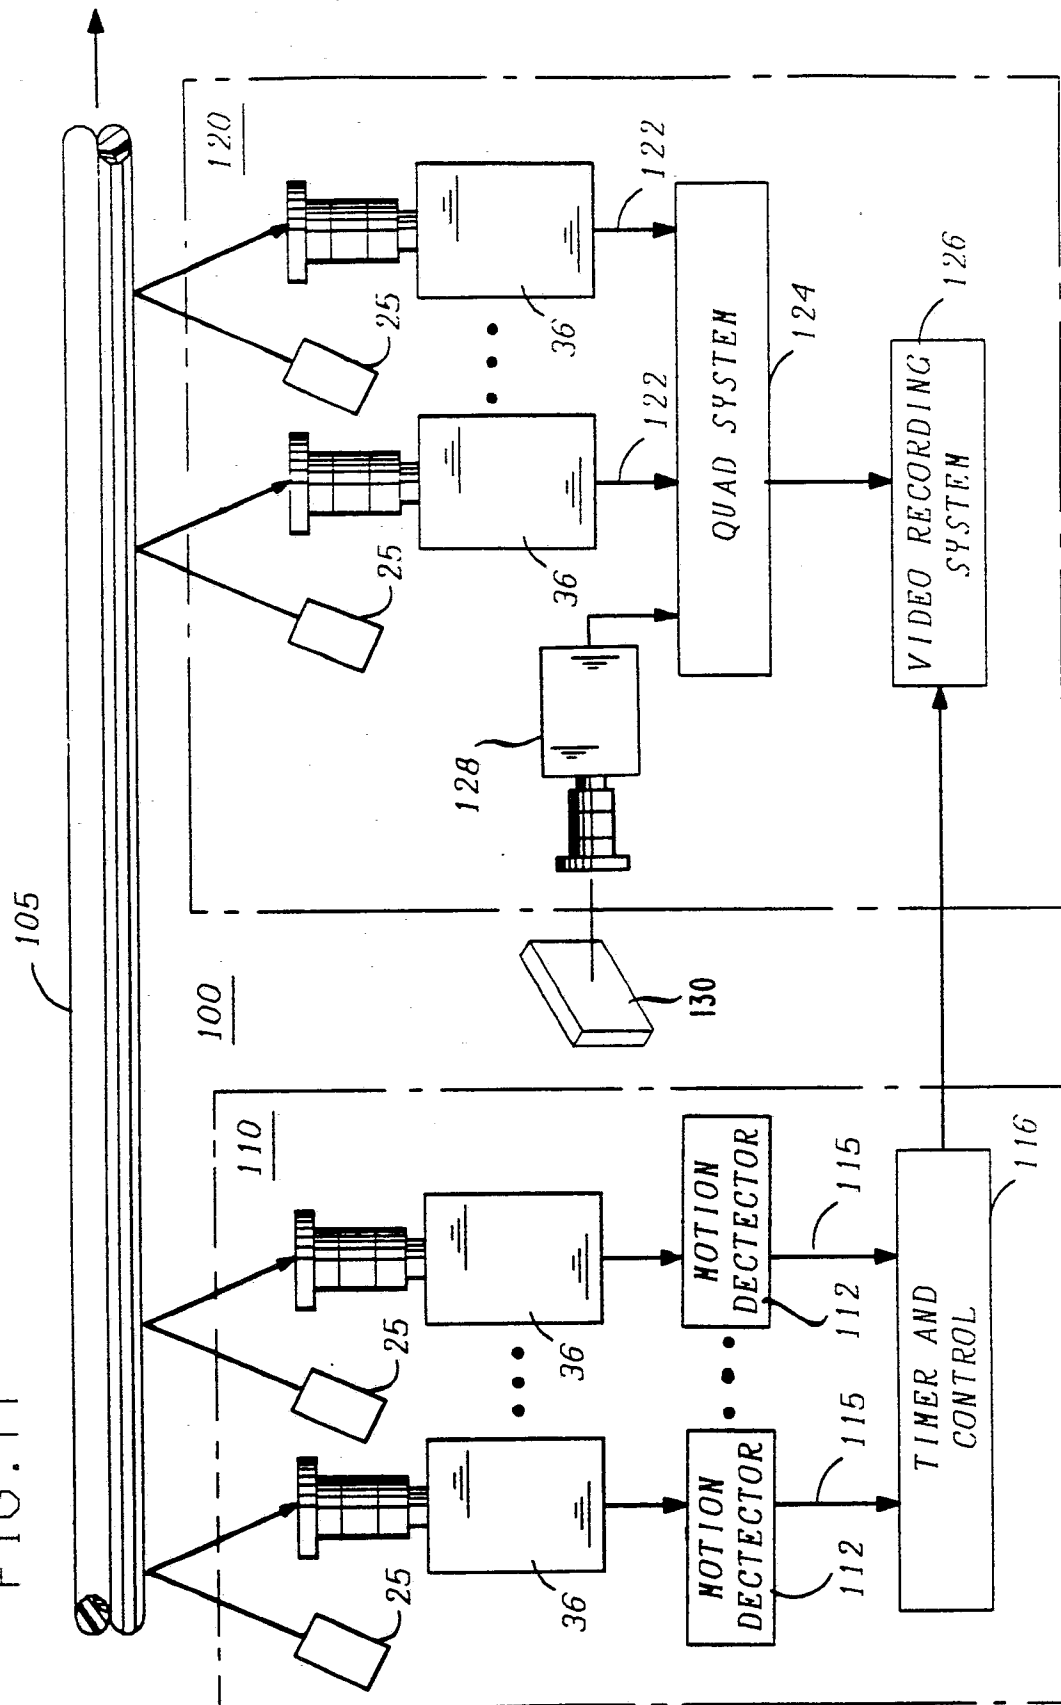
FIG. 11 is a diagram of an arrangement for performing continuous non-destructive reflective inspection of the bulk of a natural polyethylene jacket of a continuously moving cable; and
