**EP 1 563 945 A2**

**EUROPEAN PATENT APPLICATION**

(57) A method of repairing an article, such as turbine parts of a rotary gas turbine engine, affected by sulphidation includes the steps of providing an article having a section affected by sulphidation (20), removing the affected section, and laser cladding a replacement section (50) to the article.

**[0001]** The present invention relates to a method of repairing an article affected by sulphidation, such as a gas turbine engine part.

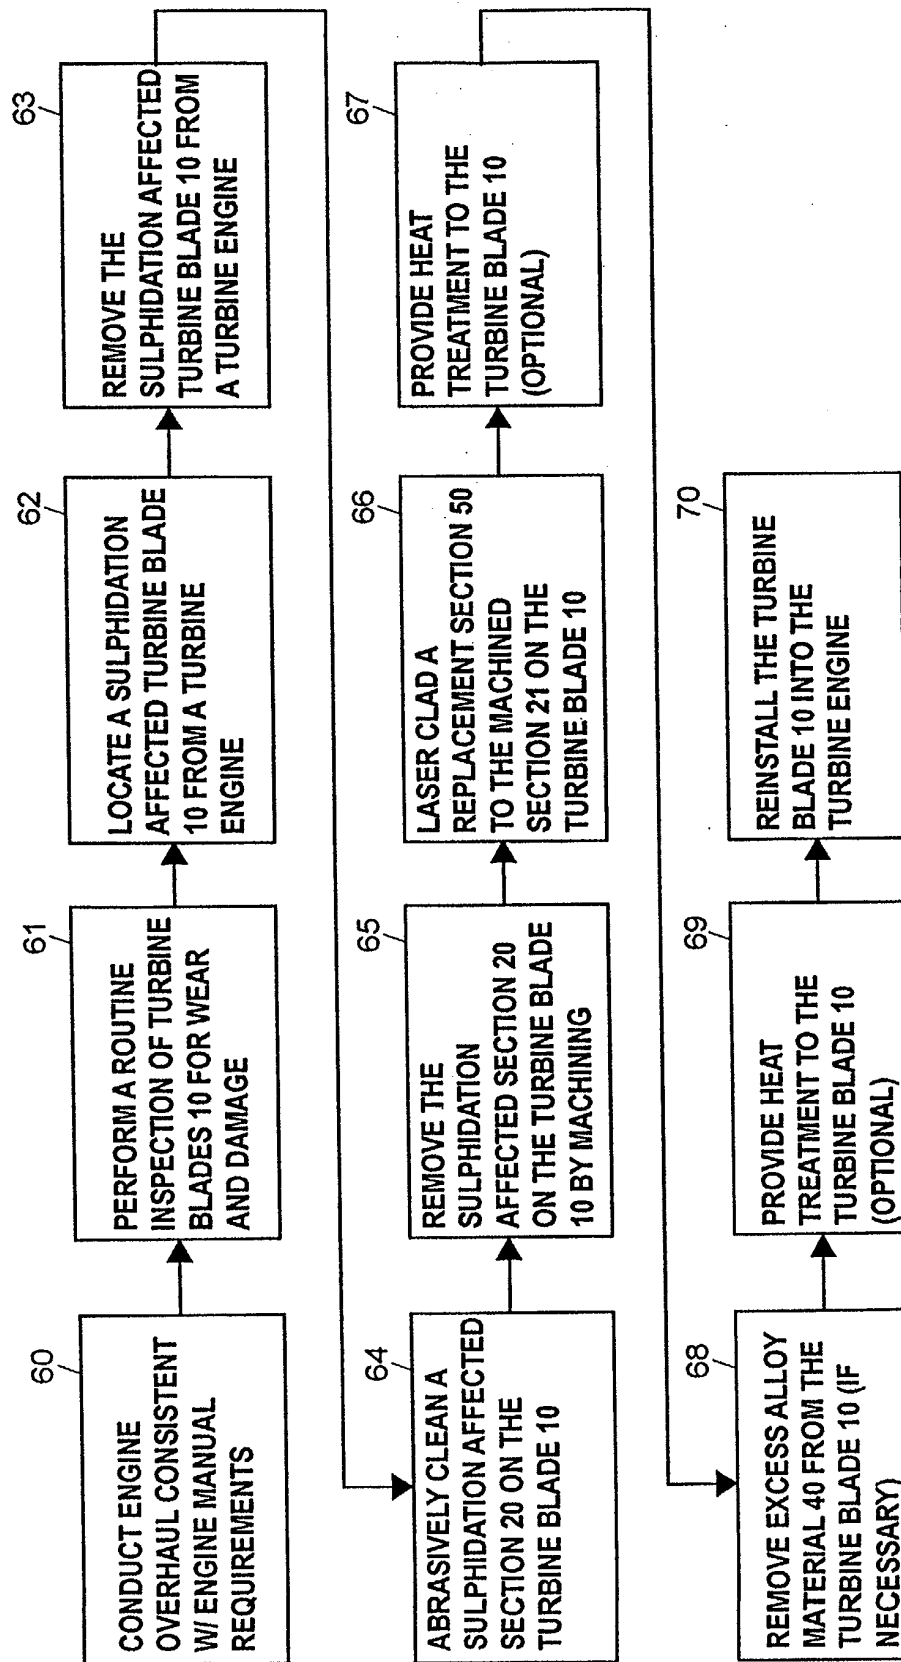
FIG. 8 is a flow diagram of an embodiment of the method of platform repair by laser cladding.
