(11) **EP 1 564 371 A2**

(71) Applicant: **United Technologies Corporation**  
**East Hartford, CT 06108 (US)**

(54) **Method of repair for cast article**

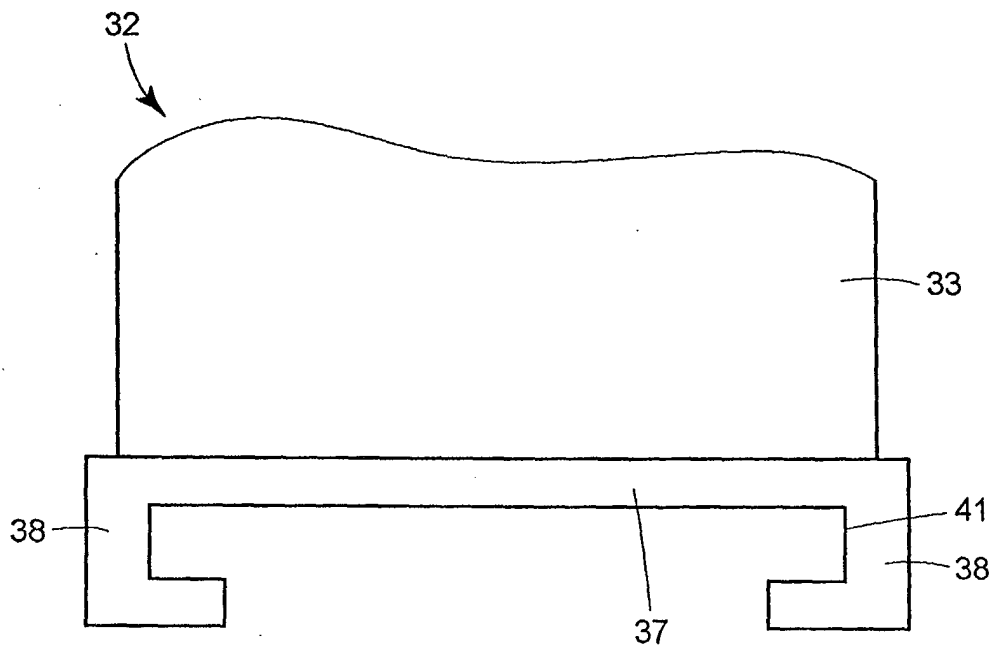
**FIG. 8**

FIG. 8 is a schematic view of the foot and the replacement foot of FIG. 7 after machining.
