(11) **EP 1 701 004 A1**

(54) **Gas turbine blade having a monocrystalline airfoil with a repair squealer tip, and repair method**

(57) A repaired gas turbine blade (20) has a monocrystalline airfoil (22) made of a first nickel-base superalloy, and a repair squealer tip (46) welded to a tip of the airfoil (22). The repair squealer tip (46) is made of a second nickel-base superalloy different from the first nickel-base superalloy and having less than about 0.15 weight percent total of carbon, boron, silicon, zirconium, and hafnium.

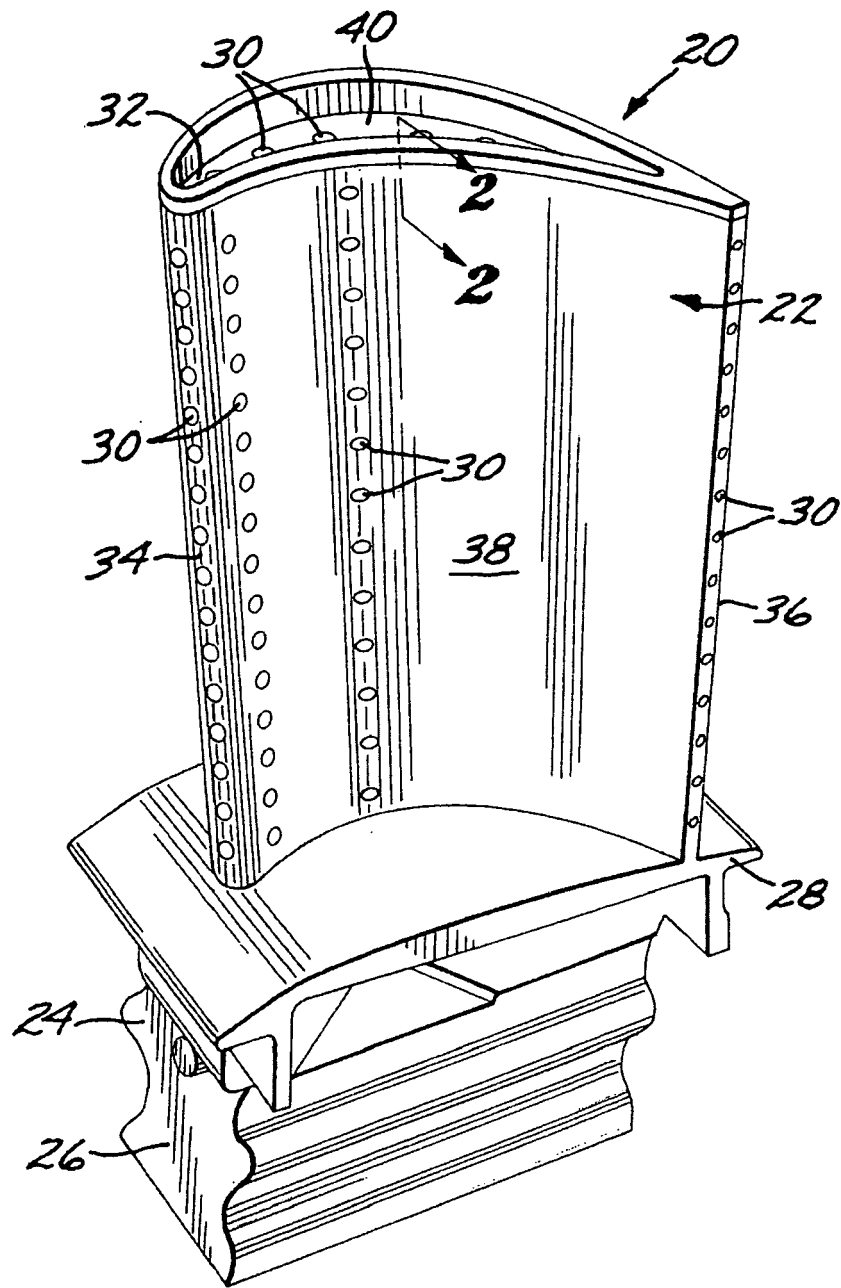
FIG. 1

Figure 1 is a perspective view of a gas turbine blade;

**[0015]** Figure 1 depicts a gas turbine blade 20 which has preferably previously been in service. The previous service is operation in a gas turbine engine in its normal operating circumstances. The gas turbine blade 20 has an airfoil 22 against which the flow of hot combustion gas impinges during service operation, a downwardly extending shank 24, and an attachment in the form of a dovetail 26 which attaches the gas turbine blade 20 to a gas turbine disk (not shown) of the gas turbine engine. A platform 28 extends transversely outwardly at a location between the airfoil 22, and the shank 24 and dovetail 26. The airfoil 22 may be hollow so that cooling air may be forced through the airfoil 22, with the flow of cooling air exiting the airfoil 22 through air-flow holes 30 found on a tip 32, a leading edge 34, a trailing edge 36, and the lateral sides 38 of the airfoil 22.

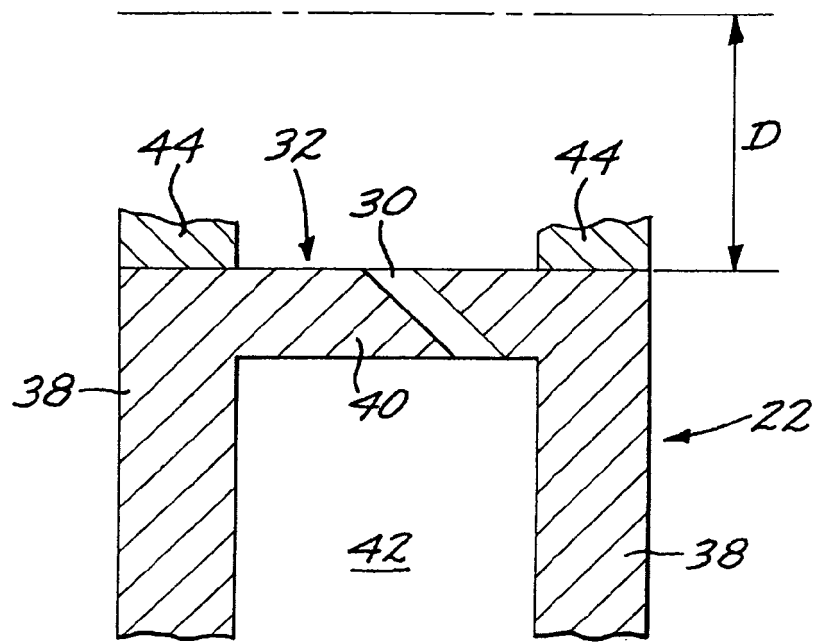
FIG. 2

Figure 2 is a sectional detail of the gas turbine blade of Figure 1, taken on line 2-2, after service but prior to repair;

**[0018]** Figure 2 illustrates the region near the tip 32 of the airfoil 22 (which is also the tip of the turbine blade 20) in greater detail. The airfoil 22 includes its lateral sides 38 and a tip cap 40, which together define a hollow volume 42 through which the cooling air passes to exit at the air-flow hole 30.

**[0020]** The squealer tip of a new-make gas turbine blade 20 starts out with a length indicated by the dimensional marker D, but is gradually worn, oxidized, corroded, and burned away to a length such as shown for the squealer tip 44 of Figure 2. This shortening of the squealer tip 44 allows hot combustion gas to leak around the gas turbine, so that the efficiency of the gas turbine is reduced. It is therefore conventional practice during refurbishment of the gas turbine to repair and lengthen the squealer tips of the gas turbine blades 20 back to substantially the same length as indicated by the dimension D. The loss of efficiency of the gas turbine due to damage to the squealer tip is thereby eliminated.

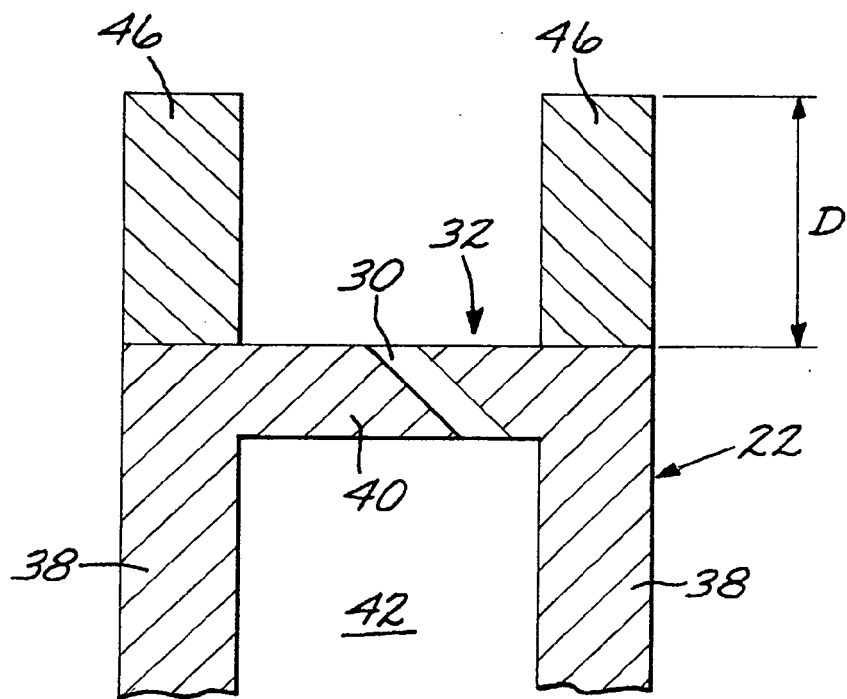
FIG. 3

Figure 3 is a sectional detail of the gas turbine blade of Figure 1, taken on line 2-2, after service and after repair; and

**[0021]** To effect the repair, there is a repair squealer tip 46 welded to the tip 32 of the airfoil 22 to restore the length of the squealer tip to the desired value D, as shown in Figure 3. The repair squealer tip 46 is made of a second nickel-base superalloy having less than 0.15 weight percent total of carbon, boron, silicon, zirconium, and hafnium. More preferably, the repair squealer tip 46 has less than 0.10 weight percent total of carbon, boron, silicon, zirconium, and hafnium, and most preferably less than 0.05 weight percent. The second nickel-base superalloy preferably has a composition that is different from that of the first nickel-base superalloy, particularly in that it is weldable.
