(12) **EUROPEAN PATENT APPLICATION**

(71) Applicant: **United Technologies Corporation**
Hartford, CT 06101 (US)

(54) **Process for repairing turbine engine components**

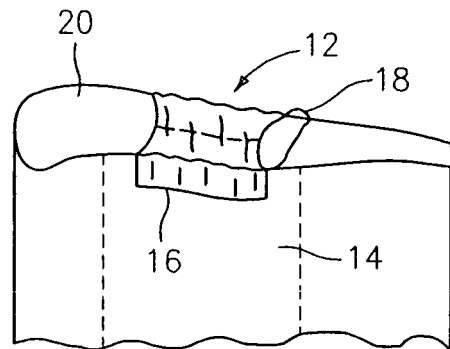
(57) A process for repairing a component includes the steps of placing a piece of refractory metal material (16) over an area (12) of component to be repaired; depositing a repair filler metal (18) material proximate to the piece of refractory metal material (16) in an amount

sufficient to repair the component; subjecting the repair filler material (18) to a welding treatment without directly heating the piece of refractory metal material (16); flowing the repair filler material (18) within the area (12); and casting the repair filler material (18).

FIG. 2 is a representation of a prepared turbine engine blade with a refractory metal core inserted into a damaged area of the blade tip; and

[0011] Referring now to FIG. 2, a tip 20 of a turbine blade to be repaired is illustrated. The blade tip 20 has

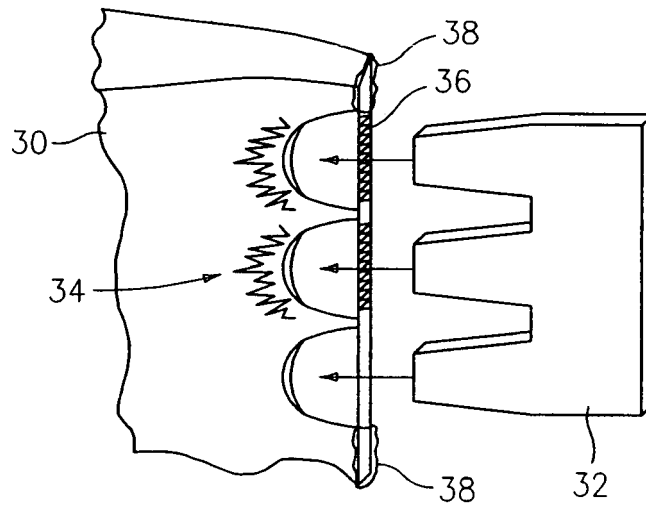
FIG. 3 is a representation of a prepared turbine engine blade with a refractory metal core inserted into a damaged area of the trailing edge.

[0018] Referring now to FIG. 3, a process for repairing a trailing edge 30 of a turbine blade is illustrated. A piece 32 of refractory metal material is first cut to conform to the shape of the blade trailing edge and any internal cavity 36 therein. Any suitable cutting technique known to one of ordinary skill in the art such as laser cutting, photo etching, stamping, or water jet cutting may be used to cut the refractory metal material. The refractory metal material may be one of the aforementioned materials and may be coated or uncoated as known to one of ordinary skill in the art. The piece 32 of refractory metal material, preferably in foil form, may be placed over the area 34 to be repaired. One of the aforementioned repair filler metal materials 38 may then be deposited proximate to the piece of refractory material 32 and subjected to a welding treatment.
