(11) **EP 1 978 346 A1**

(54) **Method for checking surface condition after cleaning process**

(57) Methods for inspecting gas turbine component parts for possible distress after hydrogen fluoride cleaning are disclosed. The methods selectively remove a small amount of material for intergranular attack (IGA) analysis, determine corrosion in the component part, and restore the component part back to its original dimensions.

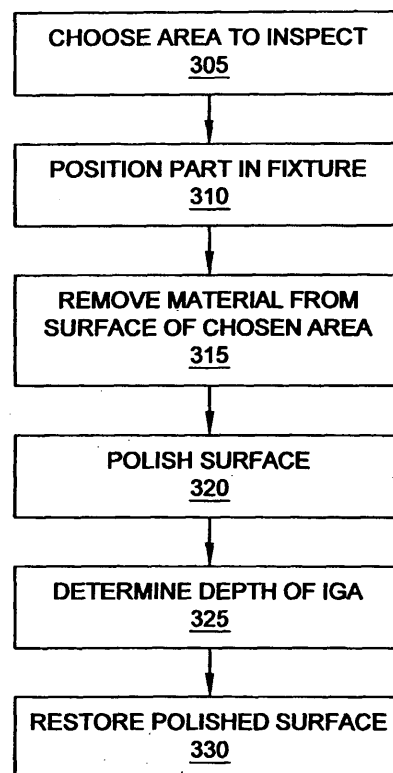
**Fig. 3**

FIG. 3 is a block diagram of an exemplary inspection method according to the invention.

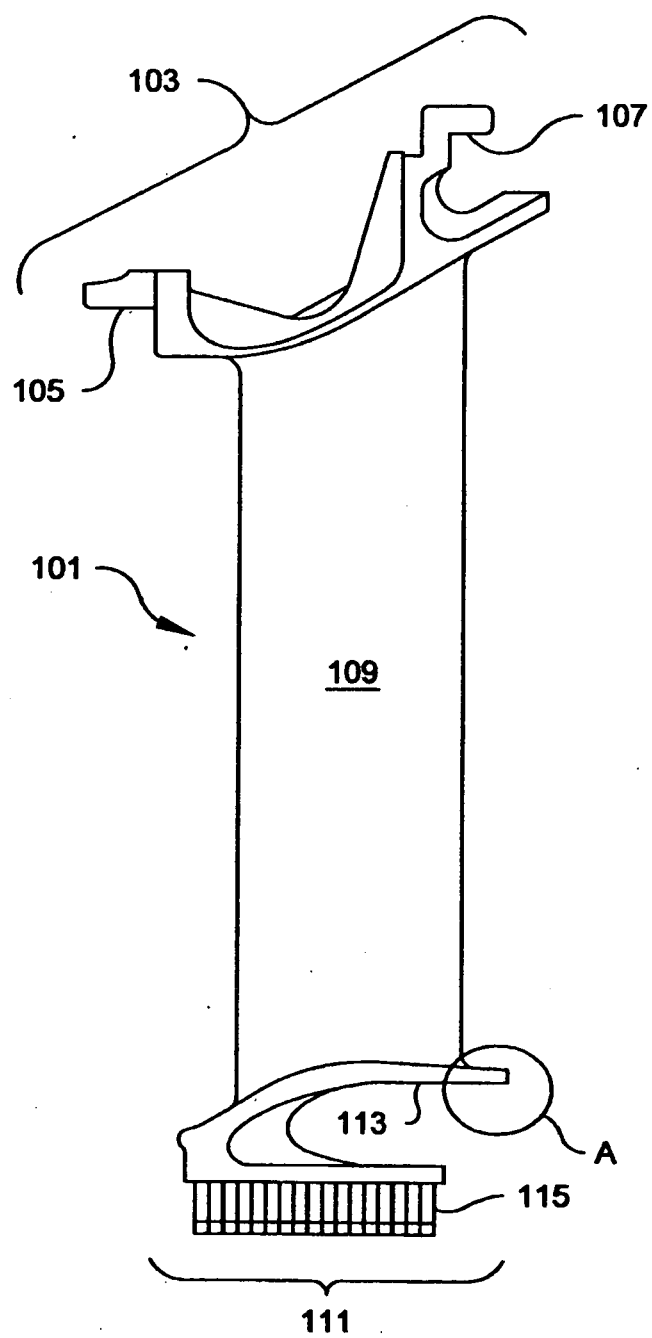
***Fig. 1***

FIG. 1 is an exemplary gas turbine vane showing a post cleaning inspection point.

**[0017]** Shown in FIG. 1 is an illustration of a turbine vane 101 that has undergone HF cleaning. Areas of the turbine vane 101 include an outer platform 103 that includes front 105 and rear 107 hook attachments, an airfoil section 109, and an inner platform 111 that includes a rear inner platform edge 113 and a honeycomb seal 115. Shown in FIG. 3 is an exemplary, non-limiting method of the invention. The method examines an area that is typically the most vulnerable and susceptible to IGA. An area, A, determined to be susceptible may be chosen for inspection (step 305). In embodiments, the exemplary area, A, of the rear inner platform edge 113 is chosen due to its gas path and non-gas path exposure, accessibility, and ease of repair after performing the inspection method. The surface chosen for examination may be a marginally loaded edge, or surface, such that performing the method does not impact the structural integrity of the component part. The part 101 may be put in a fixture for positioning and to provide an examination surface reference (step 310).

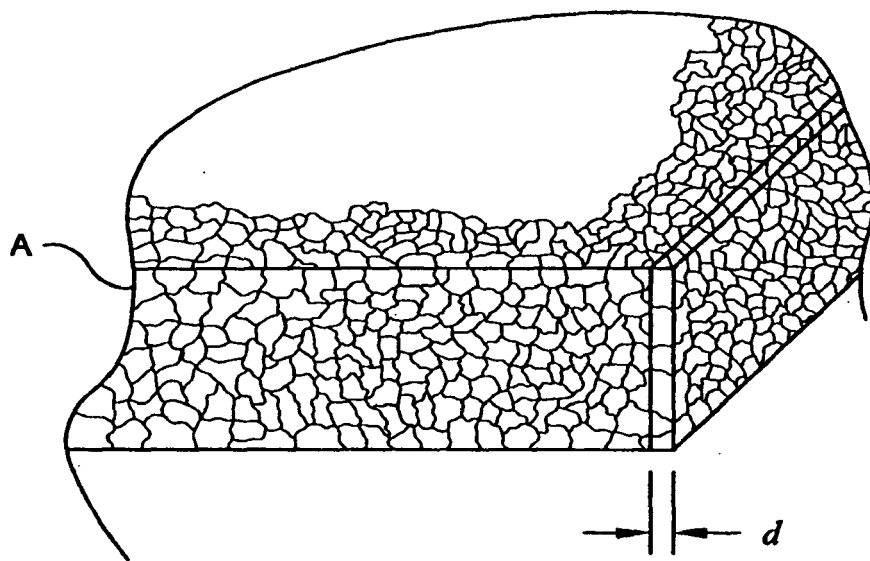
***Fig. 2***

FIG. 2 is the inspection point from FIG. 1 showing intergranular attack affecting all cleaned surfaces.

**[0018]** Material may then be removed from the surface of the chosen area (step 315) to a predetermined depth as shown in FIG. 2 (in embodiments, about 0.010 to 0.020 inch (0.25 to 0.51 mm) deep) using a series of abrasive papers that may be comprised of SiC, aluminum
