EP 1 995 409 A2

(54) **Repair method for turbine vanes**

(57) A method of repairing a vane cluster for a gas turbine engine includes attaching (84) a first registration block (90A,90C) to a salvageable airfoil segment (88A) of the vane cluster (88), machining (86) a face of the first registration block (90A,90C) relative to datum surfaces of the vane cluster (88), removing (106,110) a damaged airfoil segment from the vane cluster (88), adding (112) new material to the salvageable airfoil segment (88A), joining (122) a replacement airfoil segment (88B) having a second registration block (90E,90F) to the salvageable airfoil segment (88A) to replace the damaged airfoil segment, removing (130) the first registration block (90A,90C), and removing (130) the second registration block (90E,90F). The respective first and second registration blocks of the salvageable airfoil (88A) segment and the replacement airfoil segment (88B) are aligned in a configuration substantially identical to a configuration of the vane cluster (88) prior to undergoing repair.

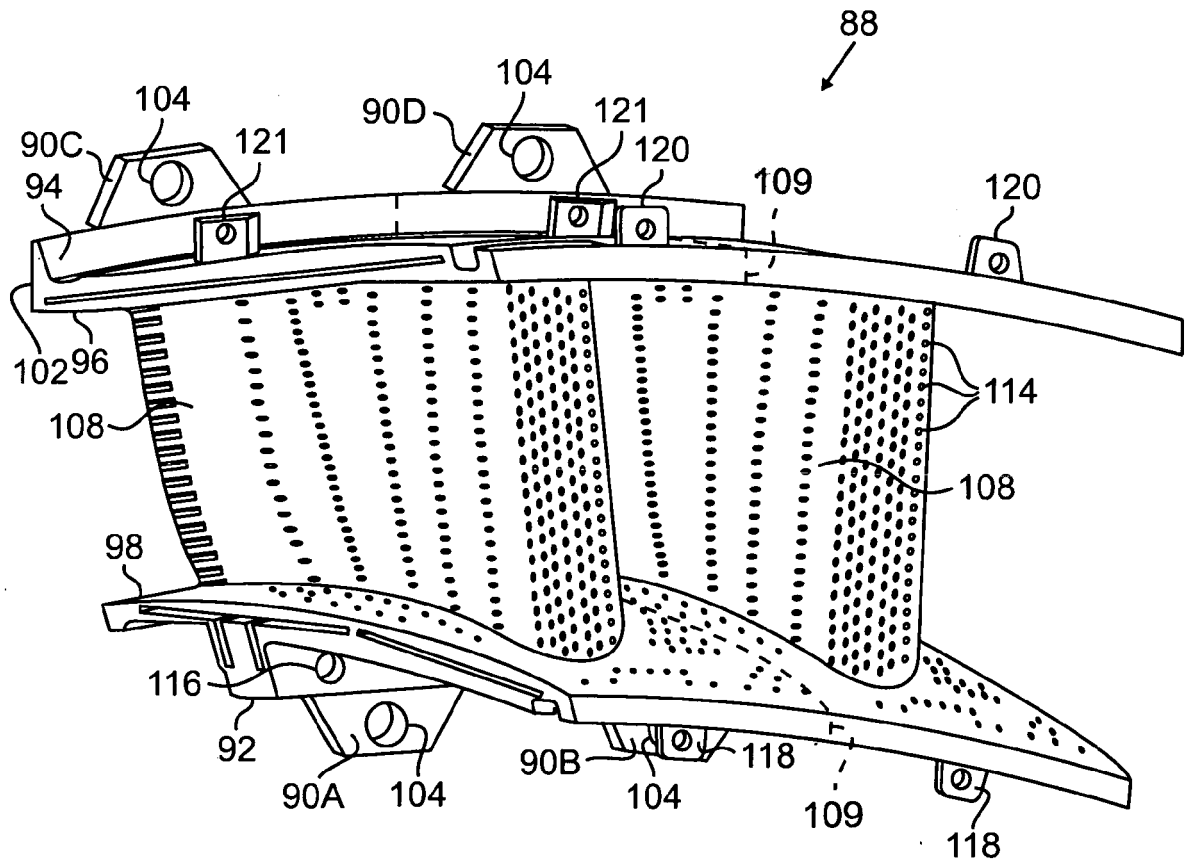
FIG. 2 is a perspective view of the HPT nozzle segment having registration blocks attached thereto.

[0009] Registration blocks are then attached to the nozzle segment (step 84), which can be accomplished by welding, brazing or other firm attachment processes. Once the registration blocks are attached, they are machined to register vane datums in a desired number of dimensions (step 86). Steps 84 and 86 of the repair process can be better understood with reference to FIG. 2, which is a perspective view of a HPT nozzle segment 88 having machined registration blocks 90A-90D (collectively 90) attached thereto. The registration blocks 90A-90D are each generally trapezoidal-shaped, and are made of a metal such as steel. In the illustrated embodiment, the registration blocks 90A and 90B are attached to an inner side of an inner flange 92 of the nozzle segment 88 and the registration blocks 90C and 90D are attached to an outer side of an outer flange 94, such that the registration blocks 90 are supported by outer and inner platforms 96 and 98 of the nozzle segment 88.

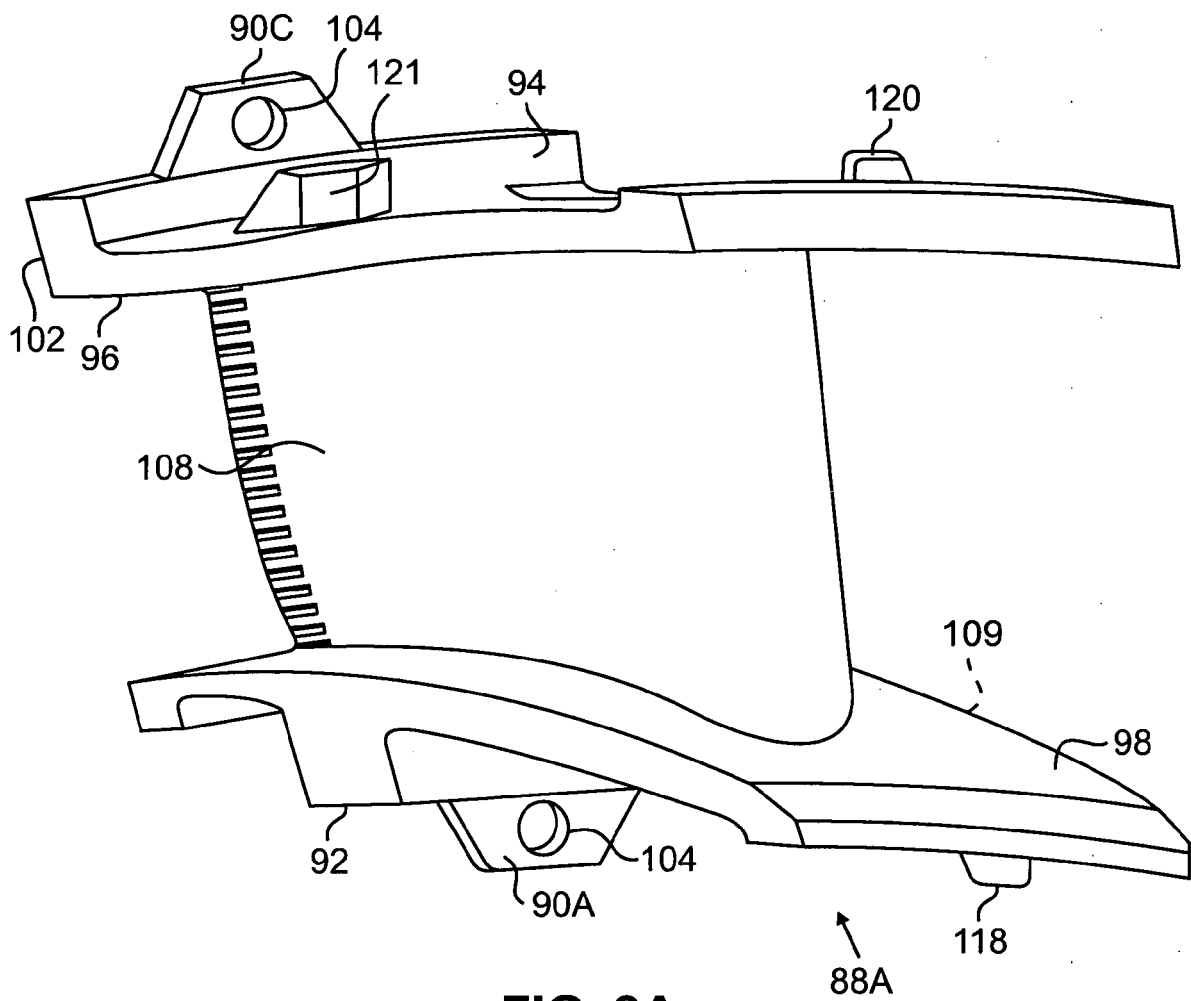
FIG. 3A is a perspective view of a salvaged vane singlet cut from the original HPT nozzle segment and having material added.

[0013] FIG. 3A is a perspective view of a salvaged vane singlet 88A that has been cut from the original HPT nozzle segment 88 shown in FIG. 2. The salvaged singlet 88A as shown in FIG. 3A has had new material added subsequent to being cut from the nozzle segment 88. For example, the cooling openings 114 have been filled in, material has been added at the perimeters of both the outer and inner platforms 96 and 98, and material has been added where machining was performed at the cut location 109. As noted above, the areas where new material is added for a particular repair will vary as desired.

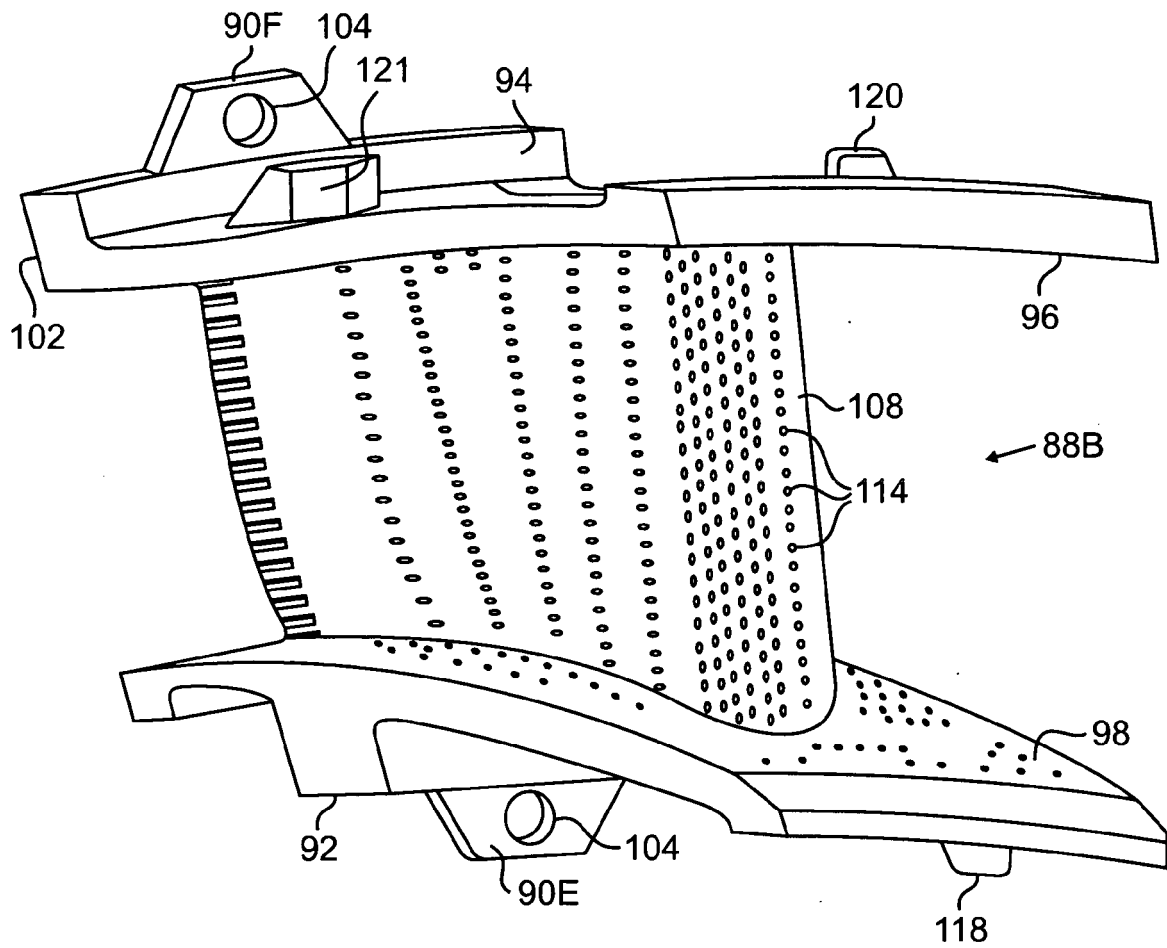
FIG. 3B is a perspective view of a newly manufactured replacement vane singlet.

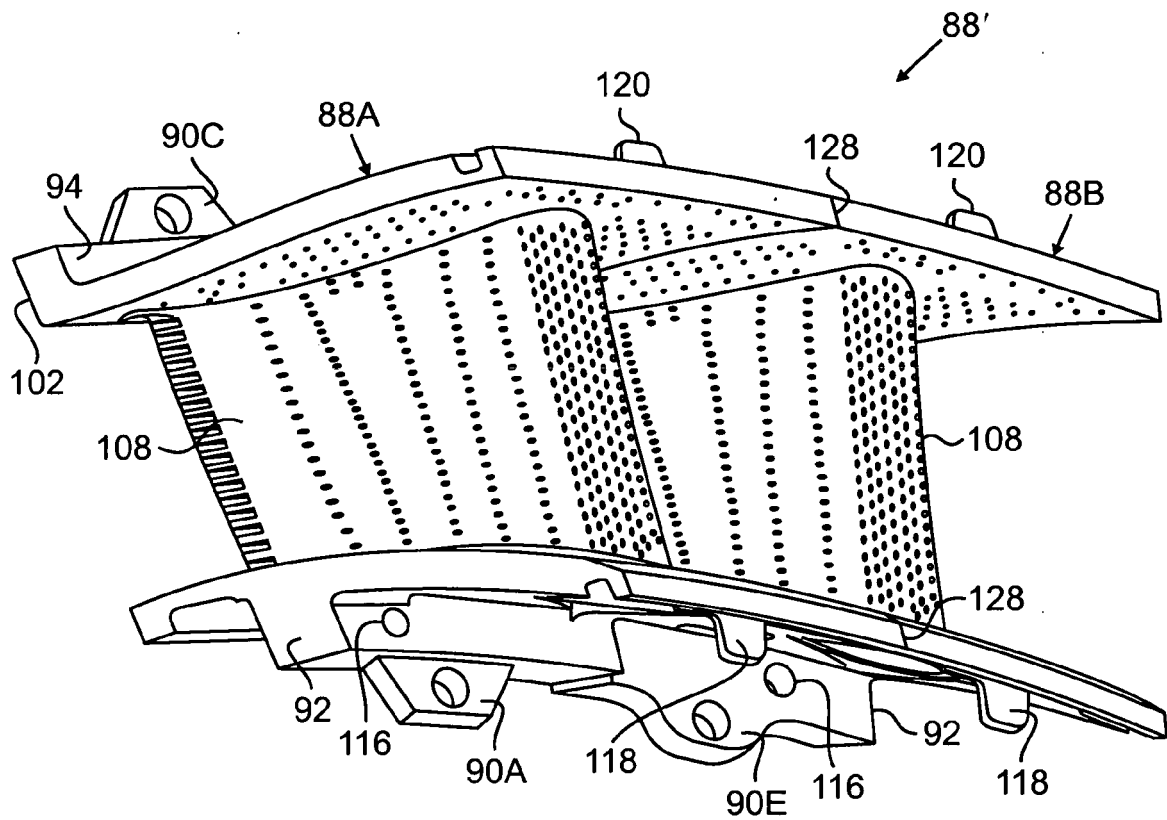
FIG. 4 is a perspective view of the salvaged vane singlet of FIG. 3A and the newly manufactured replacement vane singlet of FIG. 3B joined together.

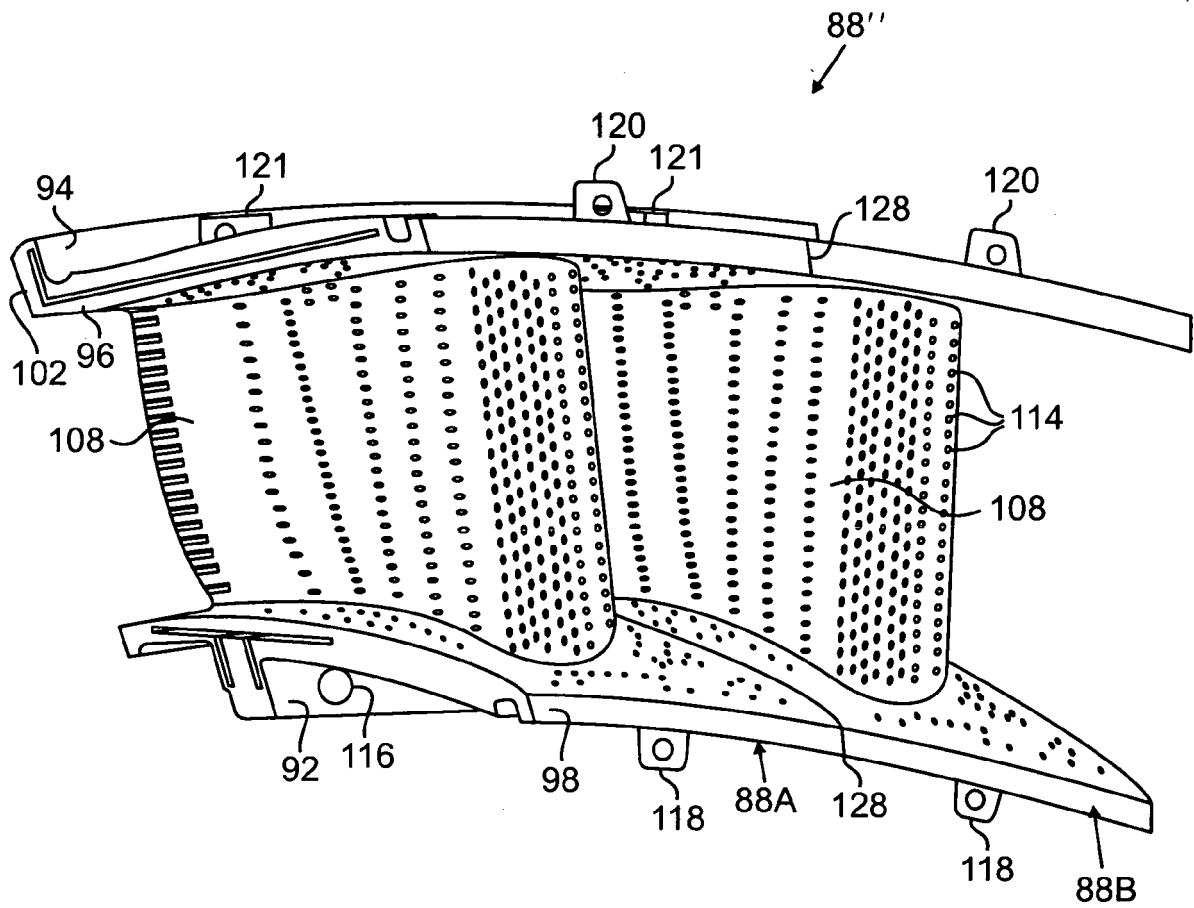
FIG. 5 is a perspective view of a repaired HPT nozzle segment.
