(11) EP 2 028 342 A2

(54) Method of repair of a turbine blade tip

(57) A method of repair of a turbine blade (30) involves inspecting a turbine blade (30) having an internal cavity (54) and a cap (42). The cap (42) is removed and replaced with a replacement cap (46). The replacement

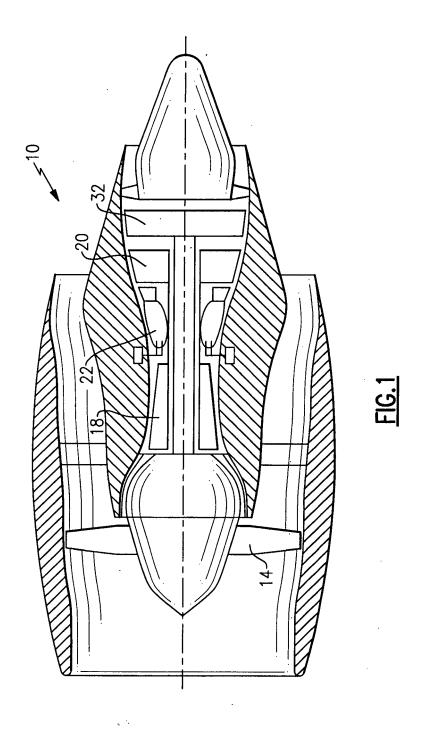
[0010] Figure 1 illustrates an example of a gas turbine engine 10, here a turbofan engine, that would benefit from the inventive repair technique. As other types of gas turbine engines will likewise benefit from the inventive technique, the term gas turbine engine is not limited to the disclosed embodiment. As shown, gas turbine engine 10 has fan 14 which propels ambient air into gas turbine engine 10. Multistage high and low pressure compressors 18 compress the air. The compressed air is then mixed with fuel and ignited in a combustor 22, where the gas expands. Expanded gas then passes through high pressure turbine section 20 and low pressure turbine section 32 as known and passes out of gas turbine engine 10. **[0011]** Figure 2 illustrates a turbine blade 30 as known in the art. Here, turbine blade 30 is shown in cut-away cross-section. As shown, turbine blade 30 has blade body 34 and blade tip 38. In addition, blade tip 38 has cap 42 that covers internal cavity 54. Squealer 50, a rail, extends around the perimeter 62. Within blade body 34 is internal cavity 54, which has structural supports 66 extending throughout to support turbine blade 30 as known. Between structural supports 66 are cooling passages 67, 69. These cooling passages 67, 69 permit air to cool blade body 34 as known. Cap 42 has internal cavities 71 that permit air to come close to surface 73 of cap 42 for air to cool so as to relieve heat buildup within blade body 34.

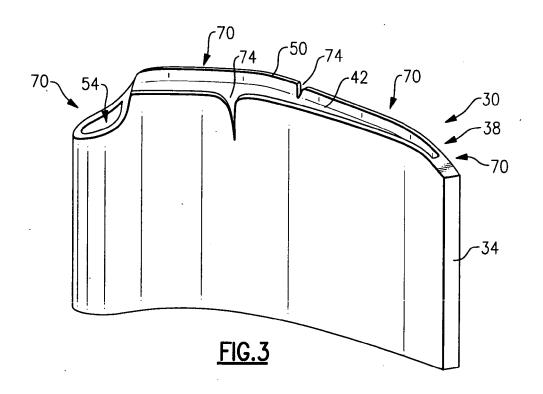
Figure 3 illustrates an example of a worn turbine blade.

[0012] Due to stress and wear, turbine blade 30 may develop areas of wear 70 and cracks 74, as shown in Figure 3. Indeed, areas of wear may be large enough to expose internal cavity 54 as shown. Because of the high expense of replacing turbine blade 30, it may be desirable

[0013] As shown in Figure 3, the inventive repair technique involves grinding down squealer 50 of the worn turbine blade 30 shown in Figure 3 to the level of cap 42 as shown in Figure 4. Following this step, areas of wear 70 and cracks 74 are built-up by welding with weld wire to the level of cap 42. When this step is complete, cap 42 is removed by electrical discharge machining, leaving blade body 34 with exposed internal cavity 54 as shown in Figure 5.

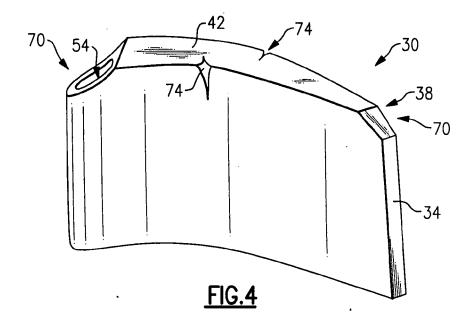
Figure 4 illustrates an aspect of the inventive technique of repairing a turbine blade.

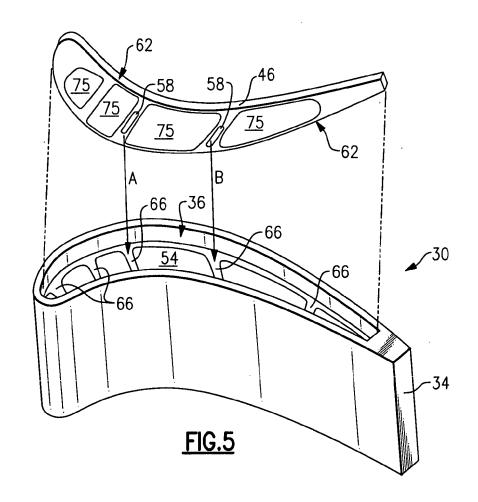
Figure 5 illustrates another aspect of the inventive technique, highlighting replacement cap with openings permitting access to an internal cavity of the turbine blade.

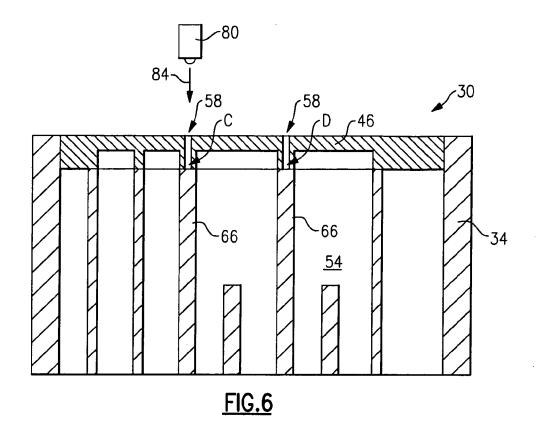
Figure 6 illustrates a side cross-sectional view of the turbine blade with replacement cap.

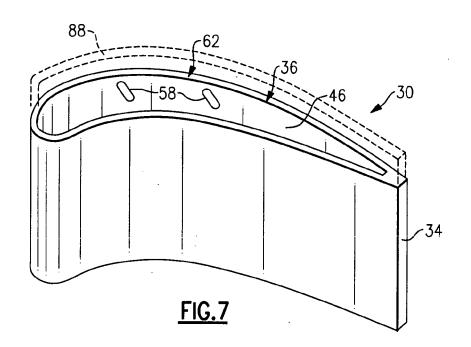
Figure 7 illustrates a perspective view of the turbine blade with replacement cap.
