(12) **EUROPEAN PATENT APPLICATION**

(71) Applicant: **United Technologies Corporation**
Hartford, CT 06101 (US)

(54) **Method of repairing a turbine engine component**

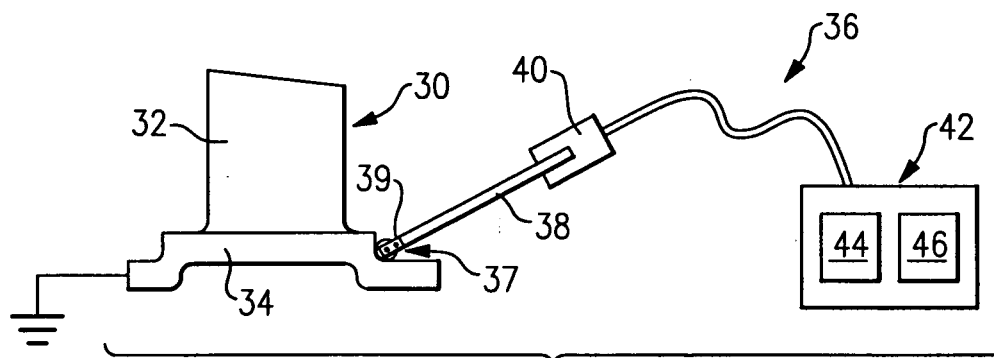
Figure 2A is a schematic view an electrospark deposition (ESD) process.

Figures 2B-2D are respectively schematic views of a worn or damaged area, material deposited onto the worn or damaged area, and the material in the previously worn or damaged area subsequent to machining.

[0011] Referring to Figures 2A-2D, the example airfoil 30 includes an airfoil portion 32 extending from a platform 34. The platform 34 is used to locate the airfoil 30 in the axial and radial directions. The airfoils 30, are arranged circumferentially about the rotational axis A of the turbine engine 10. Various features of the platform 34 are subject to galling or damage, which can render the airfoil 30 scrap. In one example, an electrospark deposition (ESD) process is employed to repair the worn or damaged area.

[0013] In operation, the airfoil 30 is grounded. An arc 37 is generated between the rod 38 and a repair area 60 having a worn area 62. In one example, the rod 38 is constructed from a material that is substantially the same material as the airfoil 30. In another example, the rod 38 is constructed from a material with substantially different properties than the airfoil 30 in order to increase wear resistance or impart some other desirable property to the repaired area. The arc 37 is pulsed, which delivers material 39 from the rod 38 to the worn area 62 to provide deposited material 64 to the repair area 60. The deposited material 64 is built up with thin layers that are metallurgically bonded to the airfoil 30. The ESD process does not generate significant heat in the repair area 60, so there is a minimal heat affected zone and the repair area 60 is not distorted. The deposit material 64 can then be machined, for example, by grinding, to provide a machined area 66 which restores the surface to a desired specification, as shown in Figure 2D. The airfoil 30 may be heat treated prior to or subsequent to machining.

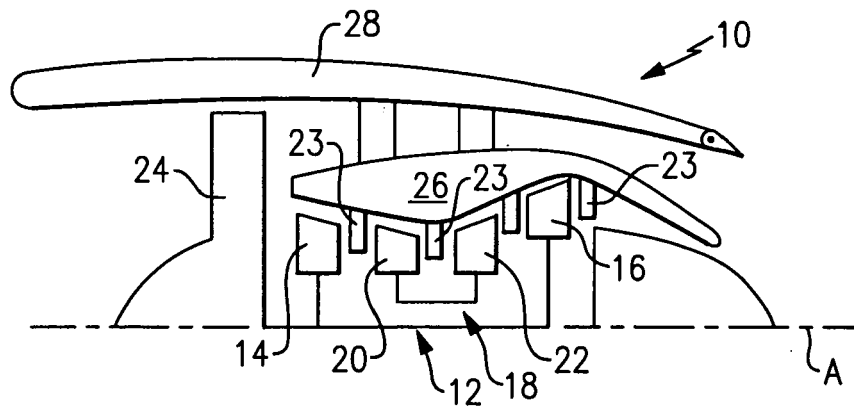
FIG. 1

Figure 1 is a highly schematic view of an example turbine engine.

[0009] One type of turbine engine 10 is shown schematically in Figure 1. The turbine engine 10 includes a low spool 12 having a low pressure compressor and turbine 14, 16. In the example, a fan 24 is also driven by the low spool 12. The turbine engine 10 also includes a high spool 18 having a high pressure compressor and turbine 20, 22. The low and high spools 12, 18 rotated about an axis A. Stator vanes 23 are arranged adjacent to each stage of the low pressure compressor and turbine 14, 16 and high pressure compressor and turbine 20, 22. However, it should be understood that the application relates to any type of turbine engine.

[0010] The low and high spools 12, 18 are housed within a core nacelle 26. The core nacelle 26 and fan 24 are arranged within a fan nacelle 28. The turbine engine 10 utilizes various airfoils in the compressor and turbine stages. For example, airfoils include compressor and turbine blades and the stator vanes 23. During engine operation, the airfoils become damaged or worn due to galling, for example, thus requiring their repair or replacement. In one example, an airfoil 30, which is shown in Figure 2A, can be repaired so that the worn or damaged area is restored to extend the service life of the airfoil.
