(54) **Metallic doubler for repair of a gas turbine engine part**

(57) A method and system of repairing an engine part having a cracked metal skin (42) bonded to a honeycomb core (44) includes removing a portion of the honeycomb that corresponds to a cracked portion of the metal skin. A crack in the metal skin originates from an edge of the engine part. A portion of the honeycomb is removed to form a slot in the honeycomb beginning at the edge of

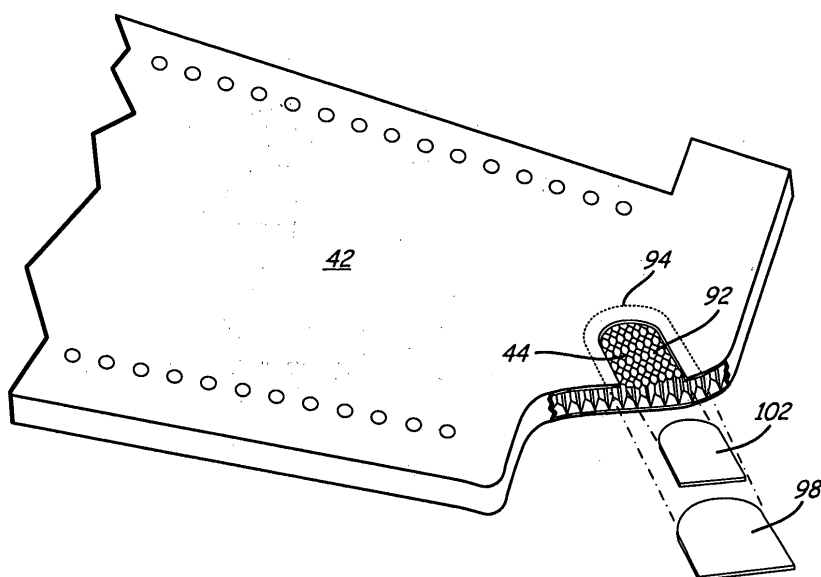
the part. A doubler (98) is inserted into the slot in the honeycomb and is attached to an underside of the metal skin to form a lap joint between the doubler and the metal skin. In one embodiment, the portion of the metal skin that includes the crack remains. In an alternative embodiment, the cracked portion of the metal skin is removed and a metal patch (102) is attached to the doubler such that the patch replaces the removed metal skin.

[0010] FIG. 6 is a perspective view of the panel of FIG. 4 illustrating the method of repairing the crack in the back skin.

[0035] FIG. 6 is a perspective view of panel 30 from FIG. 4 after the repair or restoration process for back skin 42 is already underway. Doubler 98 and patch 102 are also shown in FIG. 6. A portion of back skin 42 has already been removed from panel 30, and this area is labeled as area 92 in FIG. 6. Due to removal of back skin 42, underlying honeycomb 44 is visible in area 92. A shape of patch 102 is generally similar to removed area 92. Some of honeycomb 44 has already been removed from panel 30 in FIG. 6 to form a slot (see slot 96 in FIG. 7) for receiving doubler 98. The removed area of honeycomb 44 is designated by dashed line 94. Doubler 98 has a shape generally similar to the area represented by dashed line 94. As shown in FIG. 6, the removed area of honeycomb 44 is larger than the removed area 92 of back skin 42.

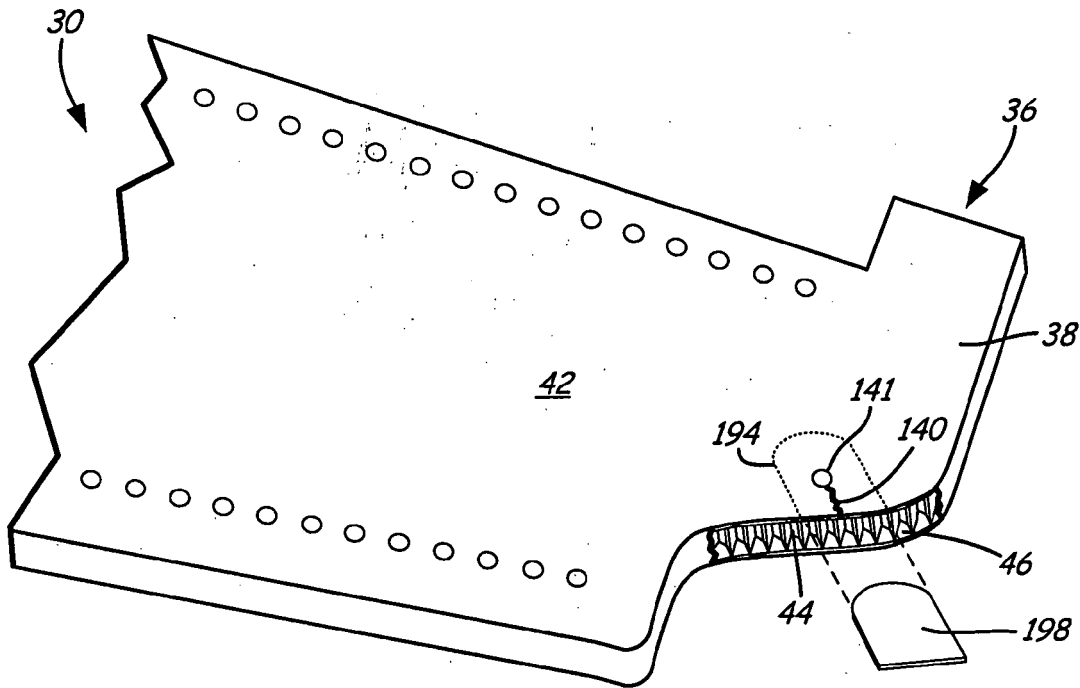
[0012] FIG. 11 is a perspective view of the panel of FIG. 4 illustrating an alternative embodiment for repairing a crack in the back skin.

iment shown in FIGS. 6 through 10, the repair includes removal of the portion of back skin 42 having crack 40. The removed back skin is then replaced with a patch. In another embodiment shown in FIGS. 11 and 12, panel 30 includes crack 140 in back skin 42 and the cracked portion of back skin 42 remains as part of the repair.

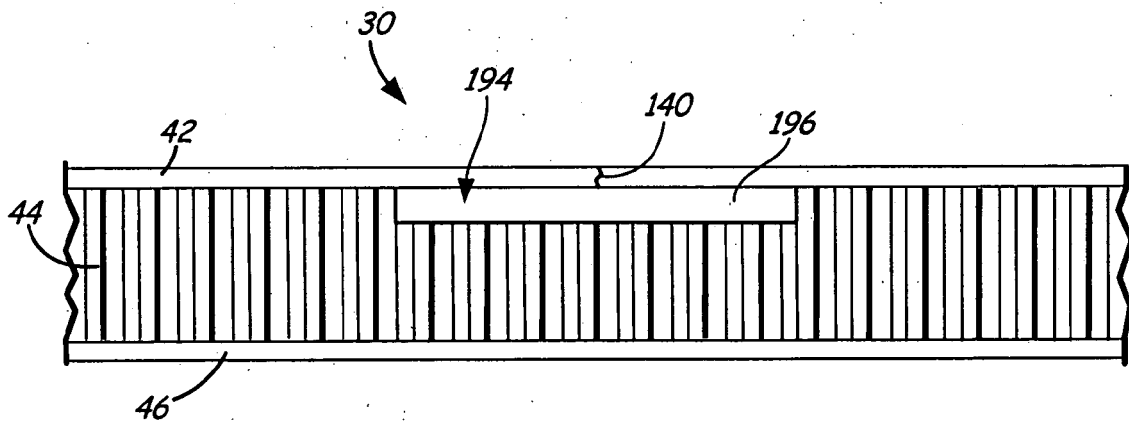
[0013] FIG. 12 is a cross-sectional view of the panel from FIG. 11 showing a slot formed in the honeycomb core as part of the repair.
