(71) Applicant: **United Technologies Corporation**  
**Hartford, CT 06101 (US)**

(54) **Repaired turbine exhaust strut heat shield vanes and repair methods**

(57) A method (50) of repairing a turbine exhaust case strut heat shield vane includes removing (52) a damaged portion of the vane, solution heat treating (54) the vane, attaching (58) a replacement section to the vane, and relieving local stresses (60) in an attachment area between the replacement section and the vane.

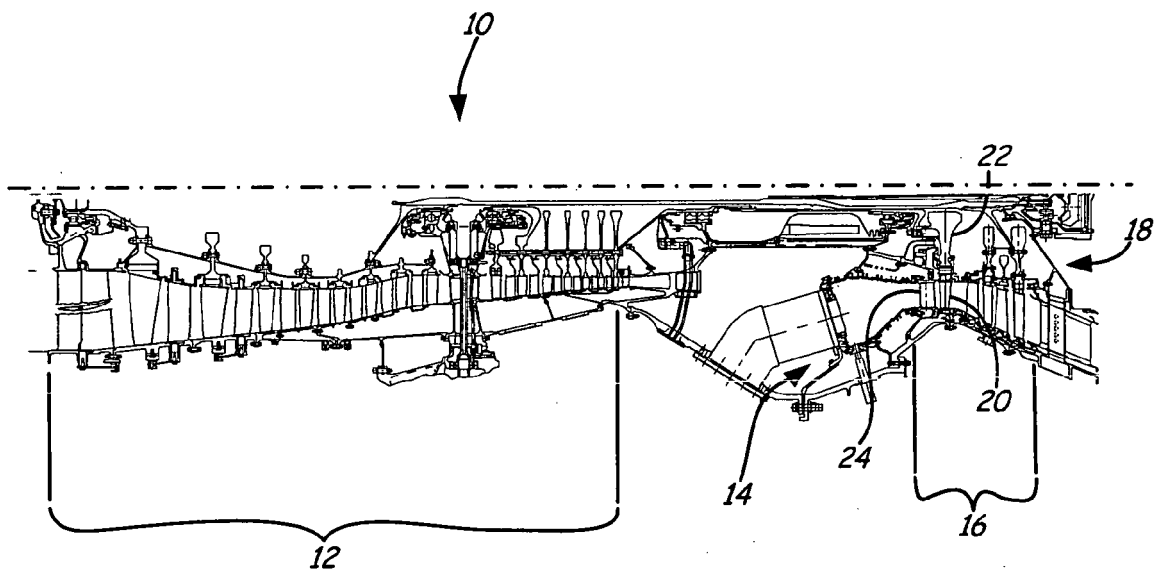
[0008] FIG. 1 is an axial section view of an industrial gas turbine including a turbine exhaust case.

[0012] FIG. 1 is a partial axial section view of industrial gas turbine 10 including compressor 12, combustor 14, turbine section 16, and exhaust case 18. Although the section view of FIG. 1 shows only one combustor 14, turbine 10 will generally include multiple combustors 14 circumferentially distributed around a turbine main shaft (not shown). Turbine section 16 includes a plurality of rotating blades 20 secured to a rotatable rotor disk 22. A plurality of stationary vanes 24 are each alternately positioned upstream of each of the rotating blades 20. The vanes 24 are dimensioned and configured to guide the working gas over the blades 20.

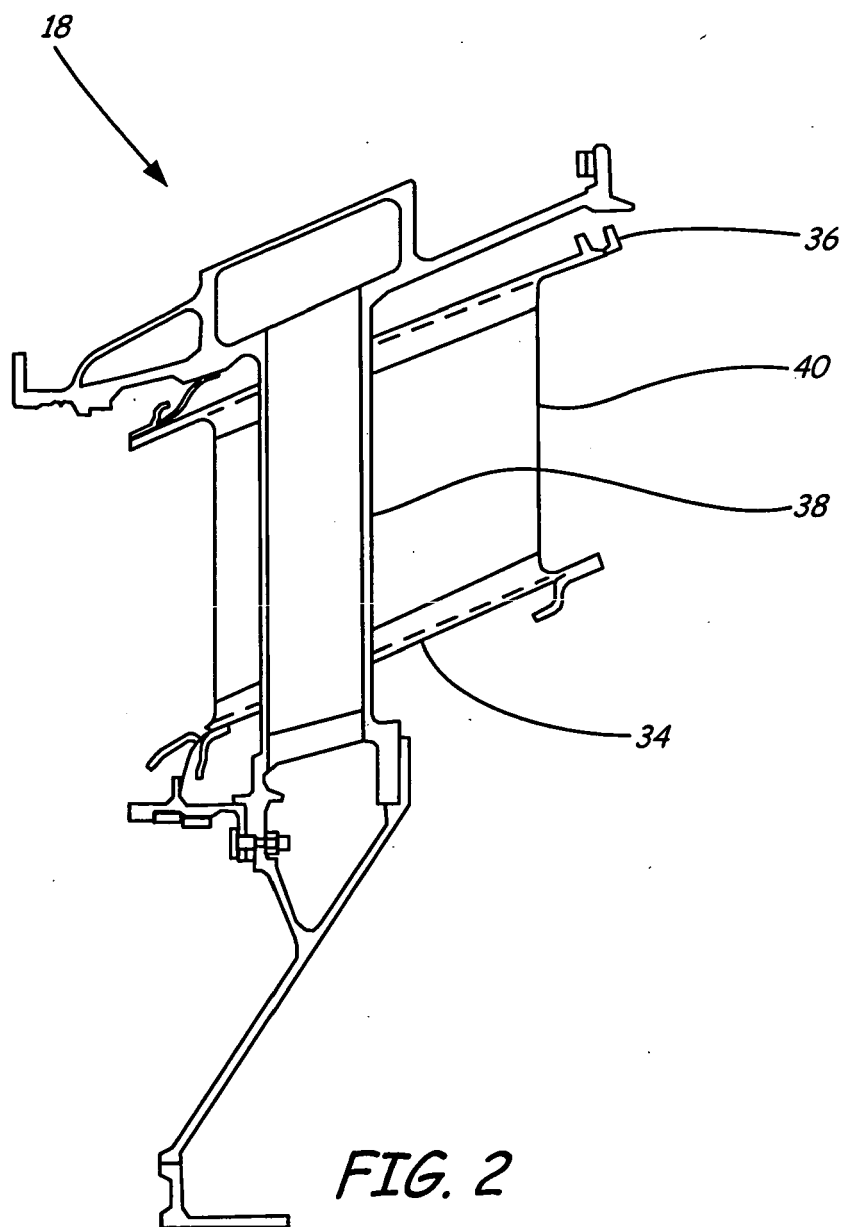
[0009] FIG. 2 is a detail view of the turbine exhaust case including a strut heat shield vane from the turbine of FIG. 1.

**[0014]** Exhaust case 18 is positioned downstream of the last row of turbine blades 20 shown in FIG. 1. FIG. 2 is a detail view of exhaust case 18 including a pair of annular rings, such as diffusers 34 and 36, struts 38, and heat shield vanes 40. Diffuser 34 forms the inner wall of the working gas path and diffuser 36 forms the outer wall of the working gas path. Radially extending struts 38 are circumferentially distributed about the engine axis and span the gas path between diffusers 34, 36. Each radially extending strut 38 is surrounded by vane 40. Vanes 40 act both to direct working gas flow through exhaust case 18 and to shield load bearing struts 38 from heat.

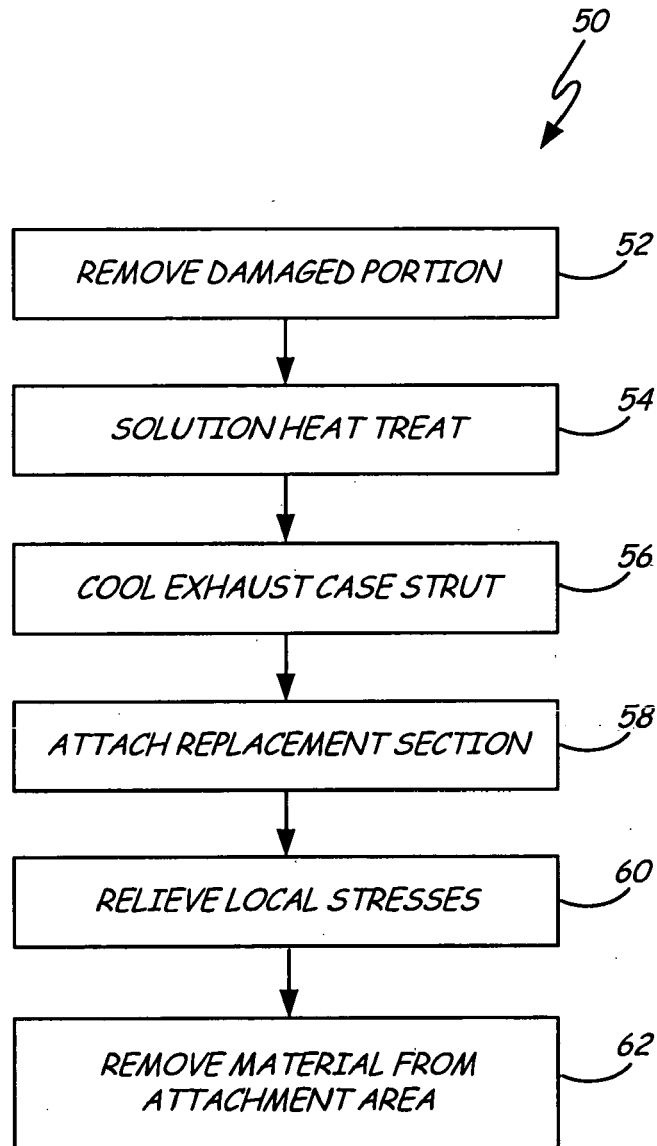
*FIG. 3*

[0010] FIG. 3 is a flow chart of an exemplary embodiment of a method for repairing the turbine exhaust strut heat shield vane shown in FIG. 2.

**[0015]** Vanes 40 shown in FIGS. 1 and 2 may experience a loss of material due to a combination of abrasion, exfoliation, oxidation, hot corrosion and some mode of metallurgical attack during engine operation. Although the damage observed on vanes 40 may not have structural repercussions, the damage may compromise, to an increasing degree over time, the heat shielding function of vanes 40. Vanes 40 may therefore be repaired by embodiments of the exemplary method, such as method 50 illustrated by the flow chart of FIG. 3. In FIG. 3, method 50 of repairing a strut heat shield vane includes removing a damaged portion of the vane (step 52), solution heat treating the vane (step 54), cooling an exhaust case strut around which the vane is arranged (step 56), attaching a replacement section to the vane (step 58), relieving local stresses in an attachment area between the replacement section and the vane (step 60), and removing material from the attachment area between the replacement section and the vane (step 62).

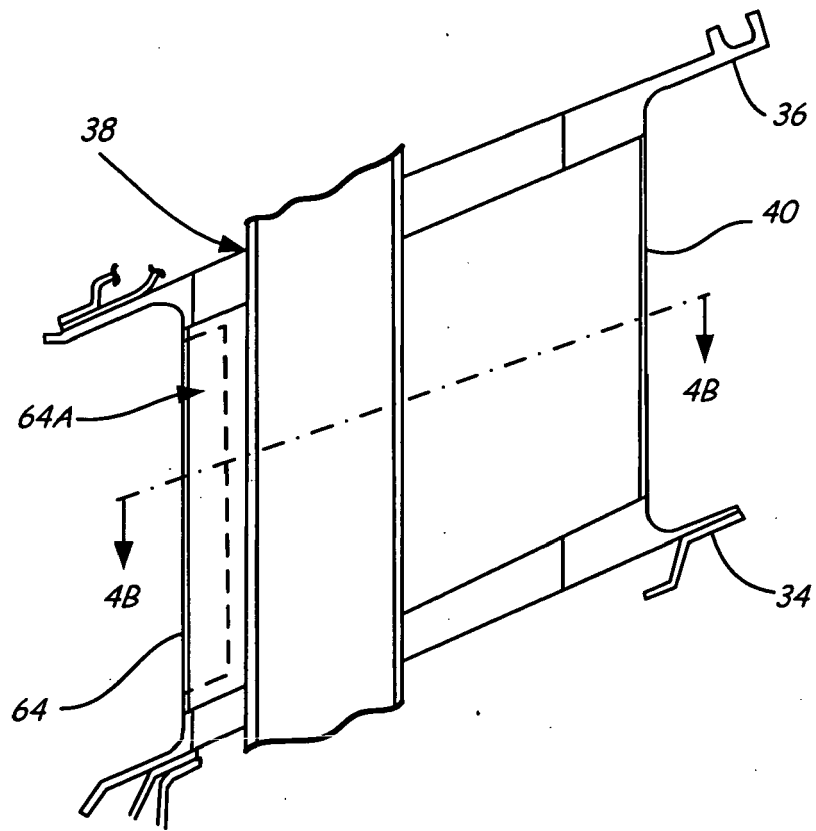
FIG. 4A

[0011] FIGS. 4A and 4B are detail views of a strut heat shield vane repaired by the exemplary method of FIG. 3.

**[0026]** FIGS. 4A and 4B are detail views of strut heat shield vane 40 repaired by method 50 illustrated in FIG. 3. Heat shield vane 40 surrounds strut 38 between diffusers 34 and 36. Vane 40 includes leading edge 64 and replacement section 64a. In the repaired heat shield vane 40 of FIGS. 4A and 4B, leading edge 64 may have experienced a loss of material due to a combination of abrasion, oxidation and some mode of metallurgical attack during engine operation. The damaged portion of vane 40 has therefore been removed in the region of leading edge 64. Replacement section 64a has then been attached to vane 40 by, for example, welding replacement section 64a to vane 40.
