(54) **Replacement of part of a turbine engine case with dissimilar material**

(57) A method of repairing a case for a gas turbine engine includes removing a first portion of the case from a second portion (26) of the case and metallurgically joining (42) a replacement material (20') to the second portion

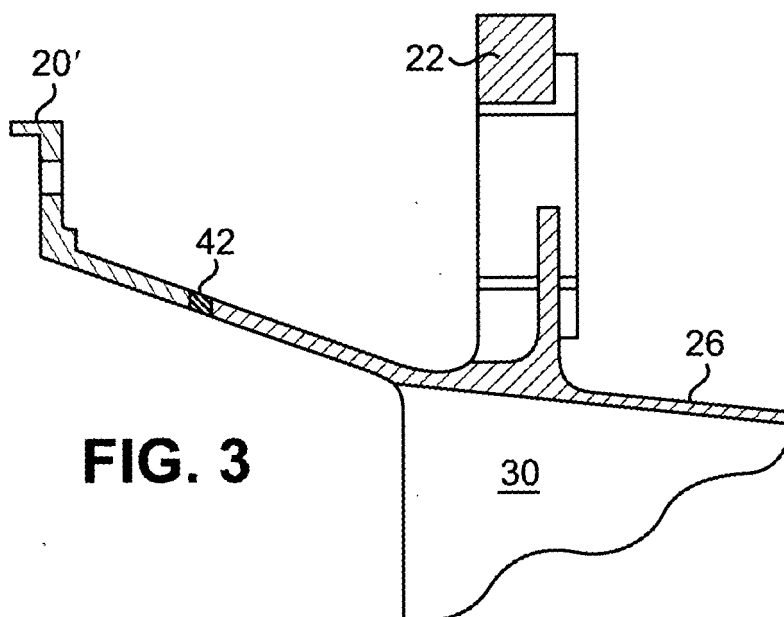
**FIG. 3**

**[0006]** FIG. 3 is a cross-sectional view of a repaired portion of the turbine exhaust case segment.

**[0012]** FIG. 3 is a cross-sectional view of a repaired portion of the TEC segment 16. A replacement detail 20' is welded to the parent material of the TEC case 16 along the OD wall 26. A weld joint 42 is formed at a location that corresponds to the location of the cut plane 40 (see FIG. 1). Electron beam welding or other suitable techniques can be used to form the weld joint 42. The replacement detail 20' can have a shape that is substantially identical to the removed material of the TEC segment 16, and can be made of a different material than the parent material of the TEC segment 16. The replacement detail 20' can be made of the same material as the LPT case 14, or a material having substantially the same

coefficient of thermal expansion as the material of the LPT case 14. For example, the replacement detail 20' can be made of an Inconel® 625 alloy while the parent material of the TEC segment 16 can be made of a Greek Ascoloy™ alloy. By making the replacement detail 20' of a dissimilar material from the parent material of the TEC segment 16, contact between the LPT case 14 and the TEC segment 16 can occur between materials with substantially the same coefficient of thermal expansion. In that way, creep at the connection between the LPT case 14 and the repaired TEC segment 16 can be reduced, which can help reduce rework, turnaround time (TAT), costs, future part damage, and engine time off-wing.

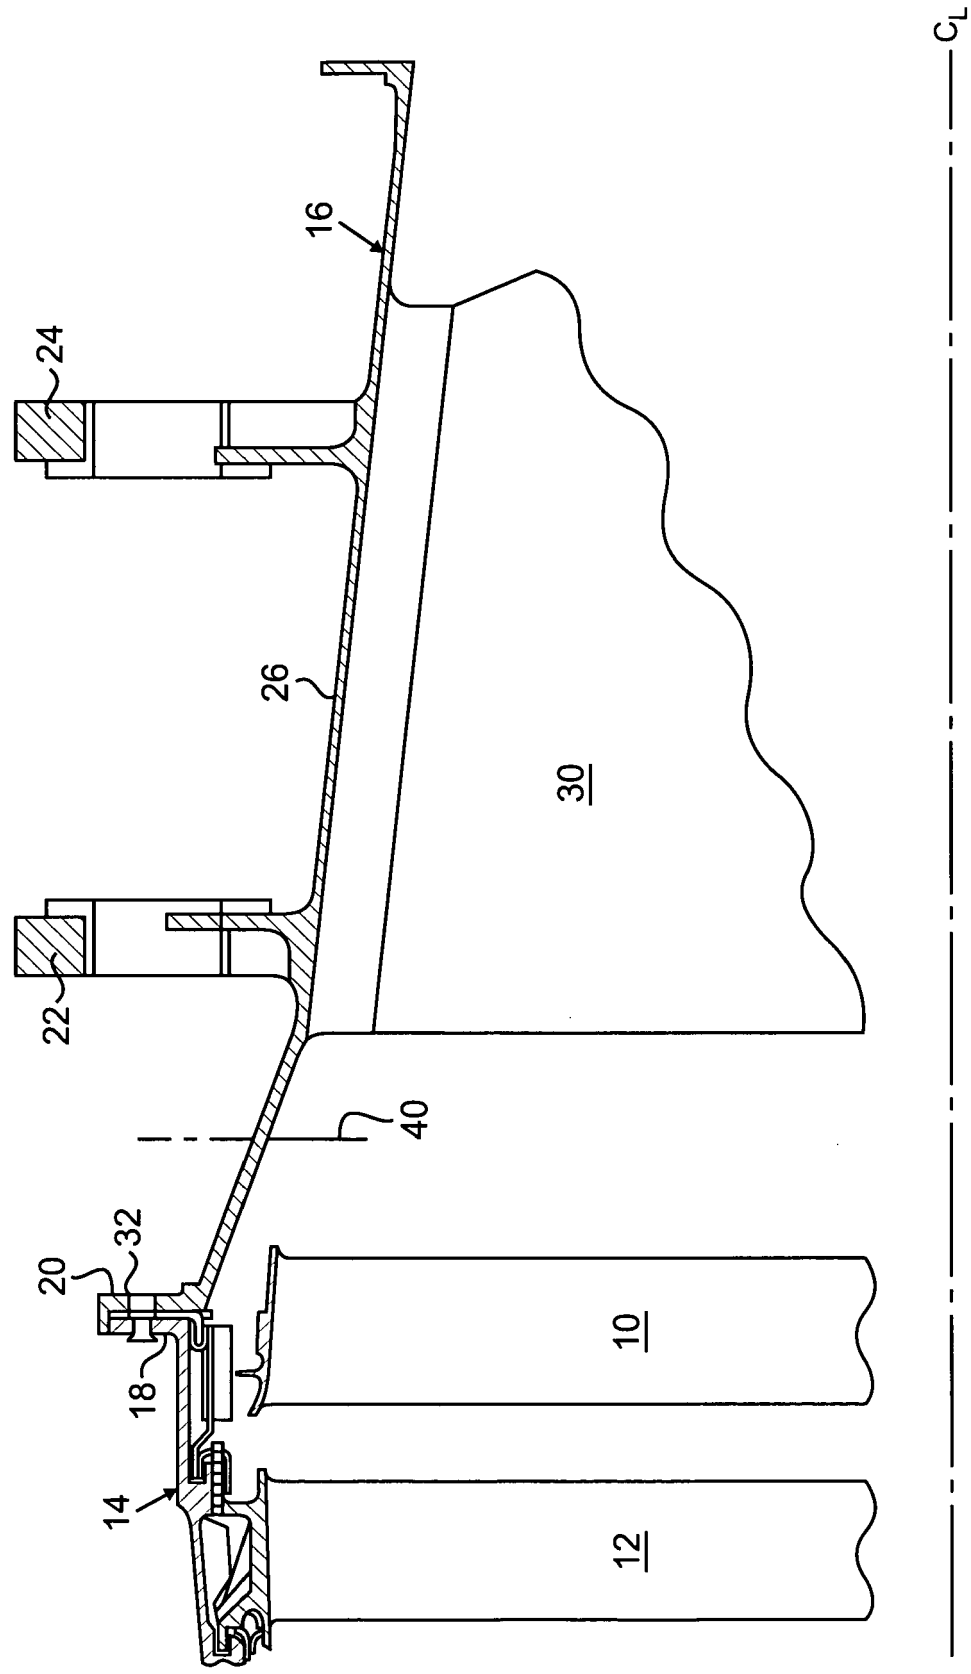
**[0004]** FIG. 1 is a cross-sectional view of a portion of a gas turbine engine.

**[0008]** FIG. 1 is a cross-sectional view of a portion of a gas turbine engine, including a low-pressure turbine (LPT) blade 10, a LPT vane 12, a LPT case 14, and a turbine exhaust case (TEC) segment 16, all arranged relative to an engine centerline  $C_L$ . FIG. 2 is an isometric view of the TEC segment 16. The LPT case 14 includes a flange 18, which is located at an aft portion of the LPT case 14 near the aftmost LPT blade 10. The LPT case 14 can be made of a metallic material, for instance, a superalloy such as a nickel-based superalloy consistent with AMS 5666 specifications (e.g., Inconel® 625).

**[0011]** During repair, a cut plane 40 on the TEC segment 16 is determined (see FIG. 1). The flange 20 is removed from the rest of the TEC segment 16 at the cut plane 40, using a suitable machining process for example. The cut plane 40 is generally located at a relatively low-stress area of the TEC segment 16. In one embodiment, the cut plane 40 is located such that the material removed includes the entire flange 20 as well as an approximately 3.81-5.08 cm (1.5-2 inch) portion of the OD wall 26. A replacement detail is created (or otherwise provided) to replace the removed material, and is welded to parent material of the TEC segment 16 at the location of the cut plane 40.

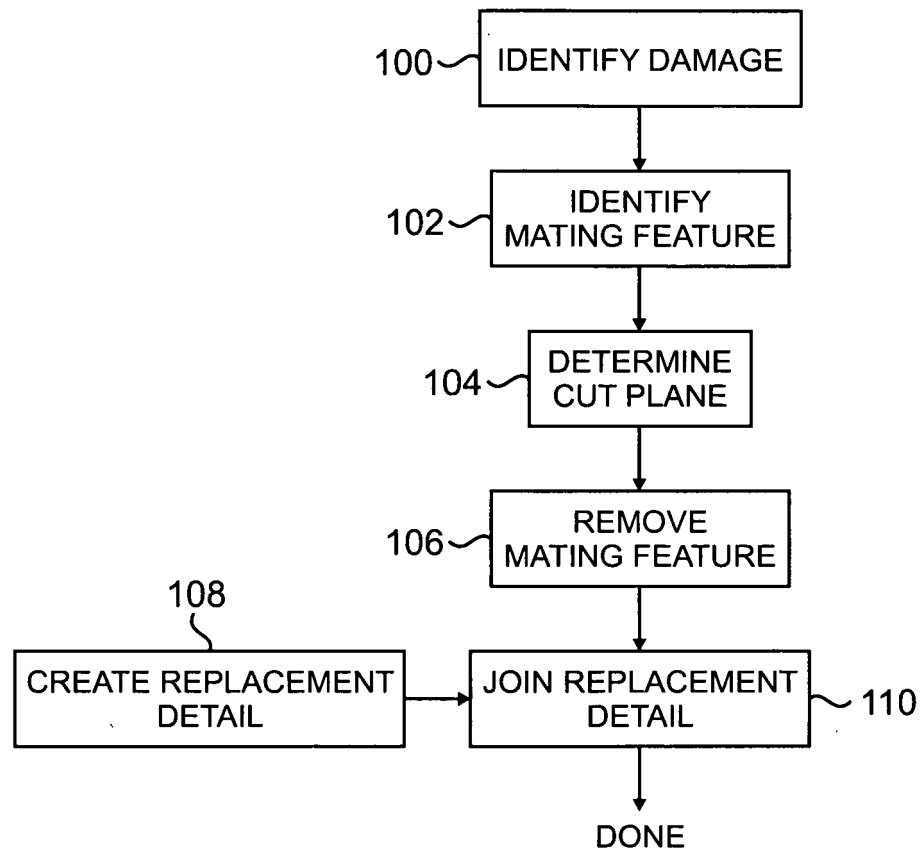
**FIG. 4**

**[0007]** FIG. 4 is a flow chart of a repair method.

**[0013]** FIG. 4 is a flow chart of one embodiment of a repair. After a part has been removed from an engine for service, a first step is to identify damage to the part (step 100). Damage can include creep, bolt hole elongation, flange bending, cracks, etc. Next, a mating feature of the part is identified (step 102). The mating feature can include a flange or other structure that connects to another part in the engine. A cut plane is then determined (step 104). A portion of the part including the mating feature is removed from another portion of the part at the cut plane (step 106). A replacement detail is created (or otherwise provided) of a replacement material having a different coefficient of thermal expansion from the parent material of the part, and generally having the same shape as the removed portion that includes the mating feature (step 108). The replacement detail is then metallurgically joined to the parent material of the second portion of the part (step 110). The repair method can include one or more additional steps not particularly mentioned, such as heat treatment. Following repair, the part can be reinstalled in the engine and returned to service.
