(54) **Wind turbine blade repair kit and method**

(57) A wind blade spar cap laminate repair (210) for wind turbine rotor blades (108), a repair kit to repair spar cap laminate damage (212), and a method of repairing damage (212) on wind turbine rotor blades (108) is provided. The wind blade spar cap laminate repair (210) includes a prepared surface (214), an adhesive region

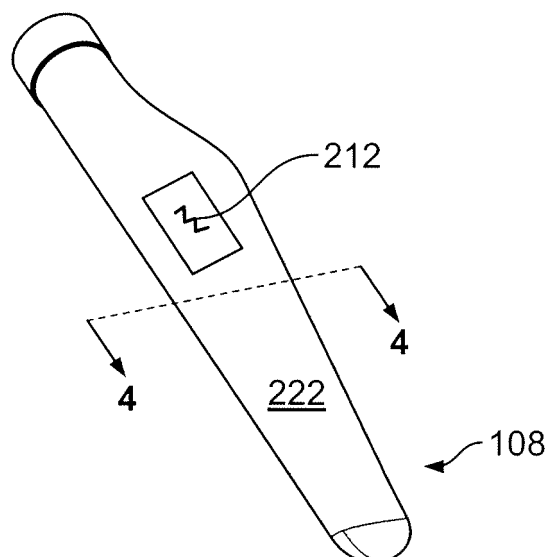
FIG. 2 is a perspective view of a wind turbine rotor blade having spar cap damage.

[0014] FIG. 2 shows damage 212 to a spar cap laminate 222 of wind turbine rotor blade 108. Spar cap laminate 222 further includes a plurality of plies of composite fabric fibers laid up and cured in a matrix to form the composite part. Damage 212 may include imperfections or defects from any number of typical composite failures, for example, such as, cracking, waves, and delamination. Currently, when wind damage 212 is discovered to spar cap laminate 222, wind turbine rotor blade 108 cannot be repaired. As such, if a wind turbine rotor blade 108 is damaged it must be replaced with a new turbine blade, usually at a great cost and well before the end of the twenty-year service life period.

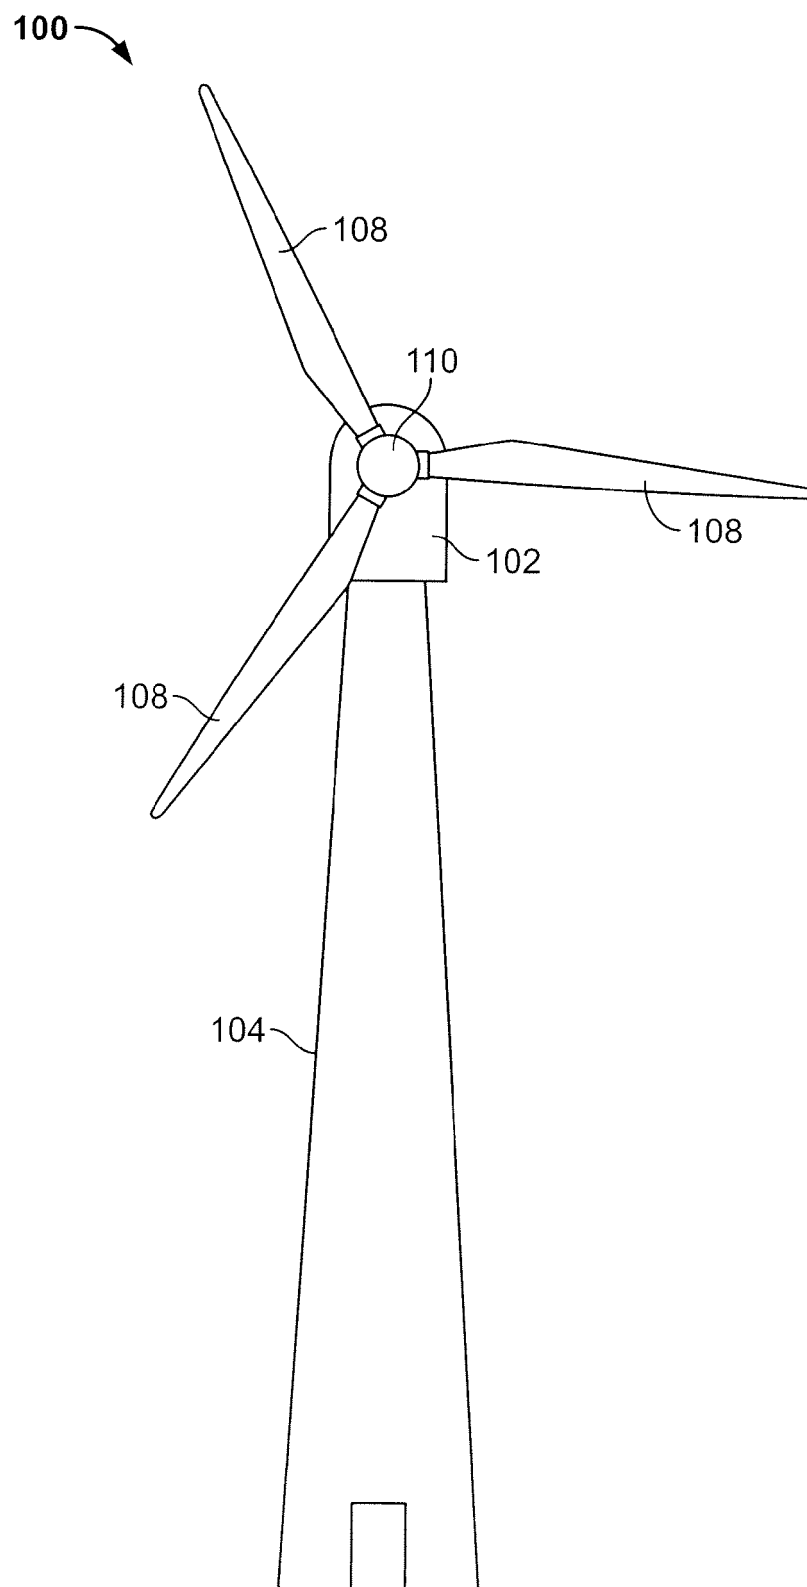
FIG. 1 is a front view of a wind turbine according to an embodiment of the present disclosure.

[0013] As shown in FIG. 1, a wind turbine 100 generally comprises a nacelle 102 housing a generator (not shown). Nacelle 102 is a housing mounted atop a tower 104. The wind turbine 100 may be installed on any terrain providing access to areas having desirable wind conditions. The terrain may vary greatly and may include, but is not limited to, mountainous terrain or off-shore locations. Wind turbine 100 also comprises a rotor that includes one or more wind turbine rotor blades 108 attached to a rotating hub 110.

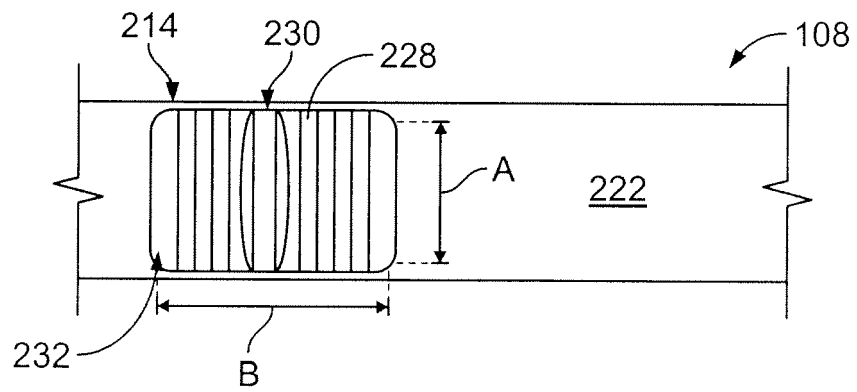
FIG. 3 is a top view of the wind turbine rotor blade depicting the prepared surface to receive a patch according to

[0015] FIG. 3 is a top view of wind turbine rotor blade 108 showing prepared surface 214 of spar cap 222. Prepared surface 214 further comprises a repair area 232 and an area 230 scarfed to receive a repair patch 210. Repair area 232, as utilized herein, is the total area that covered by repair 216. Scarf area 230, as utilized herein, is the area that is removed or scarfed from the original spar cap laminate 222. Scarfing, as utilized herein, is defined as taper sanding or any other process in which composite material surfaces may be selectively removed. Any number of methods can be used to scarf the area to be repaired, for example, such as grit wheels, sand paper, or grinding. In one embodiment, repair area 232 is scarfed with a grit wheel to grind out each ply of spar cap laminate 222. This grinding is done from the center out and down to the first ply of spar cap laminate 222. Alternatively, the grinding can be through the first ply, so that a small cut-out or hole is formed in spar cap laminate 222. Next, using the proper tooling, a preselected distance on each side of the first layer of spar cap laminate 222 is stepped out from the center of the first ply of spar cap laminate 222. The stepping distance 228 will depend on the thickness and number of plies in spar cap laminate 222. While not so limited, stepping distance 228 on each side may be from about 25 millimeters to about 50 millimeters. Next, the grit wheel is used to grind up to or step out to the second ply of spar cap laminate 222 at a preselected distance from the center of the repair area 232 of first ply of spar cap laminate 222.

[0016] The process of stepping out and grinding for each ply is repeated until all of the plies in spar cap laminate 222 are identified, and a small area of each ply is ground out of spar cap laminate 222. After the steps 228 have been made in spar cap laminate 222, scarf area 230 and repair area 232 may be sanded with sandpaper to produce prepared surface 214. In one embodiment, 180-grit to 220-grit sandpaper is on scarf area 230 and repair area 232 to produce prepared surface 214. Scarf area 230 is shown as the width measurement A and the length measurement B (FIG. 3). Scarf area 230 is prepared using a predetermined scarf ratio or scarf joint. Scarf ratio or scarf joint, as utilized herein, is defined such that for every inch of laminate thickness of the original spar cap there are a number of inches of prepared surface 214 on each side from the center of the scarf area 230 for a total number of inches (shown in FIG. 3 as length (B)) per inch of thickness of the original spar cap laminate. In one embodiment, a scarf ratio of approximately 20:1 to approximately 70:1 may be used to provide prepared surface 214, alternatively a ratio of 40:1 to approximately 60:1 may be used to provide prepared surface 214, or a ratio 45:1 to 55:1 may be used to provide prepared surface 214. Scarf angle, as utilized herein, is defined as the angle (θ) that results from the use of a particular scarf ratio. According to an embodiment of this disclosure, a scarf angle (θ) of approximately 1.0° to approximately 3.5° may result, alternatively a scarf angle (θ) of approximately 1.0° to approximately 2.0° may result, or a scarf angle (θ) of approximately 1.0° to approximately 1.5° may result from the use of a particular scarf joint. According to another embodiment of this disclosure, a scarf angle (θ) of approximately 1.0° to approximately 1.5° may result from the use of a scarf ratio of approximately 45:1 to approximately 55:1 to arrive at the desired prepared surface 214.

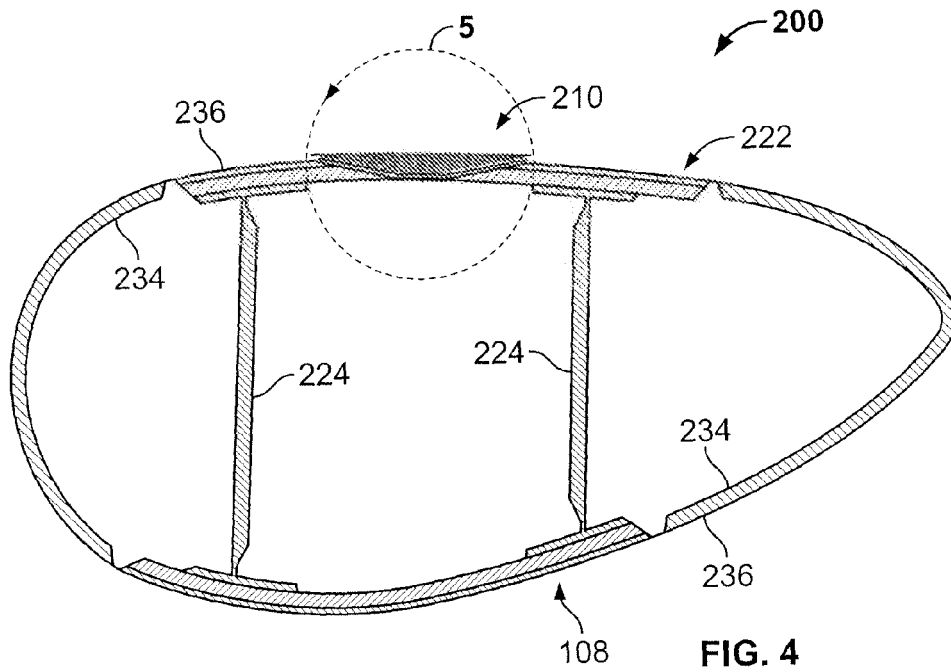
FIG. 4 is a sectional view of the spar cap of a wind blade of FIG. 2 taken in direction 4-4 showing a patch according to an embodiment of the present disclosure.

[0017] FIG. 4 is a sectional view in the 4-4 direction of FIG. 2. Wind turbine rotor blade 108 comprises spar cap laminate 222 and shear webs 224. Spar cap 222 comprises an interior surface 234 and an exterior surface 236. As shown in the figure, exterior surface 236 contains repair patch 210.
