EP 2 549 062 B1

EUROPEAN PATENT SPECIFICATION

(54) Repair of coated turbine vanes installed in module

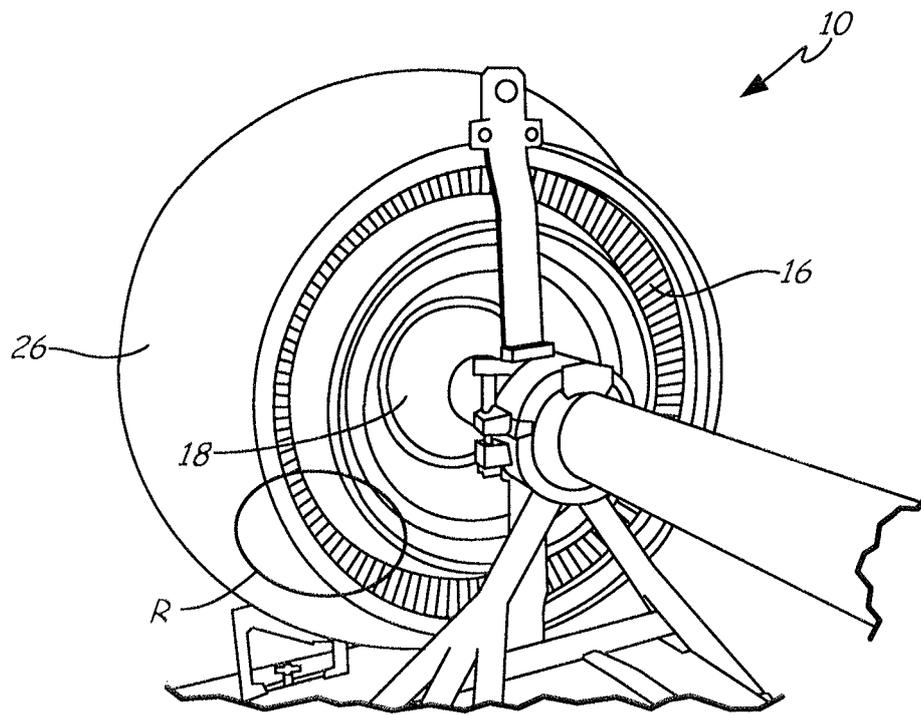
Fig. 2

FIG. 2 is a perspective view of a module similar to that of FIG. 1 showing the intake surface downstream from a combustor.

[0009] A perspective view of turbine module 10 is shown in FIG. 2. Case 26 and inner drum 18 are as indicated. Vanes 16 are seen to be readily accessible for inspection and in situ repair without further disassembly of module 10.

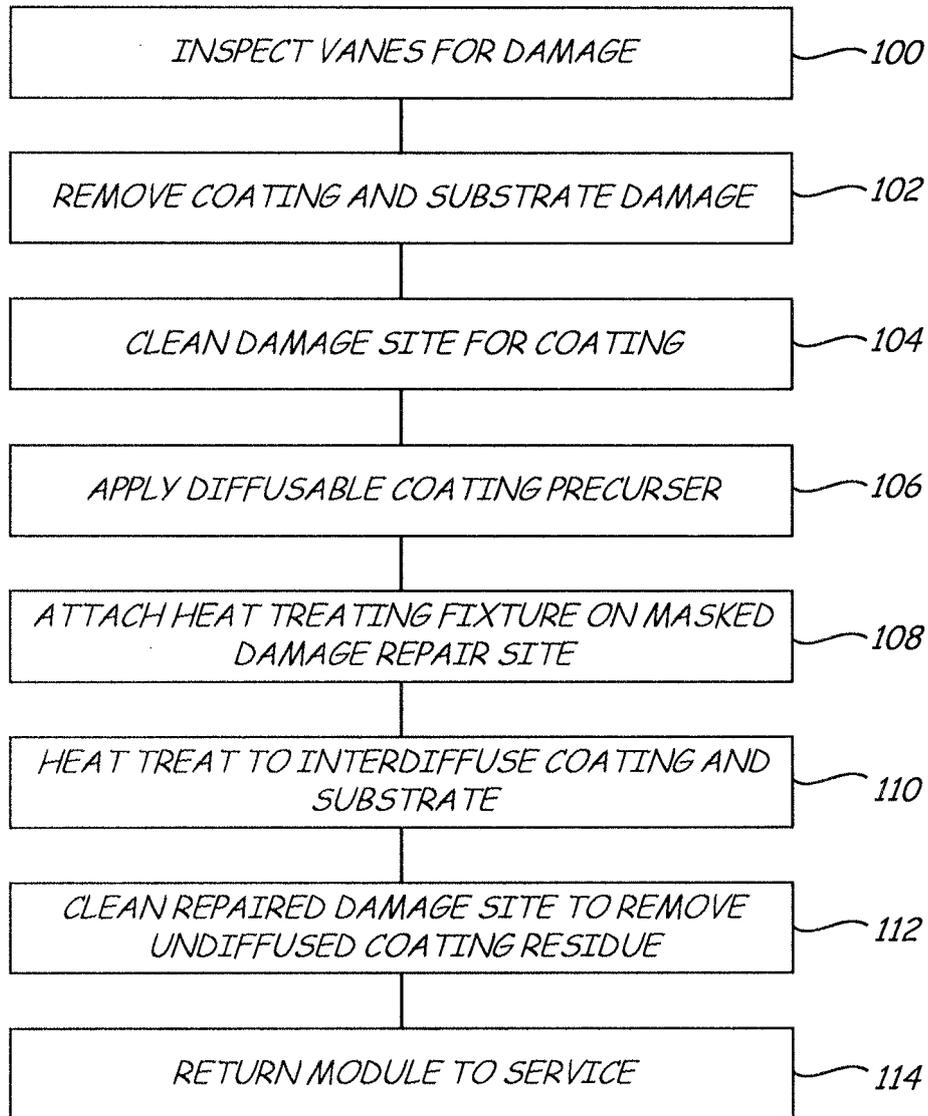
Fig. 3

FIG. 3 is a diagram of a repair process for damaged vanes in a turbine module.

[0010] The inspection and repair procedures according to this invention are diagramed in FIG. 3. Following inspection, damaged vanes are marked and recorded (Step 100). Damaged regions are then prepared for repair by removing the coating in the vicinity of the damage preferably by mechanical abrasion.

[0013] In the embodiment of FIG. 3, an aluminide coating is preferred. Even more preferred is a low activity aluminide coating comprising about 43 wt. % to about 47 wt. % cobalt powder and the remainder aluminum powder fluorinated by an addition of LiF. In slurry form, the diffusible aluminide precursor is either applied by brush or spray. In tape form, the precursor is applied and mechanically connected to the repair surface to ensure interdiffusion during the subsequent interdiffusion anneal.

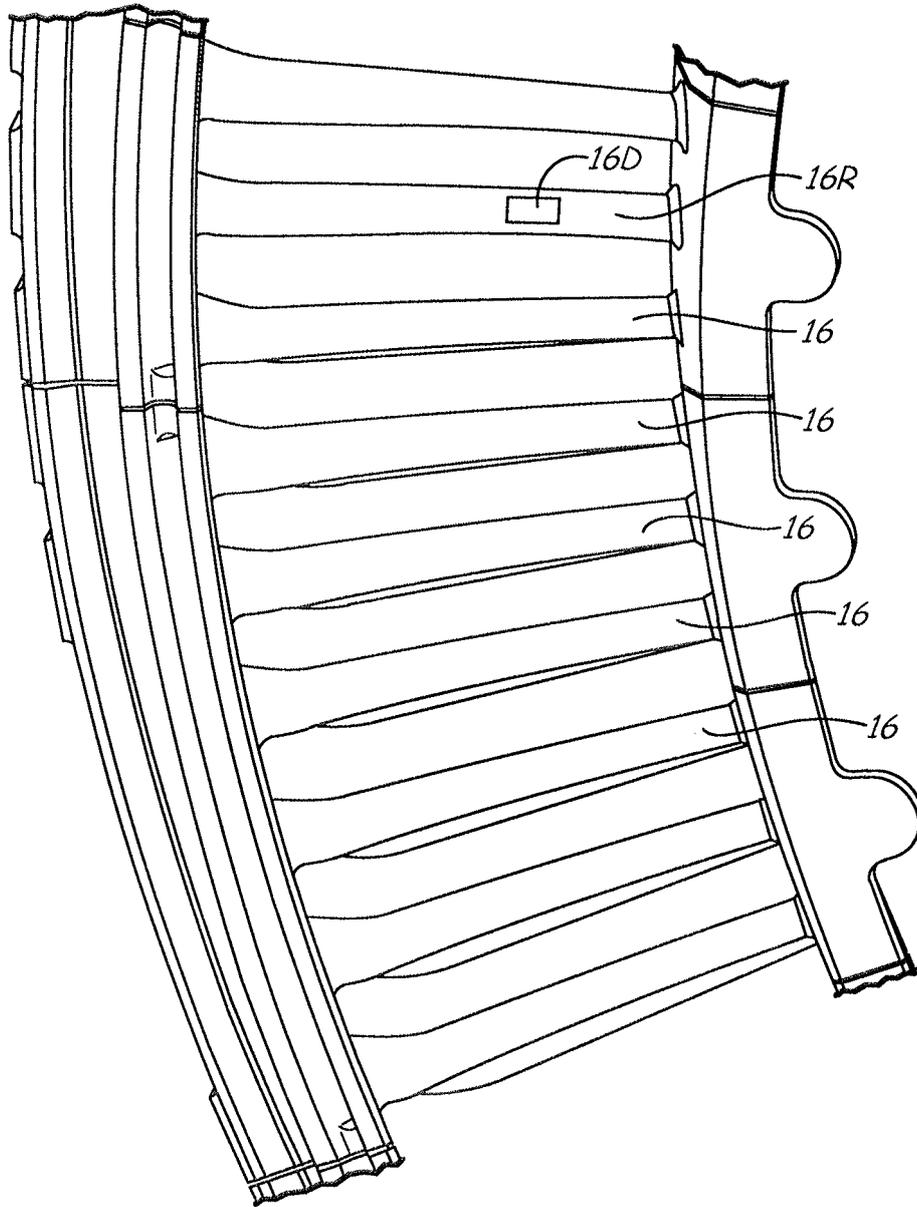
Fig. 4

FIG. 4 is a perspective enlarged view of vanes showing diffusion aluminide precursor applied to a repair region.

[0017] An enlarged view of region R of turbine module 10 of FIG. 2 is shown in FIG. 4 showing damaged vane 16R and damage site 16D that has been prepared for repair by removing the protective coating and underlying damage and by applying a diffusible coating precursor thereon. As shown in Fig. 5, in preparation for the interdiffusion anneal, heat treating fixture 240, is attached to the damaged vane in the vicinity of the coated repair site.

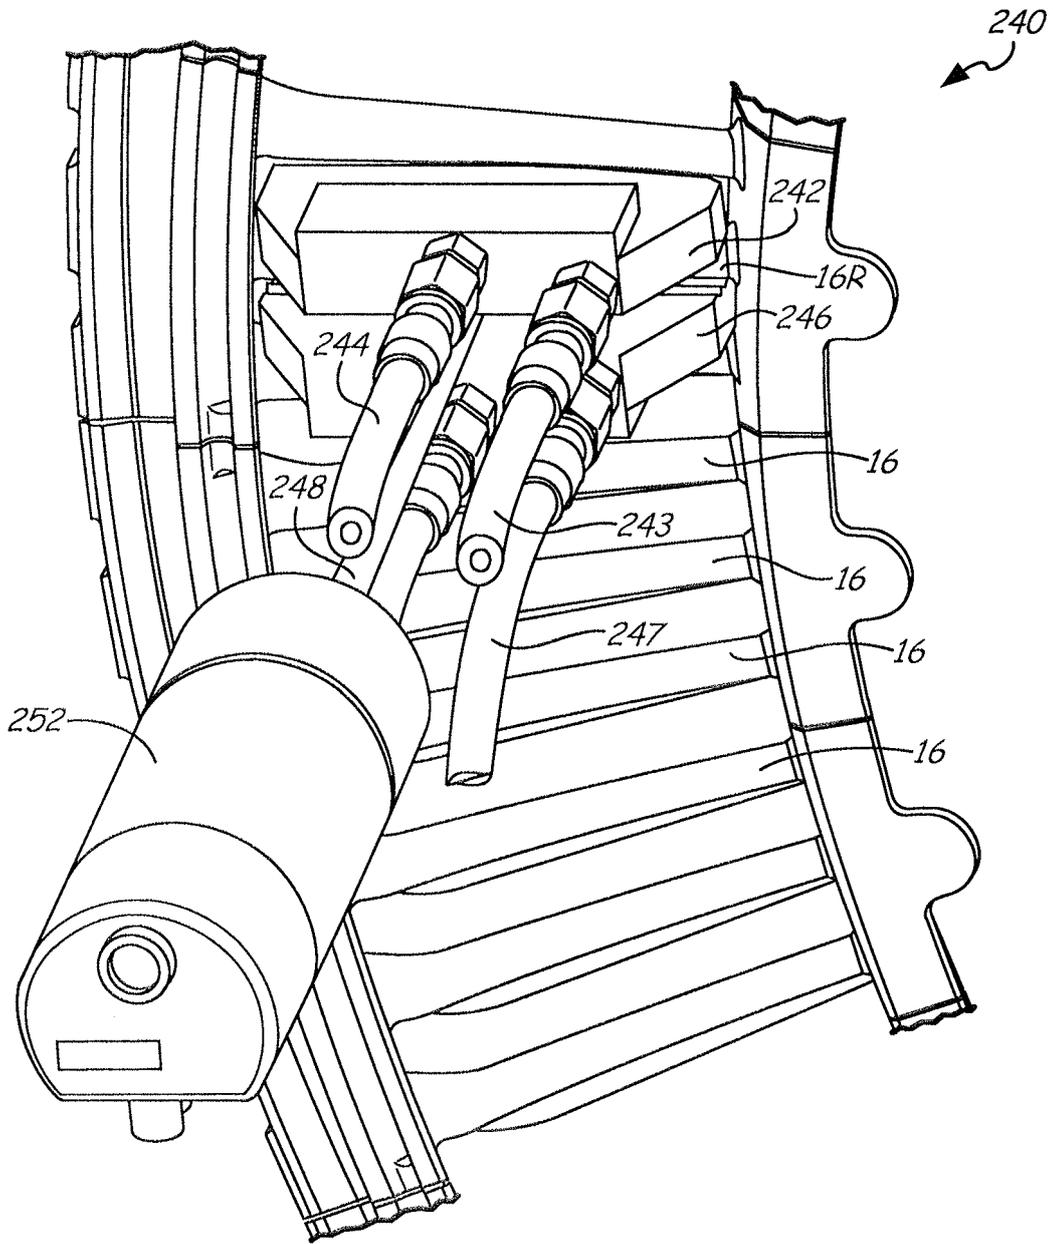
Fig. 5

FIG. 5 is a view of FIG. 4 with a heat treating fixture attached to a damaged vane.

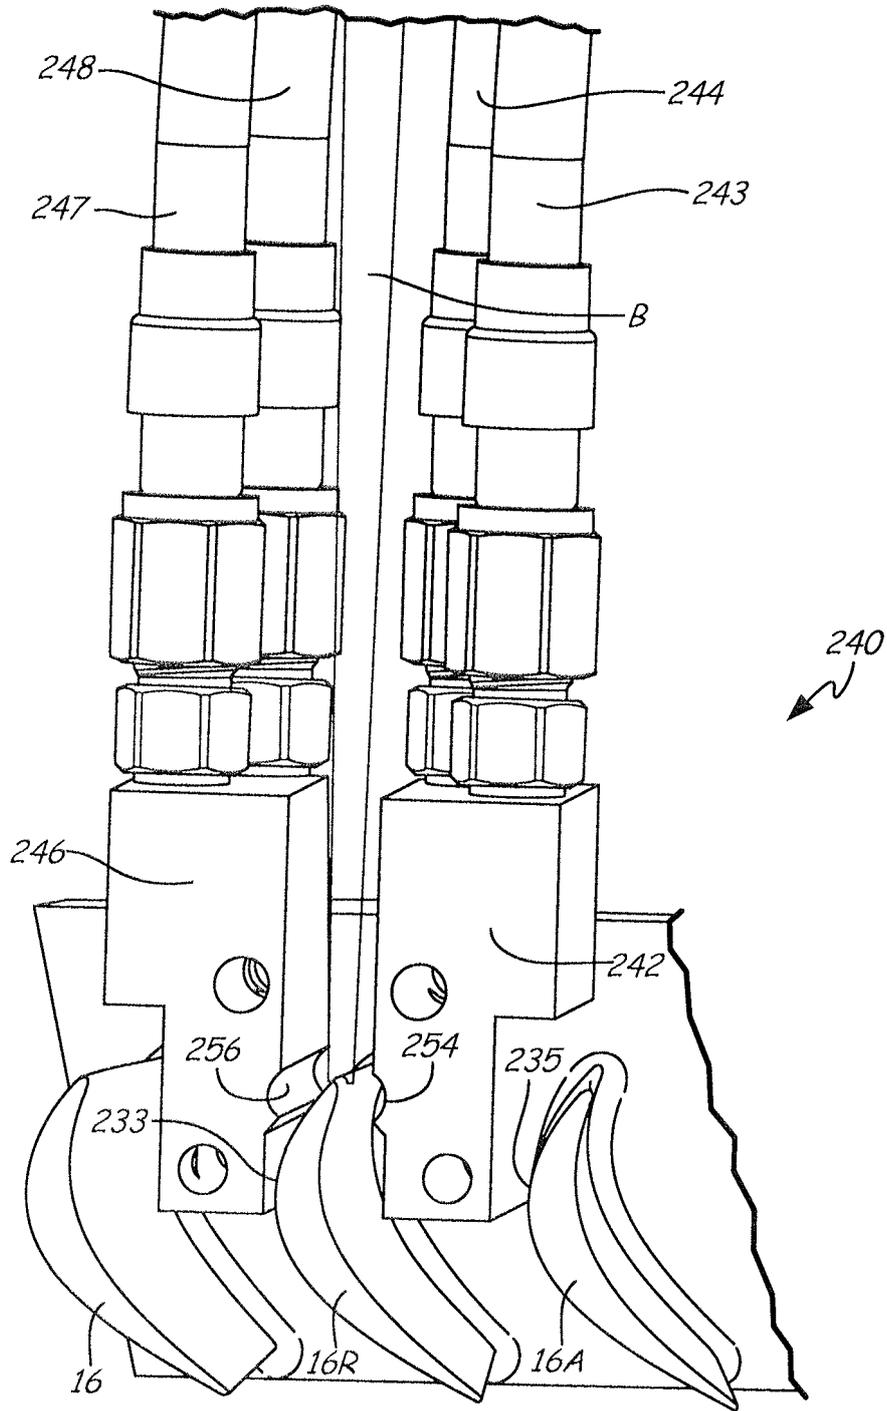
Fig. 6

FIG. 6 is a different view of FIG. 5 showing the focused heat treating assembly.

[0019] A detailed view showing the position of focused quartz lamp fixtures 242 and 246 in relation to damaged blade 16R is shown in FIG. 6. Quartz lamp fixture 246 may be positioned relative to damage site 16D by contacting vane 16R along contact line 233 and quartz lamp fixture 242 may be positioned relative to damage site 16D by contacting adjacent vane 16A along contact line 235. Care is taken to not damage the vanes in the process of locating focused quartz lamp fixtures 242 and 246 on damaged vane 16R. Cavities 254 and 256 in focused quartz lamp fixtures 242 and 244 comprise axially extending mirrors that respectively focus high energy infrared radiation from tungsten wires (not shown) in focusing cavities 254 and 256 during operation. Quartz windows (not shown) protect the tungsten heating elements from oxidation during operation. Beam B depicts the line of sight of infrared pyrometer 252 on damage site 16D to measure temperature of damage site 16D during an interdiffusion anneal. Feedback from infrared pyrometer 252 to a control system (not shown) monitors and controls the thermal program during the interdiffusion anneal.
