**EP 3 532 275 B1**

(54) **ACOUSTIC PANEL REPAIR WITH RETENTION OF ACOUSTIC PROPERTIES**

(73) Proprietor: **Rohr, Inc.**

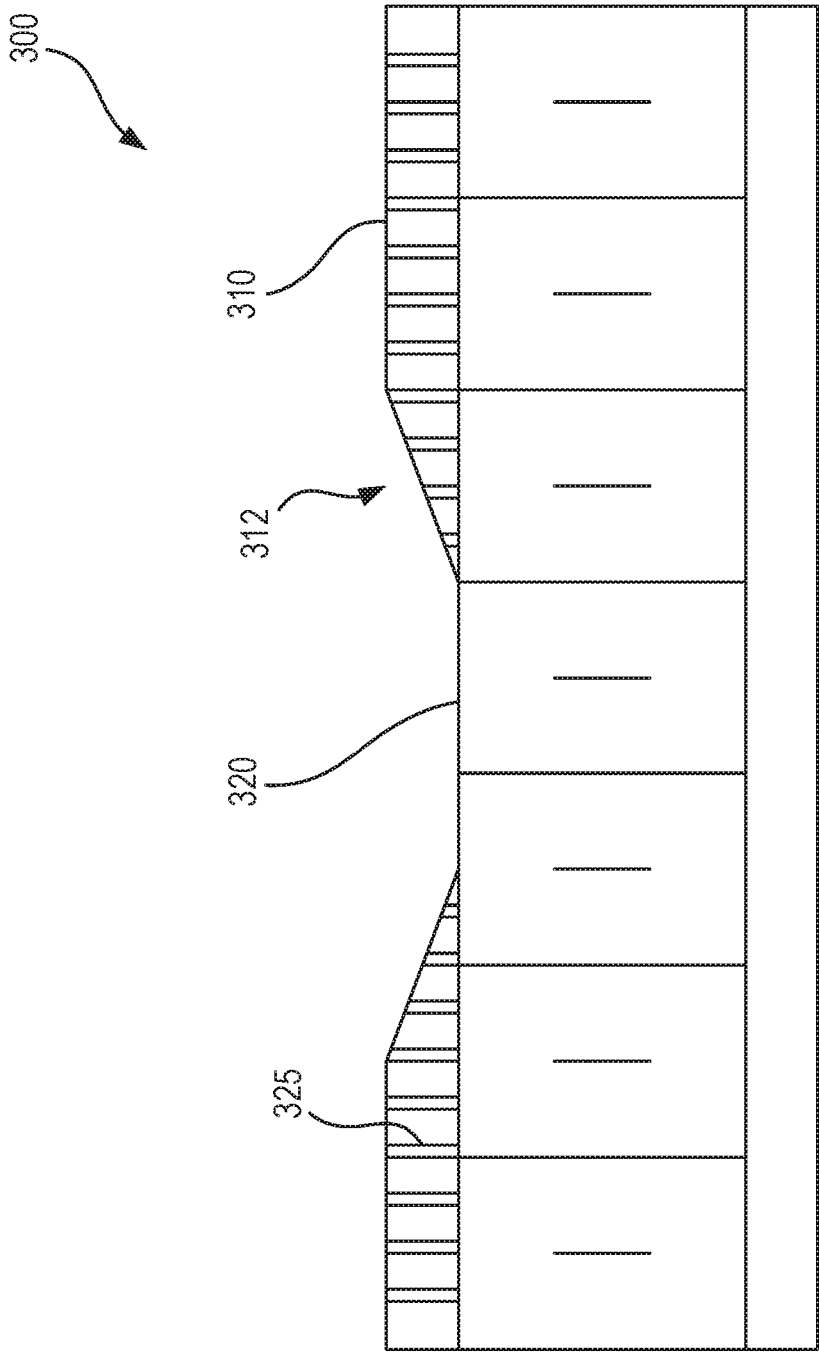
FIG. 3

**[0017]** Referring to FIG. 3, a schematic cross-section view of an acoustic panel 300 with a damaged portion of a perforated top skin 310 removed is illustrated according to various embodiments. The damaged portion may be cut with a continuously sloped ramp portion 312 between the top of the top skin 310 and the core section 320 where the top skin 310 is completely removed. However, in various embodiments, the damaged portion may be cut with

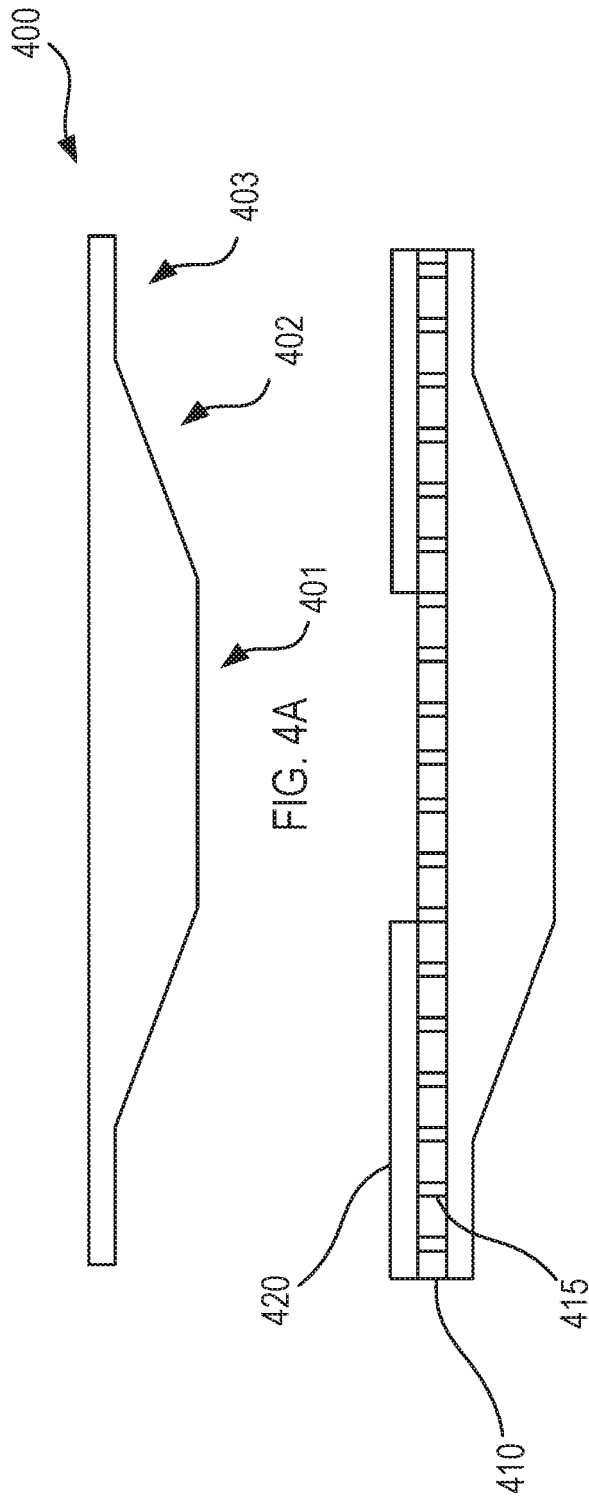
FIG. 4B

**[0019]** Referring to FIG. 4B, a maskant 410 may be coupled to the replacement patch 400. The maskant 410 may be a polymeric material. The maskant 410 may comprise a plurality of apertures 415 matching a perforation pattern of an acoustic panel. A tape 420 may be coupled to the replacement patch 400 or the maskant 410 over the ramp portion 402 and the overlap portion 403.

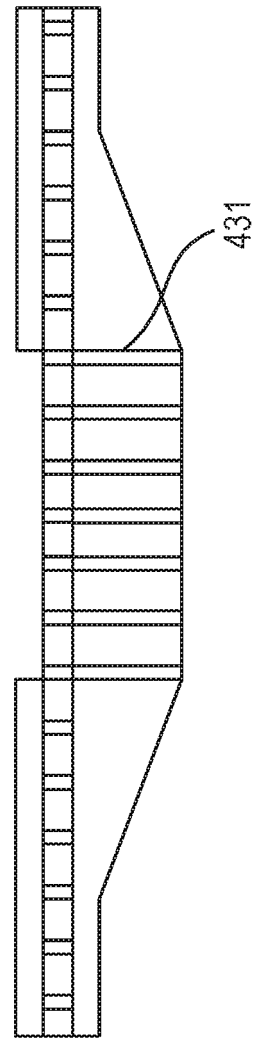
**[0020]** Referring to FIG. 4C, perforations 431 may be created in the core portion 401 with a blasting process. An abrasive material may be blasted at the replacement patch 400. In various embodiments, the abrasive material may comprise aluminum oxide, silicon carbide, or any other suitable abrasive material. The maskant 410 and the tape 420 may prevent the abrasive material from removing material from the replacement patch 400, other than through the apertures 415 in the maskant 410. The blasting may create the perforations 431 in the core portion 401.

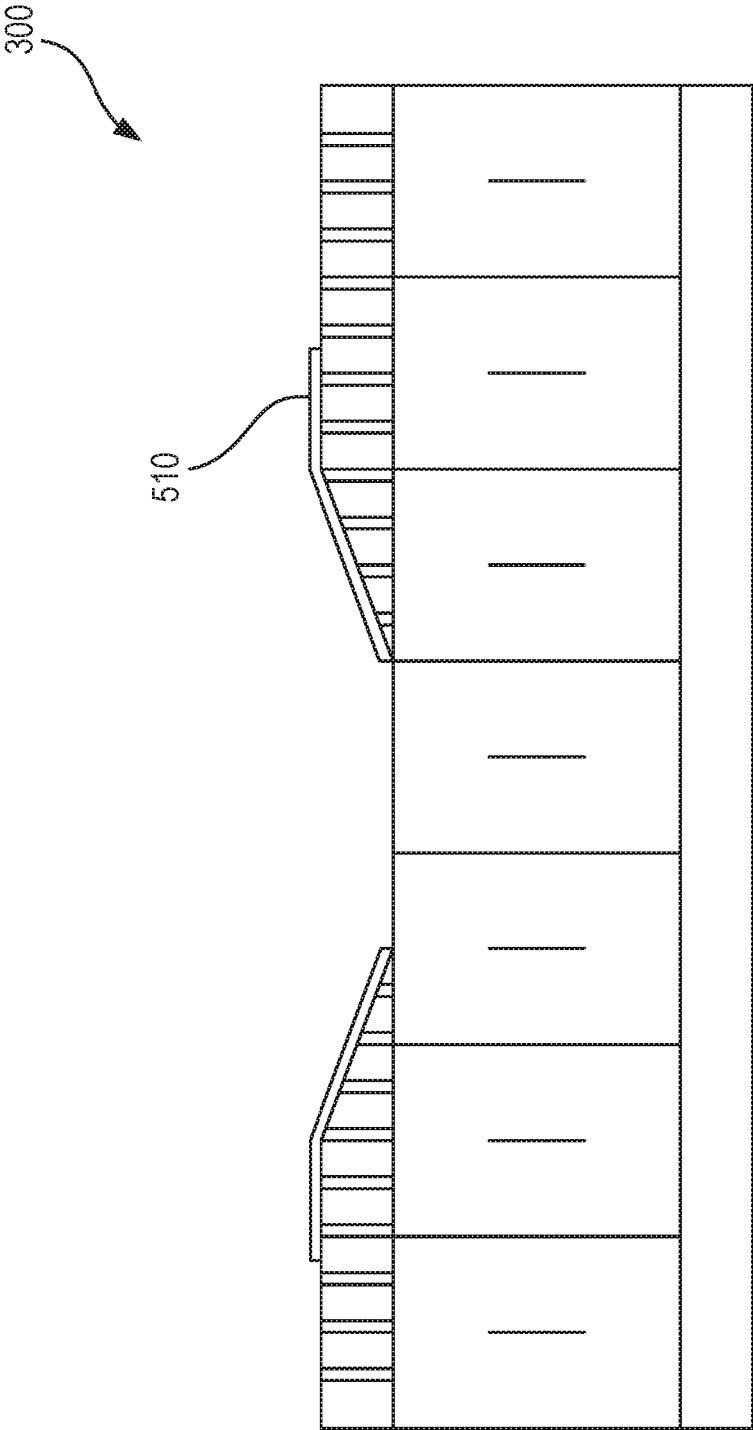
FIG. 5A

**[0021]** Referring to FIG. 5A, an uncured fiberglass ply 510 may be coupled to the acoustic panel 300. In various embodiments, a single ply may be used. However, in various embodiments, a plurality of plies may be used.

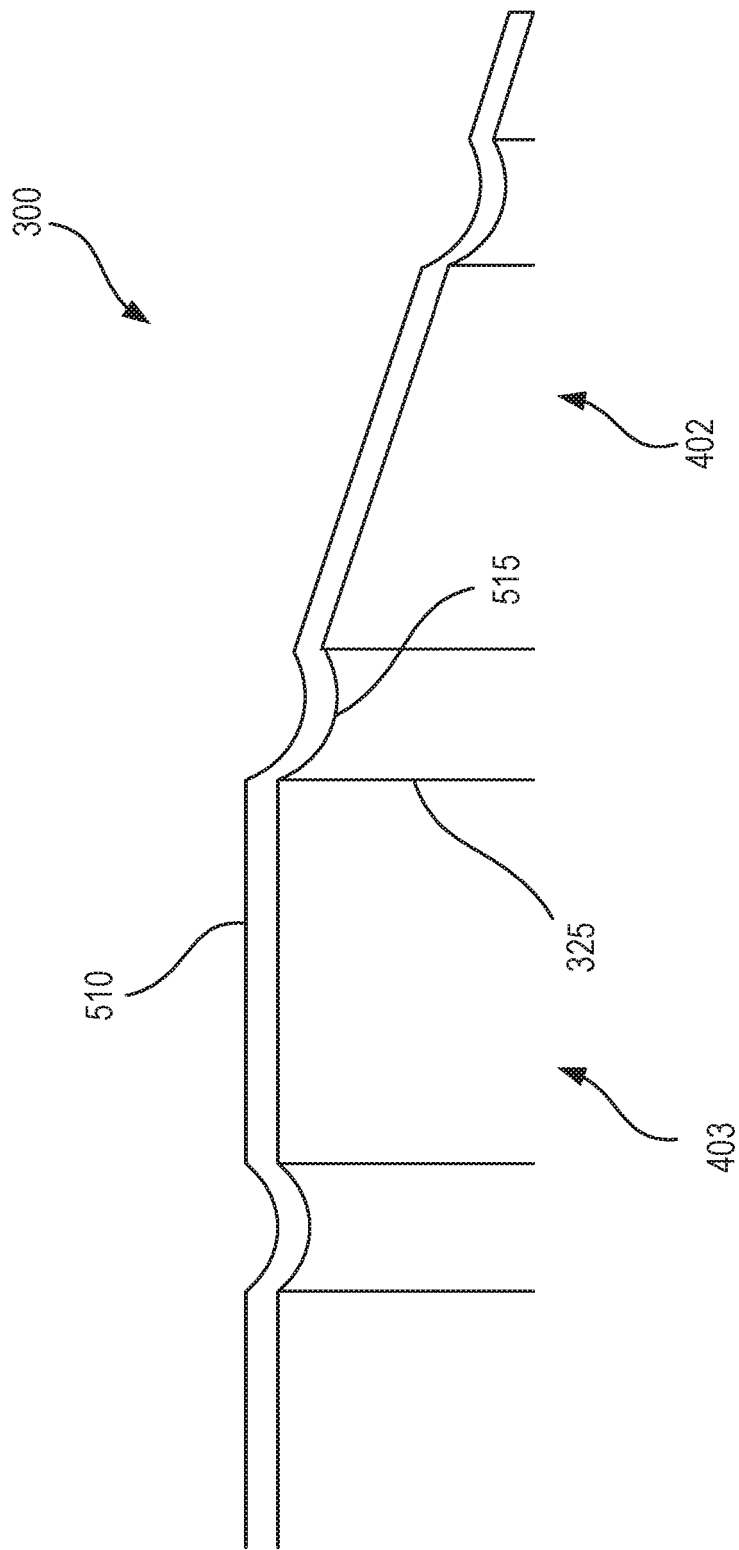
FIG. 5B

**[0022]** Referring to FIG. 5B, the acoustic panel 300 and the fiberglass ply 510 may be vacuum bagged, and a pressure differential may force the fiberglass ply 510 to droop into the perforations 325 in the ramp portion 402 and the overlap portion 403, creating dimples 515 within the perforations 325.

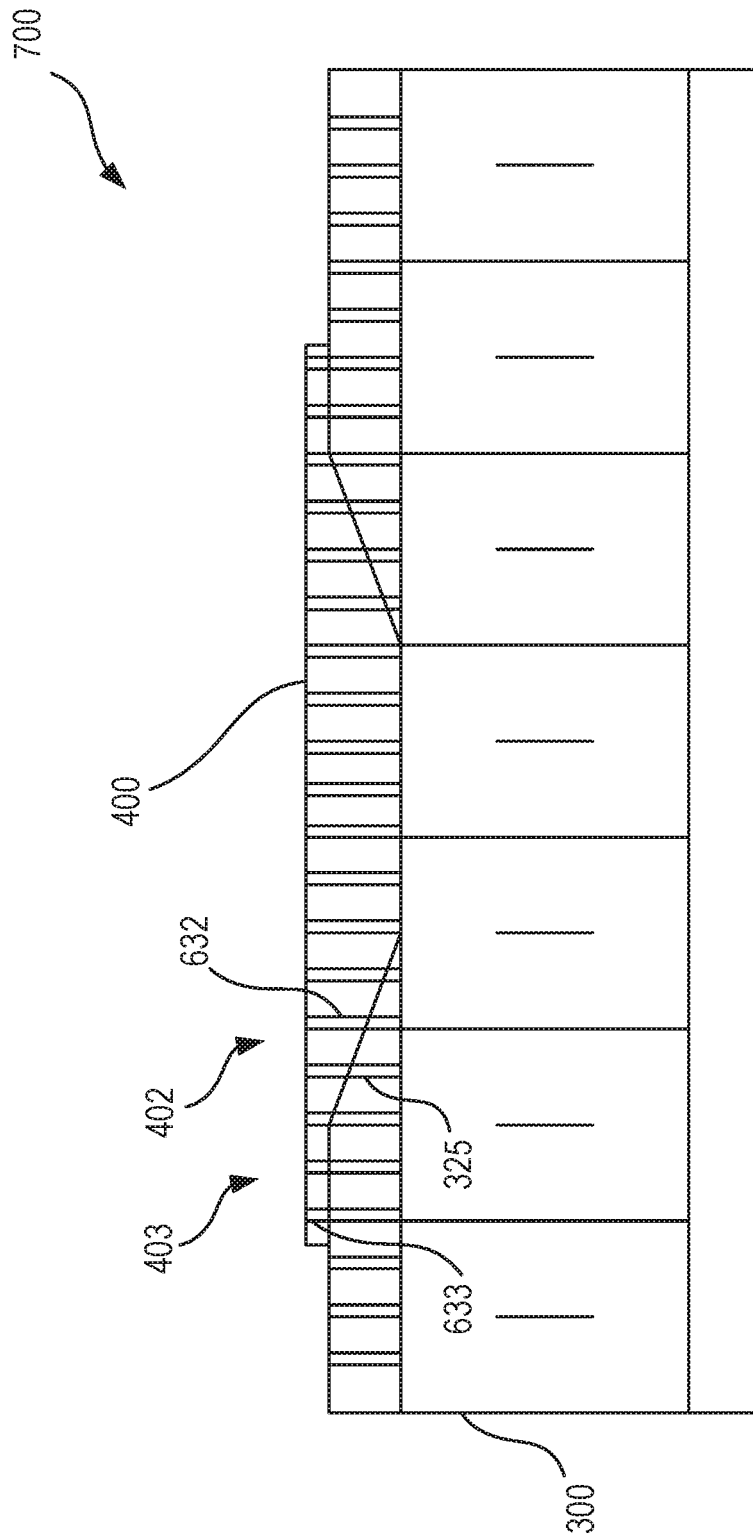
FIG. 7

**[0026]** Referring to FIG. 7, a repaired acoustic panel 700 is illustrated according to various embodiments. The replacement patch 400 may be bonded to the acoustic panel 300. The perforations 632, 633 in the ramp section 402 and the overlap section 403 of the replacement patch 400 may align with the perforations 325 in the acoustic panel 300. One or more pins may be inserted through the perforations 325, 632, 633 to keep the replacement patch 400 in place during curing. An adhesive may be placed on the replacement patch 400 and/or the acoustic panel 300 between the replacement patch 400 and the acoustic panel 300. The acoustic panel 300 with the replacement patch 400 may be cured in an autoclave. The repaired acoustic panel 700 may then be ready for operational use.

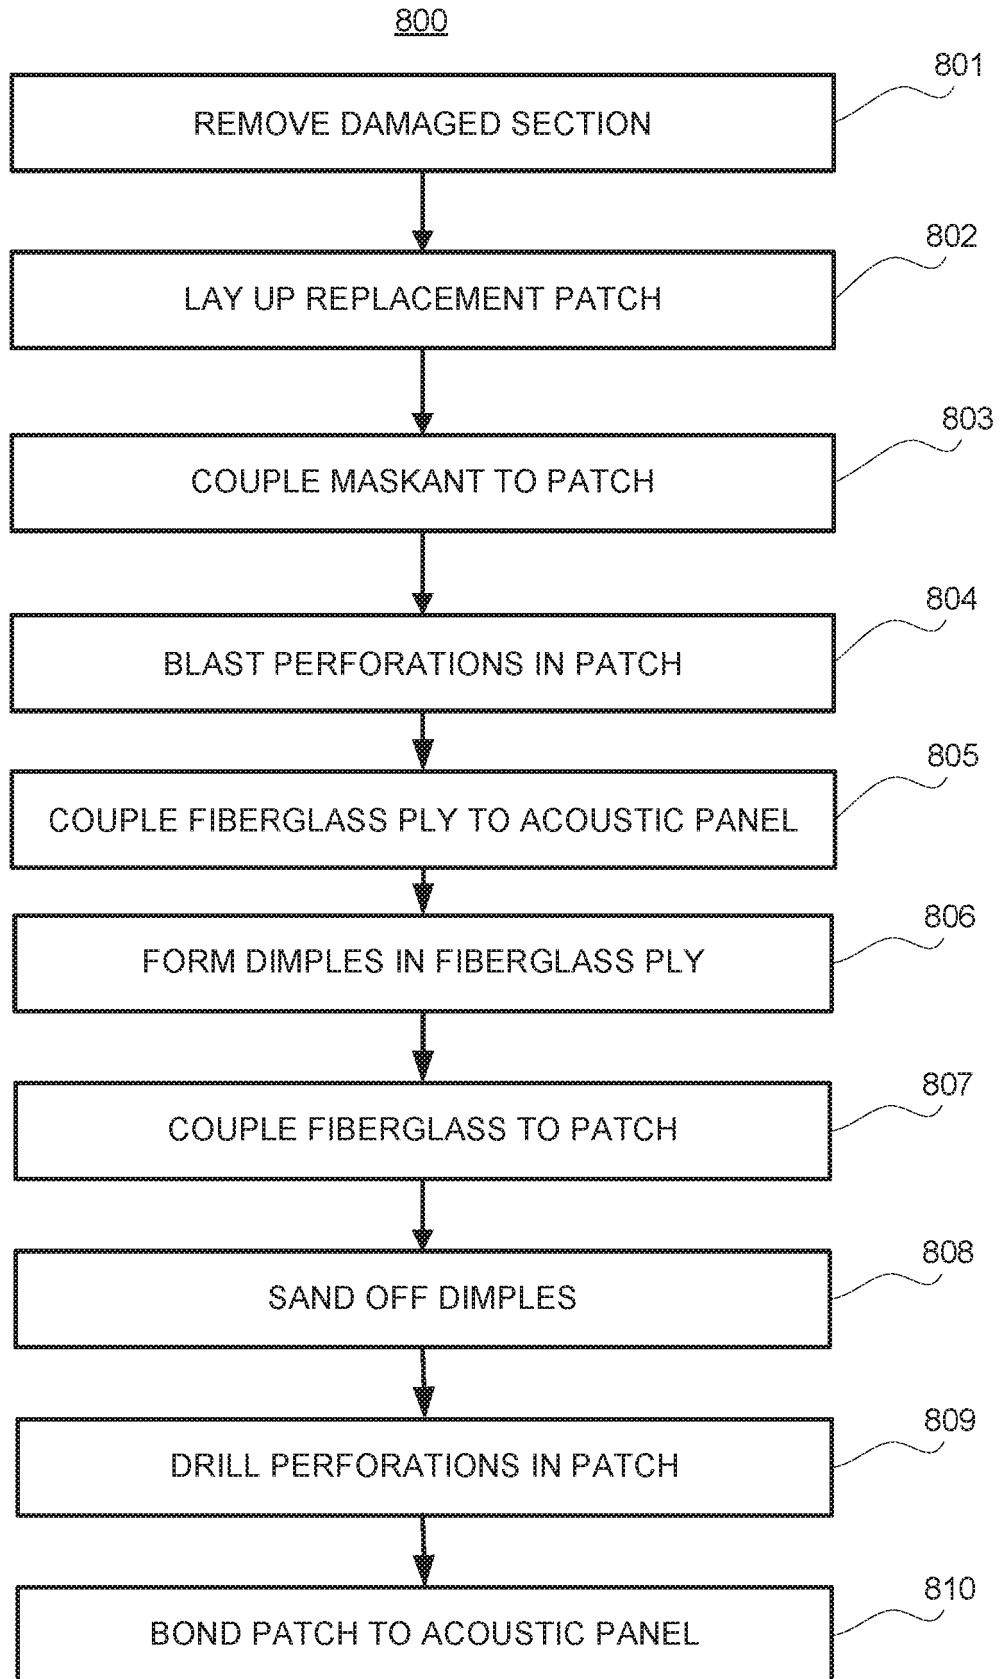
**FIG. 8**

**[0027]** Referring to FIG. 8, a flowchart 800 of a process for repairing an acoustic panel is illustrated according to various embodiments. Damage may be detected in an acoustic panel. The damaged section may be removed from the acoustic panel (step 801). A replacement patch may be laid up using a bond tool matching the shape of the acoustic panel (step 802). A perforated maskant may be coupled to the replacement patch (step 803). Perforations may be blasted in the replacement patch (step 804). The perforations may match the perforations in the maskant. A fiberglass ply may be coupled to the acoustic panel (step 805). The acoustic panel may be enclosed in a vacuum bag, such that the fiberglass ply droops into perforations in the acoustic panel, forming dimples in the fiberglass ply (step 806). The fiberglass ply may be removed from the acoustic panel and coupled to the replacement patch (step 807). The dimples in the fiberglass ply may be sanded off (step 808). Perforations may be drilled in the ramp section and overlap section of the replacement patch according to the pattern of the fiberglass ply (step 809). The replacement patch may be aligned with the acoustic panel and bonded to the acoustic panel (step 810).
