(11) **EP 3 748 125 A1**

(54) **METHODS FOR REPAIRING A MULTI-LAYER COATED COMPONENT**

(57) A method of repairing a defectively manufactured multi-layer component (100) having a substrate material (110) and a primer layer (130) includes applying, to the primer layer (130), a solvent that causes the primer layer (130) to swell to form a swelled primer layer (130).

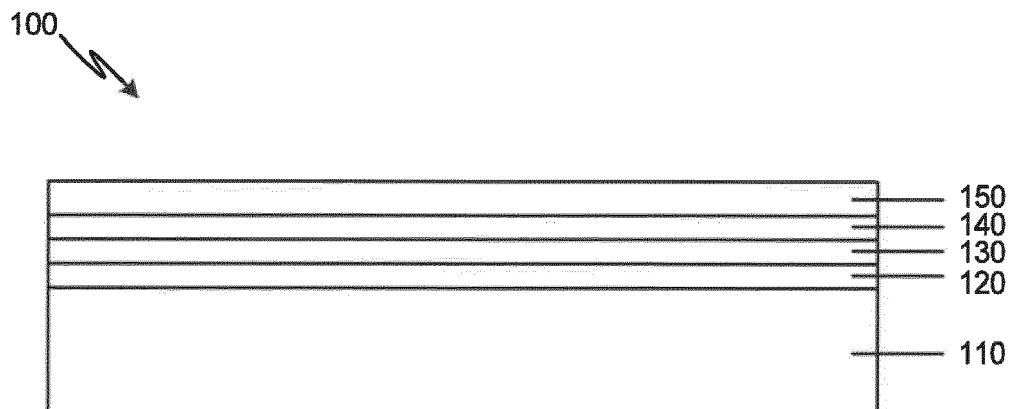
Fig. 1

The method also includes abrading away the swelled primer layer (130) from the multi-layer component (100) and rebuilding the multi-layer component (100) by forming a new primer layer (130') on the substrate material (110).

[0009] FIG. 1 is a cross-sectional view of a multi-layer component. FIG. 1 shows component 100 including substrate material 110, anodized layer 120, primer layer 130, structural adhesive 140, and coating 150. Component 100 can be, for example, a compressor blade, turbofan blade, a turboprop propeller blade, tilt rotor prop, vane strut, or other component with a toughened epoxy layer.

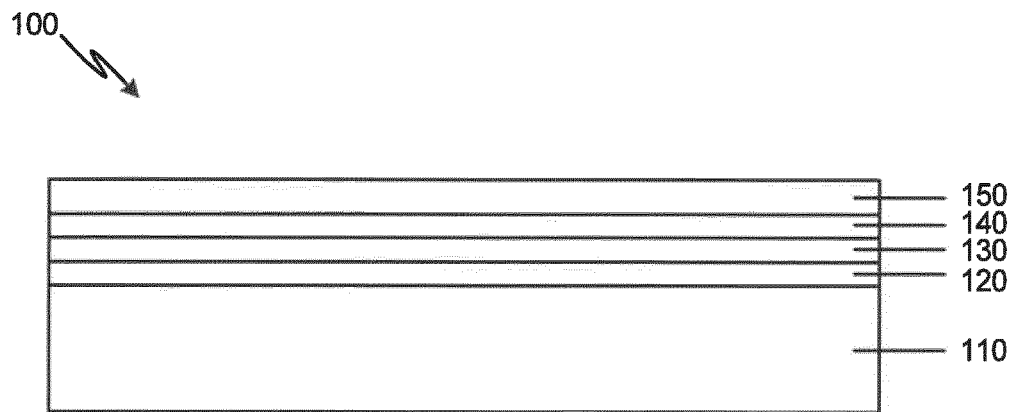
Fig. 1

FIG. 1 is a cross-sectional view of a multi-layer component.
