(54) **ACOUSTIC PANEL REPAIR WITH RETENTION OF ACOUSTIC PROPERTIES**

(57) An acoustic panel (300) for an aircraft nacelle may comprise a perforated first skin, a second skin, and a core sandwiched between them. A damaged portion of the perforated first skin may be removed. A fiberglass ply (510) may be coupled to the acoustic panel. A pres-

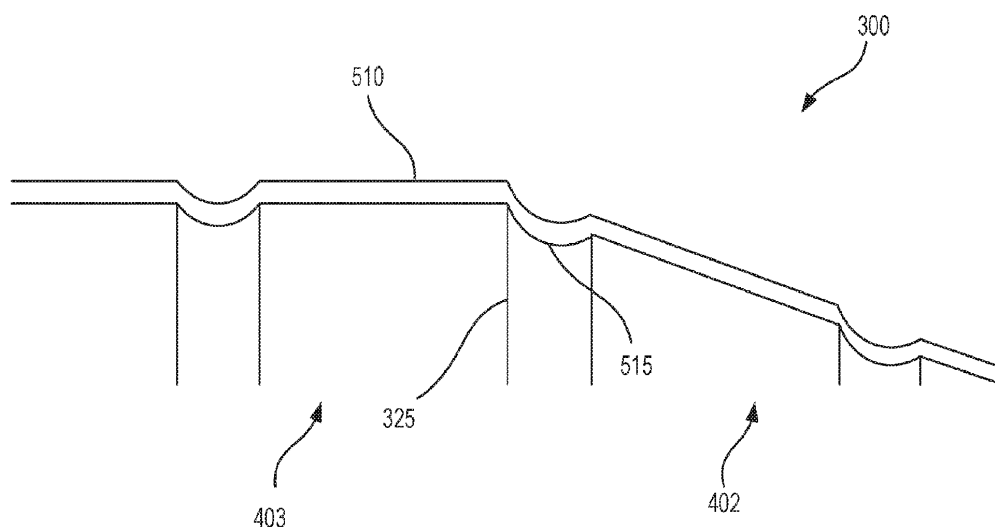
sure differential may cause the fiberglass ply to form dimples (515) within the perforations of the first skin. The fiberglass ply may be used as a template to drill holes in a replacement patch (400).

FIG. 5B illustrates a schematic cross-section view of an acoustic panel with a fiberglass ply with dimples in accordance with various embodiments

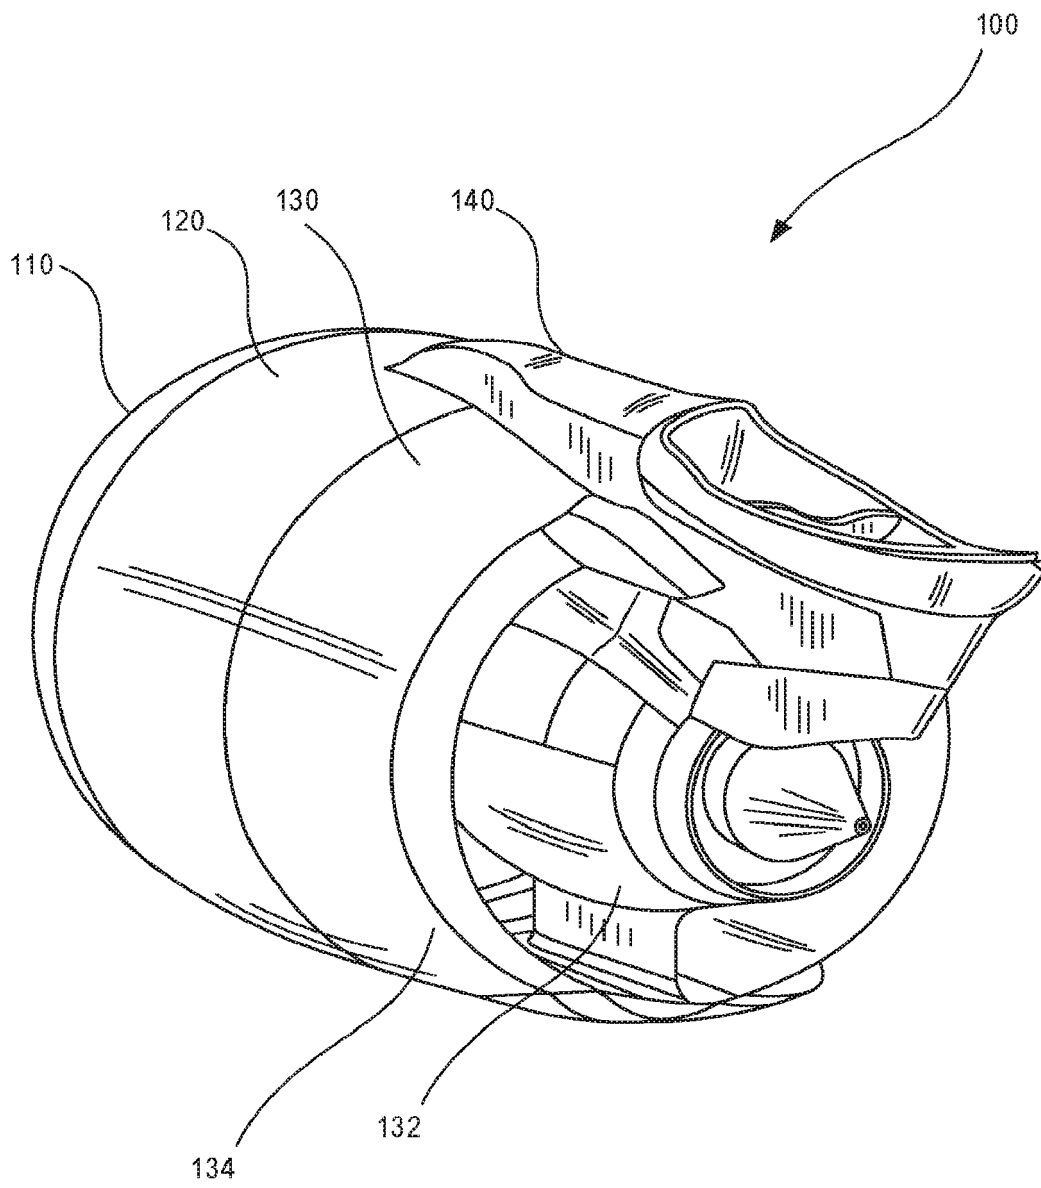
FIG. 1 illustrates a perspective view of a nacelle for an aircraft in accordance with various embodiments; FIG. 2 illustrates a perspective view of an acoustic panel in accordance with various embodiments; FIG. 3 illustrates a schematic cross-section view of an acoustic panel with a damaged portion of a perforated top skin removed in accordance with various embodiments; FIG. 4A illustrates a schematic cross-section view of a replacement patch in accordance with various embodiments; FIG. 4B illustrates a schematic cross-section view of a replacement patch with a maskant in accordance

**[0013]** Referring to FIG. 1, a nacelle 100 for a gas turbine engine is illustrated according to various embodiments. Nacelle 100 may comprise an inlet 110, a fan cowl 120, and a thrust reverser 130. Nacelle 100 may be coupled to a pylon 140, which may mount the nacelle 100 to an aircraft wing or aircraft body. Thrust reverser 130 may comprise an inner fixed structure ("IFS") 132, an outer fixed structure ("OFS"), and a translating sleeve 134. Bypass air from an engine fan may flow in a generally an-

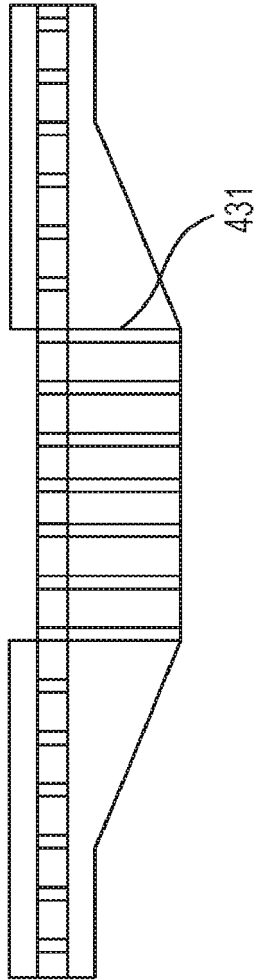
FIG. 4C illustrates a schematic cross-section view of a replacement patch with perforations in a core portion in accordance with various embodiments

**[0017]** Referring to FIGs. 4A-4C, a schematic cross-section view of a replacement patch 400 is illustrated according to various embodiments. The replacement patch 400 may comprise a plurality of composite plies. The plies may be laid up on a bond tool which matches the shape of the component which is being repaired. The replacement patch 400 may comprise a core portion 401 which is configured to be placed directly over the core of an acoustic panel where the original top skin is completely removed. The replacement patch 400 may comprise a ramp portion 402 which is configured to be placed where the original top skin is partially removed. The replacement patch 400 may comprise an overlap portion 403 which is configured to be placed over the original top skin.

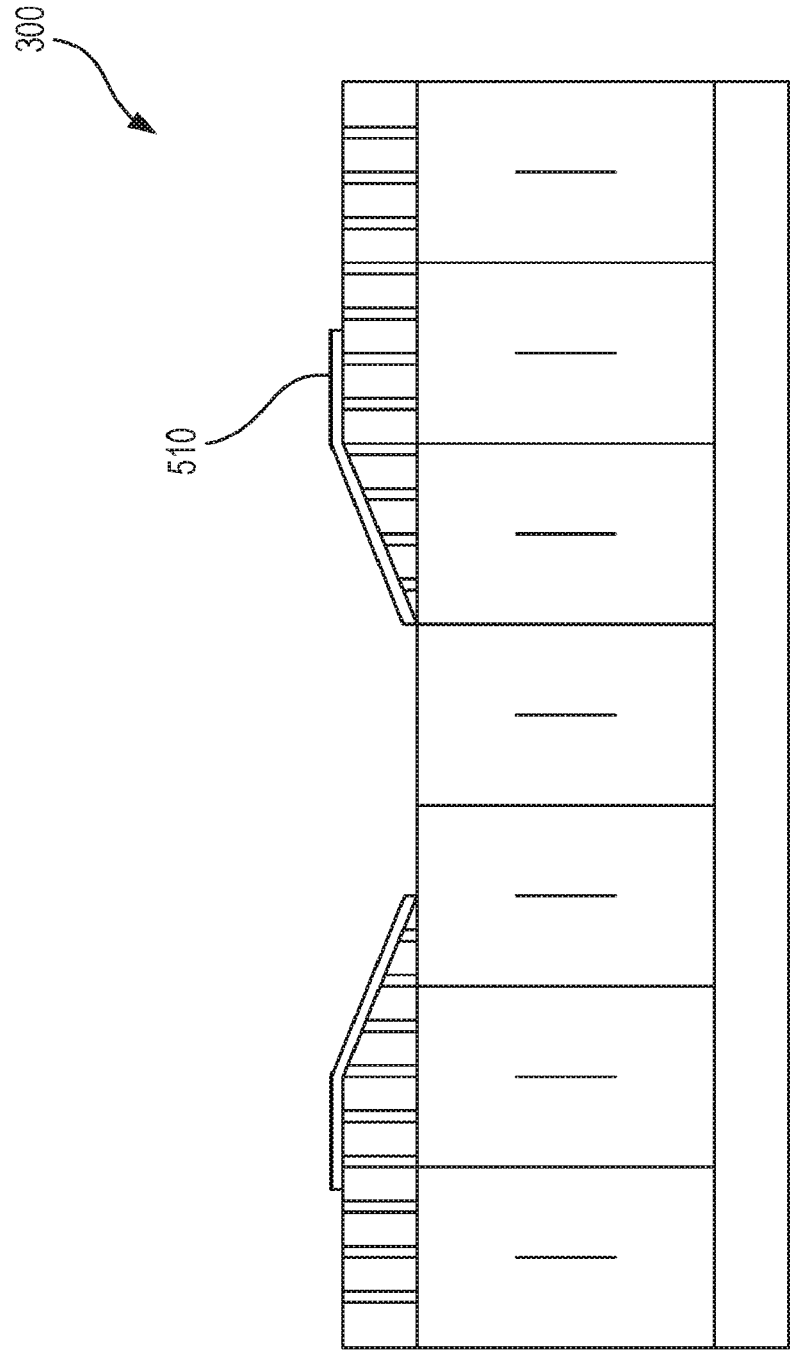
FIG. 5A illustrates a schematic cross-section view of an acoustic panel with an uncured fiberglass ply in accordance with various embodiments;

**[0020]** Referring to FIG. 5A, an uncured fiberglass ply 510 may be coupled to the acoustic panel 300. In various embodiments, a single ply may be used. However, in various embodiments, a plurality of plies may be used.
