EP 4 208 643 B1

(54) METHOD OF REPAIRING A WIND TURBINE

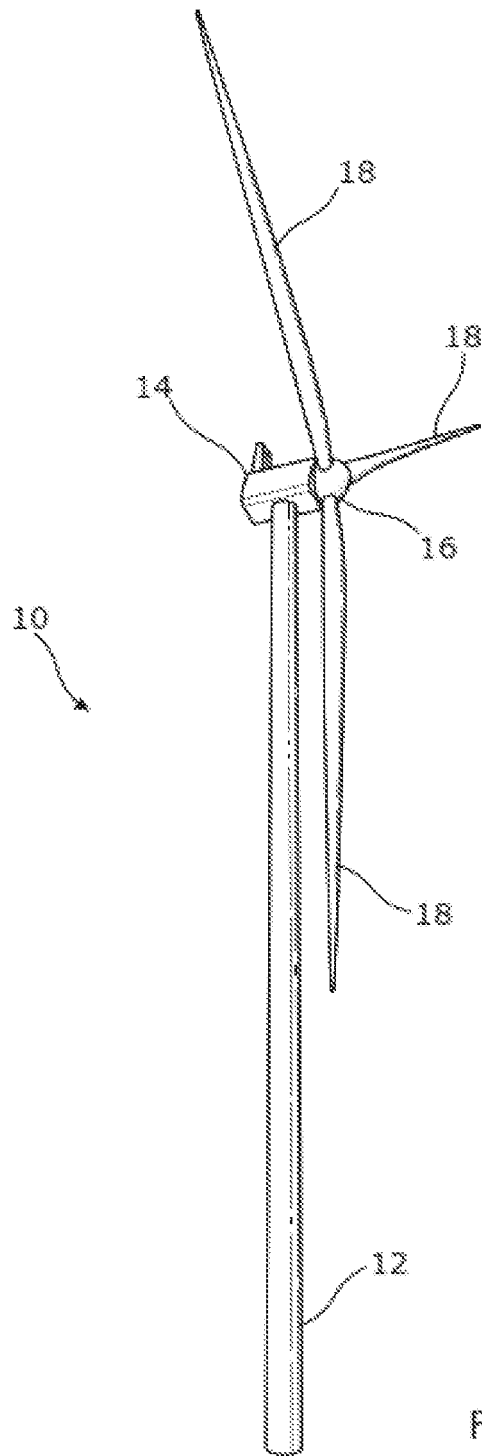
[0022] Figure 1 shows a wind turbine 10 including a tower 12, a nacelle 14 rotatably coupled to the top of the tower 12, a rotor including a rotor hub 16 mounted to the nacelle 14, and a plurality of wind turbine rotor blades 18 - in the described example, three rotor blades - which are coupled to the rotor hub 16. The nacelle 14 and rotor blades 18 are turned and directed into the wind direction by a yaw system. The nacelle 14 houses generating components (not shown) of the wind turbine 10, including a generator, gearbox assembly (gear assembly or, simply, gearbox), drivetrain and brake assembly, as well as converter equipment for converting the kinetic energy of the wind into electrical energy for provision to the grid. The wind turbine 10 is shown in its fully-installed form suitable for operation; in particular, the rotor hub 16 is mounted on the nacelle 14 and each of the blades 18 are mounted on the rotor hub 16.

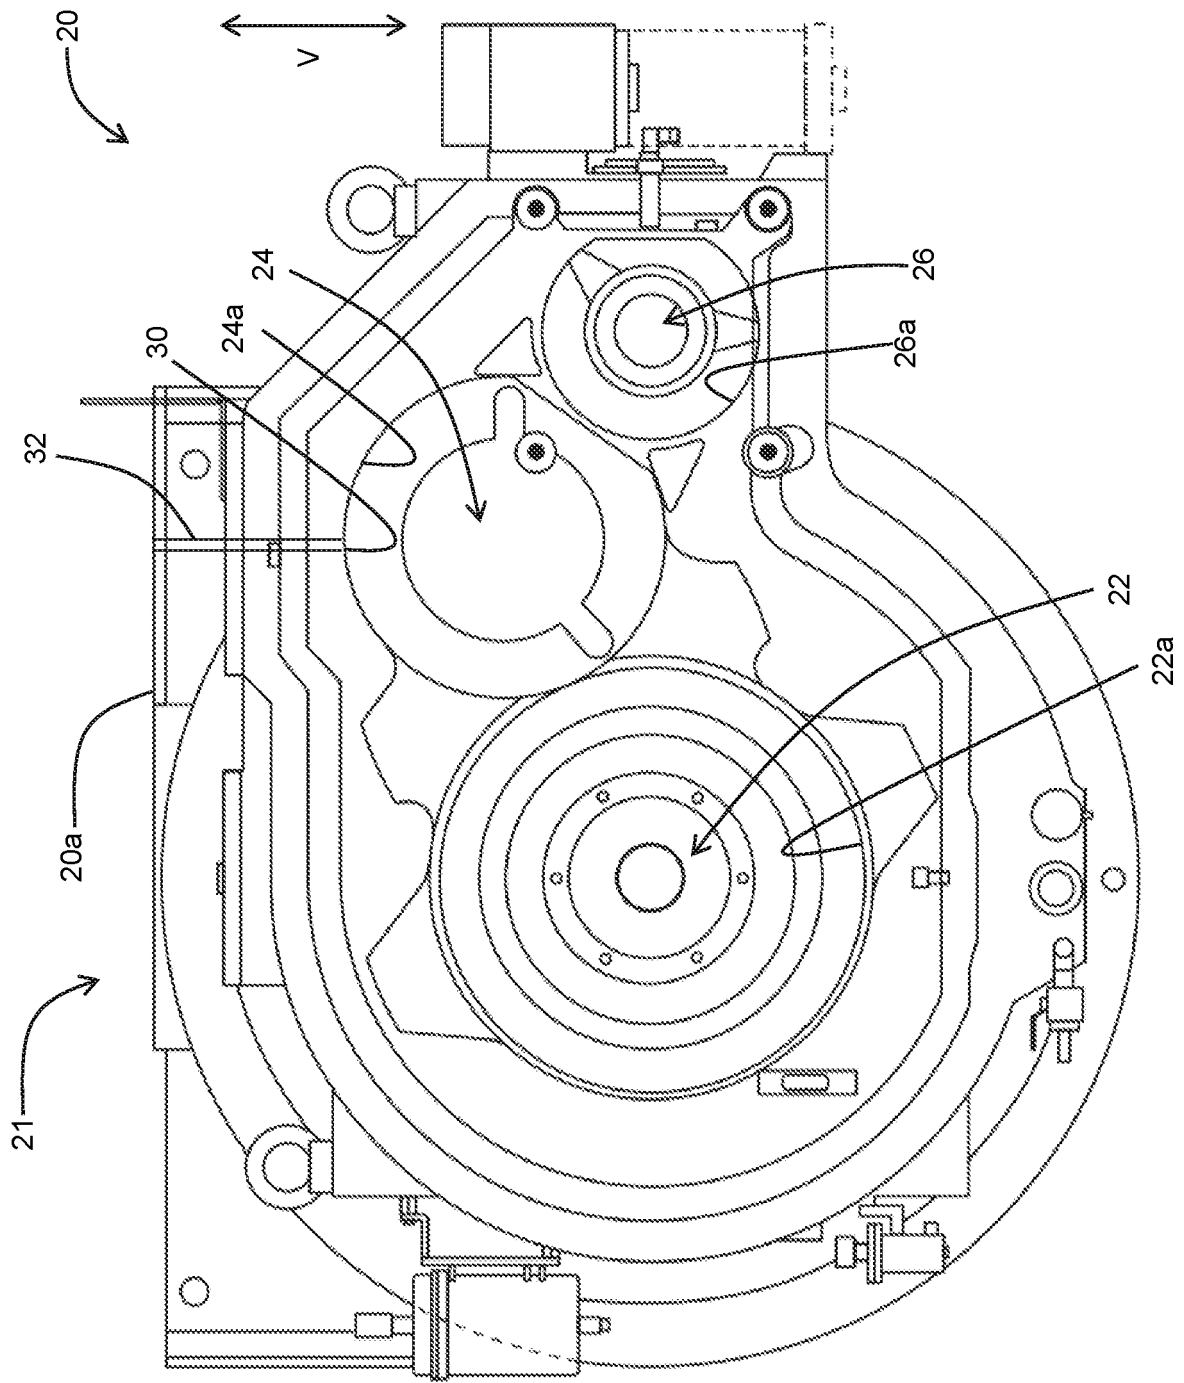
Figure 2 shows a sectional rear view of a housing component of a gear assembly of the wind turbine of Figure 1; and,

[0023] Figure 2 illustrates a sectional rear view of a bearing housing 20 - or gearbox housing - of the gearbox assembly housed in the nacelle 14 of the wind turbine 10. The housing 20 supports or houses a number of com-

[0028] A particular form of wear that may occur in a gearbox as in the described example is to the intermediate shaft bore 24. As seen in Figure 2, the intermediate shaft bore 24 is located between the low-speed and high-speed shaft bores 22, 26, the intermediate shaft bore 24 being positioned slightly higher than the low- and high-speed shaft bores 22, 26. The intermediate shaft bore 24 may in particular house a bearing at a rotor side/end of the gearbox.

[0030] The geometry of the described gearbox is such that rotation of the rotor-end bearing in the intermediate shaft may cause wear at a particular location within the bore 24. In particular, the wear may be most severe at, or be limited to, an upper part of the intermediate shaft bore 24. Specifically, it has been observed that wear is caused at the top of the intermediate shaft bore 24, that is, centrally at the upper part of the bore 24, i.e. a '12 o'clock' position or 'middle' position of the inner surface 24a as viewed in Figure 2.

[0031] The wear at the top part of the intermediate shaft bore 24 results in a gap being created or formed between the bore inner surface 24a and the rotor-end bearing outer ring centrally at the upper side of the bore 24. The location of the wear/gap is indicated generally by reference numeral 30 in Figure 2.

[0038] As indicated in Figure 2, in the described example the hole 32 is drilled in a radial direction relative to the bore 24. In particular, in the described example the hole 32 is drilled in a substantially vertical direction V through the housing component 20. One or both of these features can make it easier to drill through the housing component 20.
