EP 4 382 366 A1

(54) CLOCK SPRING ASSEMBLY

(57) A clock spring assembly comprising a stationary housing and a rotor. The stationary housing and the rotor cooperatively define a chamber that accommodates at least one flexible ribbon cable (501) that is wound in a first rotational direction onto the rotor and fixed at one end to the rotor and at the other end to the stationary housing. The flexible ribbon cable is wound around the rotor (601) and establishes an electrical connection between the rotor and the stationary housing. A rupture pin (502) is attached to the at least one ribbon cable. A slot (605) is provided in the housing and captures the rupture pin if the rotor is overwound in the second rotational direction opposite to the first rotational direction such that the rupture pin blocks the ribbon cable (501) from unwinding any further.

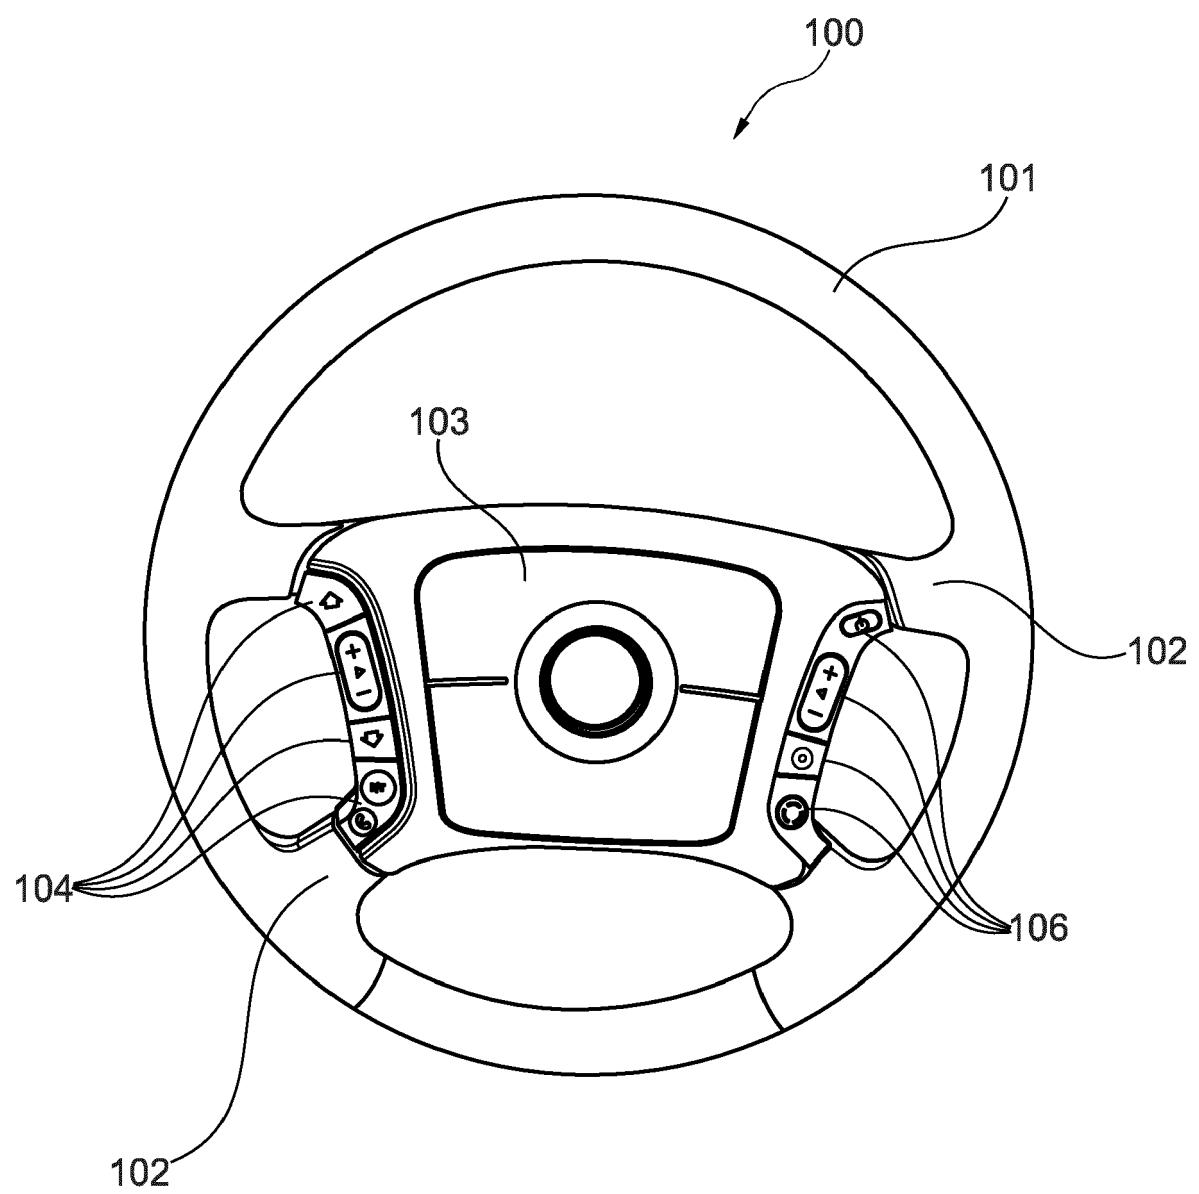
20 Fig. 1 a steering wheel with electric buttons;

[0018] Figure 1 shows an automobile steering wheel 100 with a steering wheel rim 101, steering wheel spokes 102, and an impact cup 103 in the center of the steering wheel 100. The impact cup 103 accommodates a driver airbag with its associated airbag igniter (not shown). When sensors located in the automobile detect an accident, electric signals are sent to the airbag igniter to trigger it to inflate the airbag.

45 [0019] On the left and right side of the impact cup 103 a plurality of electric buttons 104, 106 are arranged. For instance, the electric buttons 104 on the left-hand side in Figure 1 are used to control an audio and telephone system of the automobile. In the same embodiment the electric buttons 106 on the right-hand side are used to control a cruise control system of the automobile. The electric buttons 104, 106 and the airbag igniter turn together with the steering wheel 100. Nevertheless, they need to be reliably connected with a stationary cabling system that provides connection with the electronic system of the automobile. This rotatable electric connection is achieved with a clock spring.

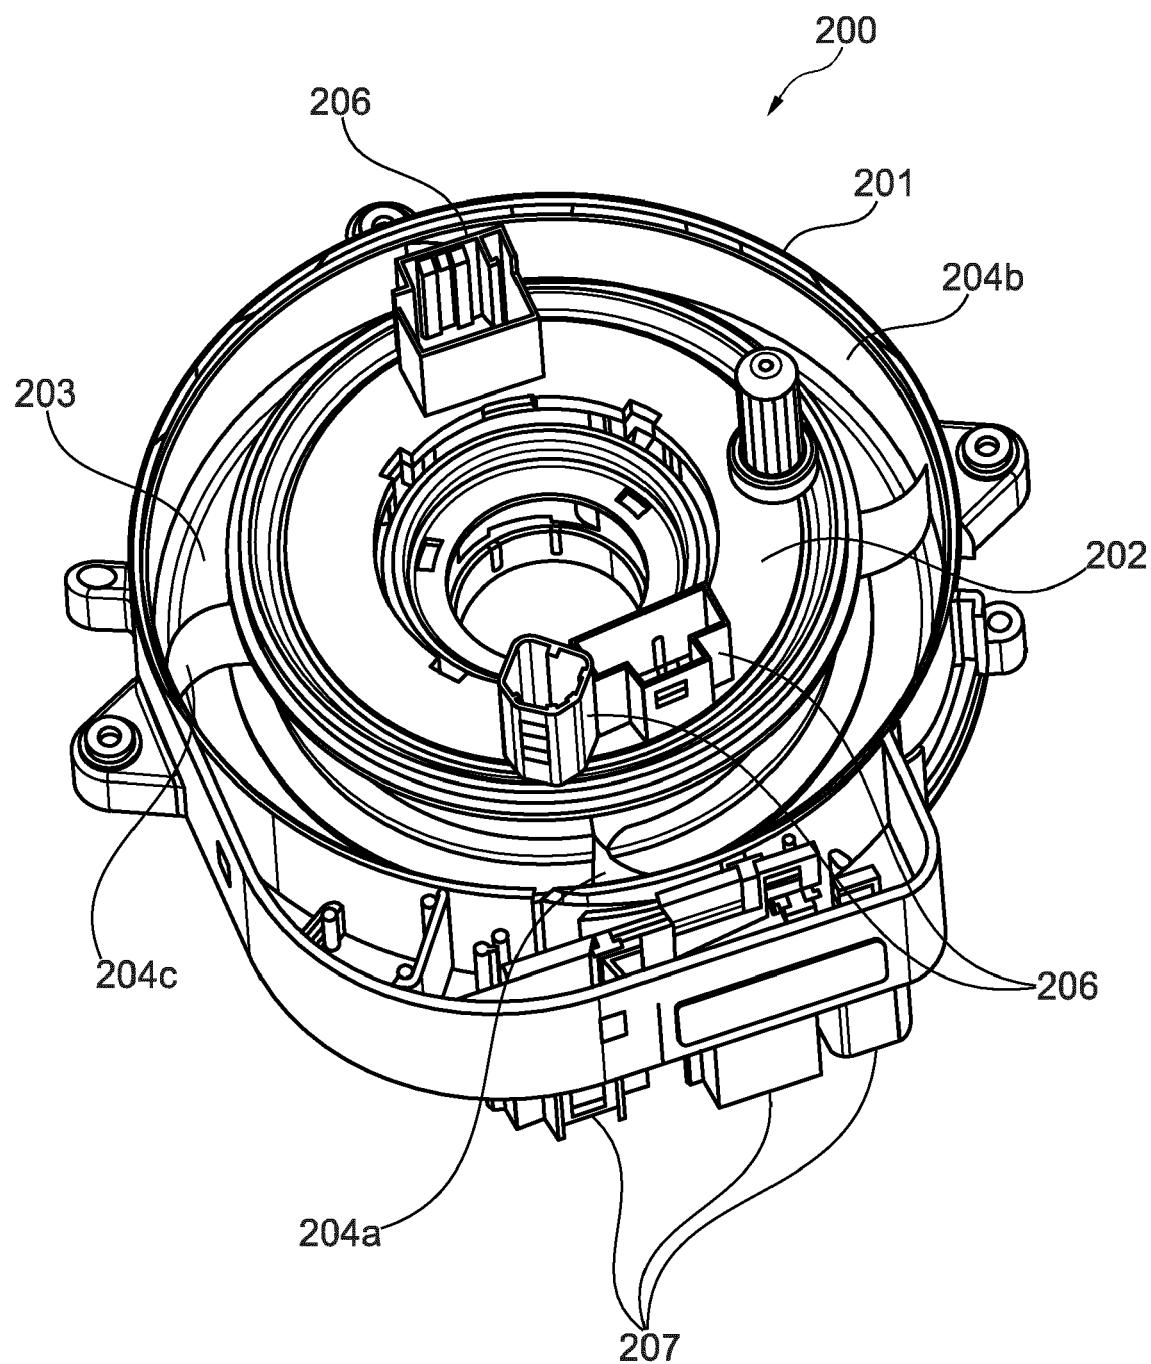
Fig. 2 a clock spring without cover in a perspective view;

50 [0020] Figure 2 shows a clock spring assembly (briefly clock spring 200) in a perspective view. The clock spring 200 comprises a stationary housing 201 which, when the clock spring 200 is installed in an automobile, is fixed for example to a steering column of the automobile. Thus, the housing 201 remains stationary. When installed in the automobile, the clock spring 200 is closed by a cover which is not shown in Figure 2 to permit a view into the interior of the clock spring 200.

55 [0021] In the housing 201 a rotor 202 is pivoted and can rotate relative to the housing 201. The housing 201, the rotor 202, and the cover (not shown) of the clock spring 200 define cooperatively a chamber 203 that accommodates four ribbon cables but in Figure 2 only three ribbon cables 204a-c are visible. In other embodiments the clock spring 200

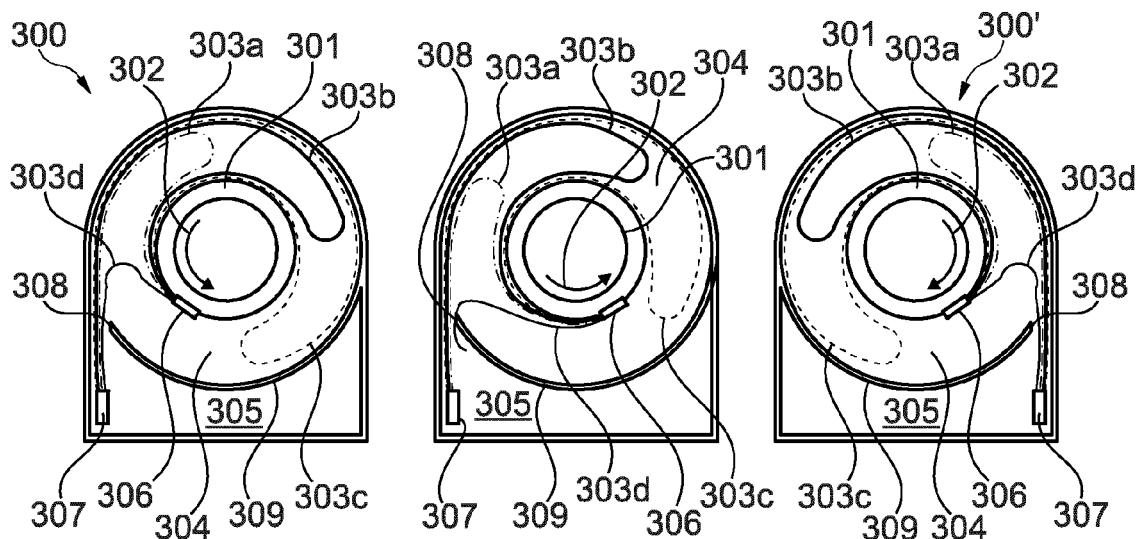
Fig. 3A

Figs. 3A, 3B a clock spring out of its centered position towards the left-hand side;

25 Fig. 3C a clock spring with ribbon cables, which are wound in clockwise direction on the rotor;

[0023] Figure 3A schematically illustrates a clock spring 300 with a rotor 301 out of the center position by a half or full rotation to the left as indicated by arrow 302. The clock spring 300 comprises four ribbon cables 303a-d located in a chamber 304 that is defined between the rotor 301 and a stationary housing 305. The ribbon cables 303a-d are connected on the one hand with a socket 306 located on the rotor 301 and with a socket 307 located on the housing 305. As can be seen in Figure 3A ribbon cable 303d is almost completely wound up on the rotor 301 in the counter-clock sense. However, since the steering wheel connected with the clock spring 300 has not yet arrived on its left stop, the ribbon cable 303d becomes at first tensioned over an edge 308 of an internal wall 309 of the housing 305 and is then disrupted as it is shown in Figure 3B. If that happens, the driver of the automobile is informed by a warning signal indicating a technical defect in the driver can take care of the problem by visiting a repair shop. Even though the described situation is undesirable, the problem can be easily managed. Much more problematic is a situation described in the following.

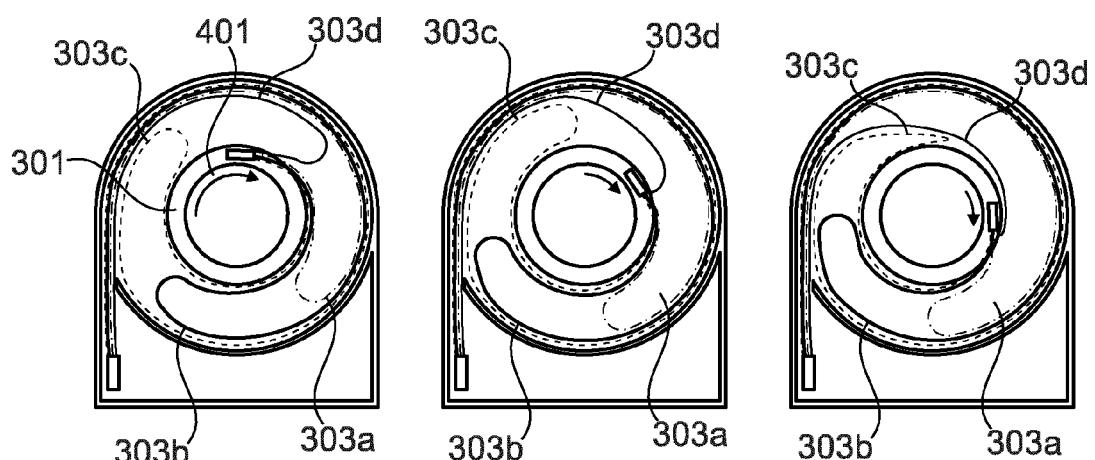
Fig. 4A

Figs. 4A-4C a clock spring out of its centered position towards the right-hand side;

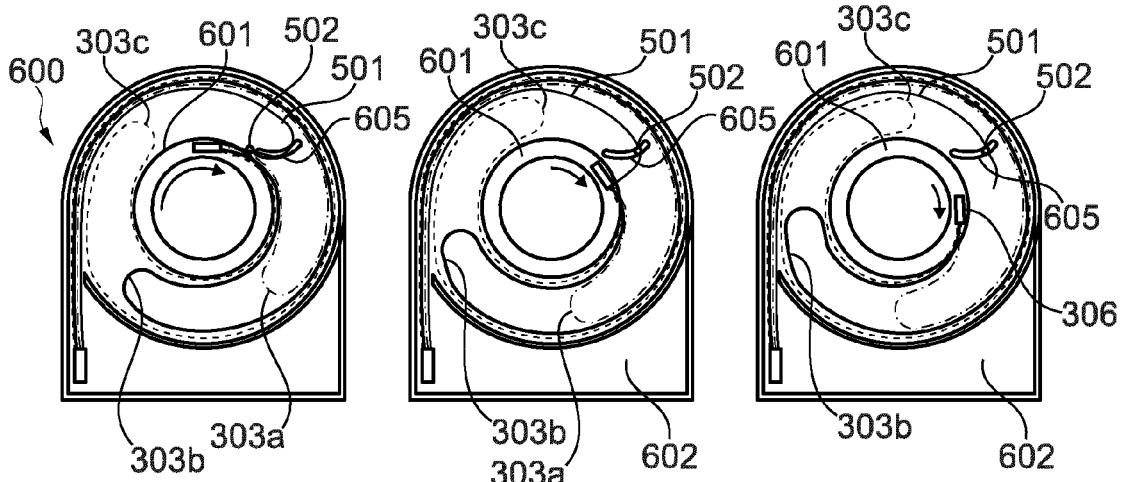
Fig. 6A

Figs. 6A-6C a clock spring according to the present disclosure out of its centered position towards the right-hand side;

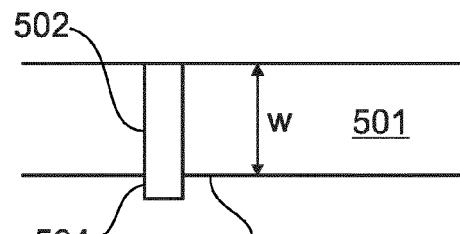
Fig. 5A

30 Figs. 5A, 5B a ribbon cable with a rupture pin;

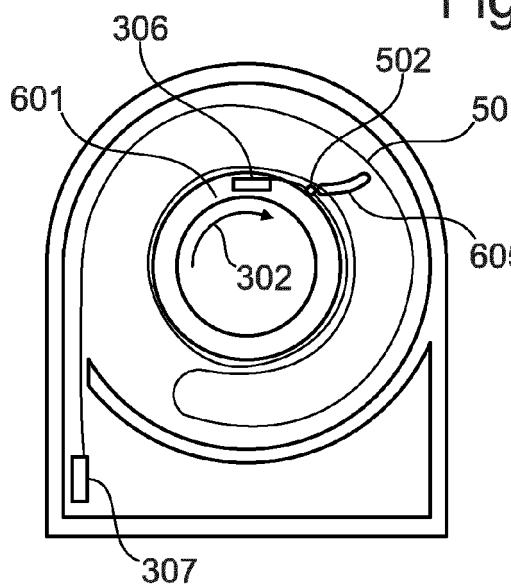
Fig. 7A

Figs. 7A, 7B a clock spring according to the present disclosure when it is installed in its centered position; and

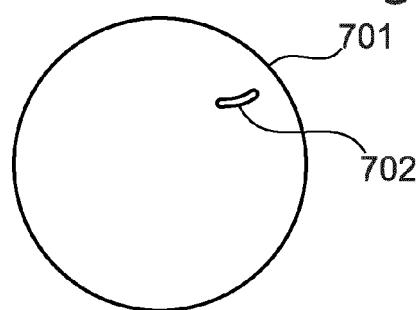
35 Fig. 7C a cover of the clock spring according to the present disclosure.
