12 EUROPEAN PATENT APPLICATION

54 Method of repairing blast furnace wall lining.

"METHOD OF REPAIRING BLAST FURNACE WALL LINING"

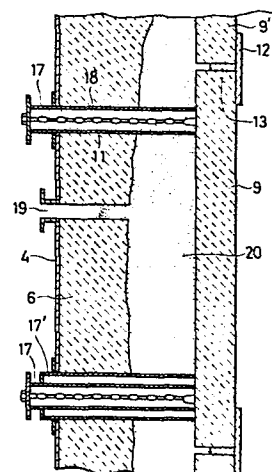
FIG. 2

57 In repairing a lining damage in a blast furnace, the furnace is blown down after lowering the burden inside to below the damaged part. Then a plurality of openings and a refractories filling aperture (19) are provided across the furnace wall in the damaged part. A preliminarily prepared panel (9) is hung down through an opening in the furnace top to a position opposite to the damaged part. One end of a string-like member (11) whose other end is fastened to the panel (9) is drawn outside the furnace through one of the openings. The whole length of the string-like member (11) is protectively covered by a single (17) or double support tube (17, 17') and stretched therethrough. Monolithic refractories (20) are pressed in through the refractories filling aperture (19) into a clearance between the damaged part (6) and panel (9) either during blowing down or after blowing in.

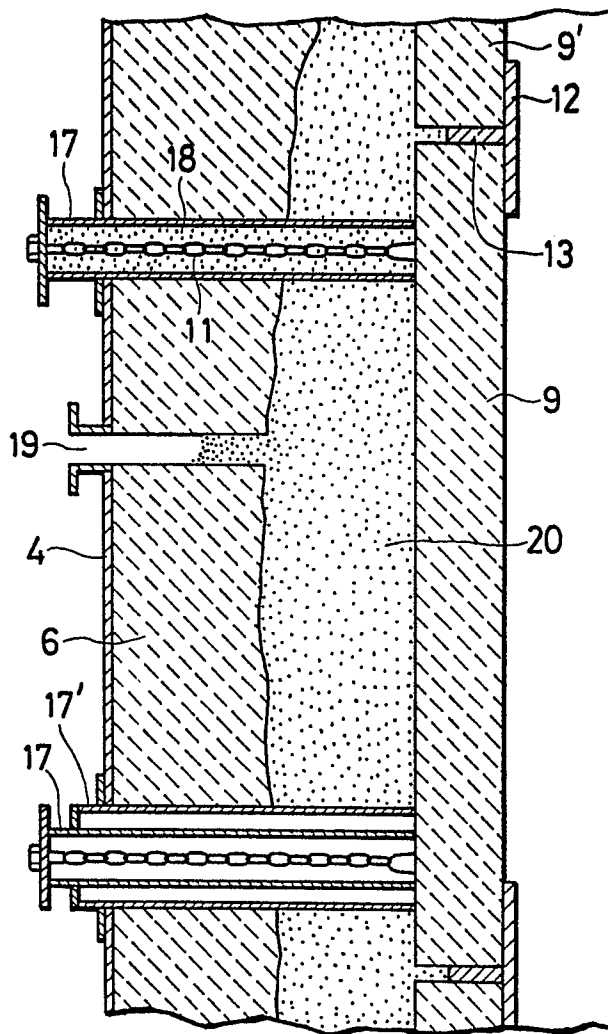
FIG. 2

Fig. 2 is an enlarged cross section showing the details of a damaged portion under repair.

Then, a support tube 17 of a given length is inserted from outside the furnace to cover the chain 11, with the chain 11 being stretched and fastened at the rear end of the tube 17, as shown in Fig. 2. By this means, the panel 9 is firmly fastened to the stack with a given clearance left between itself and the damaged lining 6. The clearance is such that the distance between the panel 9 and the steel shell 4 is substantially equal to the thickness of the original, undamaged refractory lining.

The panel 9 may be supported more firmly if two coaxially disposed tubes 17 and 17' are used instead of the single tube 17, as shown in the lower part of Fig. 2.

The refractories filling aperture 19 should preferably be opened a little above the center of each panel 9, as shown in Fig. 2. The refractories 20 can be supplied to a plurality of panels 9 through one filling aperture 19 when the panel size is small. It is therefore desirable to give adequate consideration to the positional relationship between the filling aperture 19 and the panels 9 in their design stage.

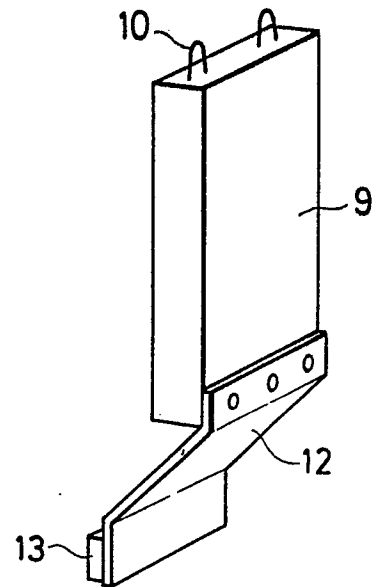
FIG. 3

Fig. 3 is a perspective view showing a preferred embodiment of the lowest panel used in implementing the repairing method of this invention.

When the lowest panel 9 has been fixed in position, the winch 3 lifts the unslung wire rope 15 for lowering the next panel. A down-inclined back-up plate 12 may be attached to the lowest panel 9, as shown in Fig. 3, to prevent the leakage or falling of the monolithic refractories to be filled in as described later.

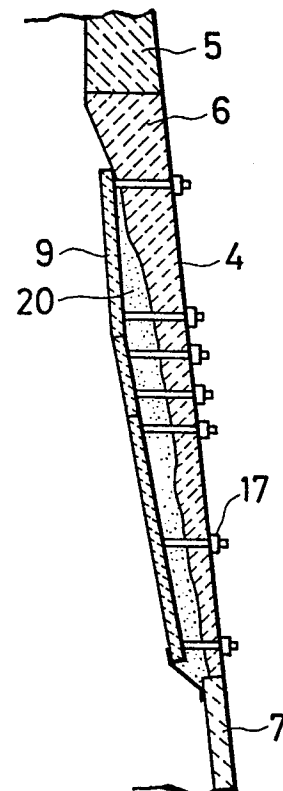
FIG. 4

Fig. 4 is a vertical cross section of the furnace

lining repaired according to the method of this invention.

damaged part a is covered with a number of panels 9 that are horizontally and vertically fastened together, as shown in Fig. 4. When all the panels 9 have been fastened in position, the furnace top opening 2 is closed to get the furnace ready for blowing in.
