# EUROPEAN PATENT APPLICATION

21 Application number: 89300976.1

54 **Inspecting glass containers for line-over finish defects.**

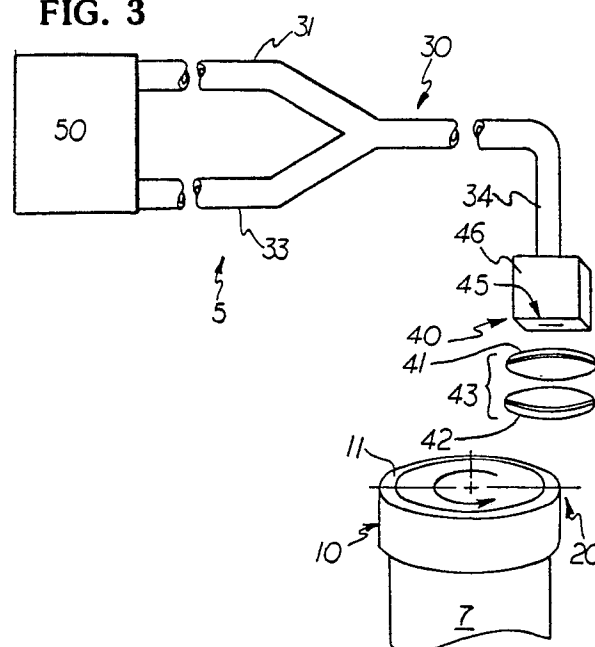
**FIG. 3**

57 Apparatus for detecting line-over defects at the finish of a glassware container. A bifurcated fiber optic bundle includes sender and receiver fiber branches; one of the branches terminates at a modulated visible red high intensity LED light source, the other at a photosensor. The non-bifurcated, probe end of the fiber optic cable terminates in a rectangular pattern of sending and receiving fibers in a random mix. The probe end of the fiber optic bundle is positioned directly over the container finish and pointed straight down. An intervening lens assembly produces a focused 1:1 image of the rectangular pattern at the bottle finish with the long axis of the rectangle oriented radially across the finish. An electronic assembly modulates the LED, demodulates the photodetector output, and detects sharp reductions in the intensity of light reflected back to the receiver fibers, indicative of line-over defects.

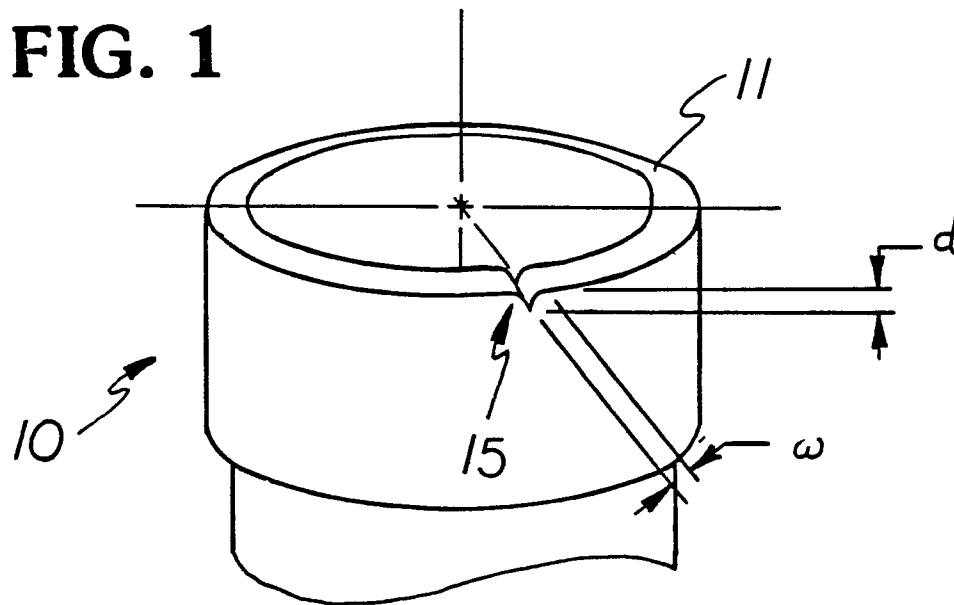
**FIG. 1**

Figure 1 is a perspective view of a glass bottle finish, with a line-over groove;

The so-called "line-over" defect is a common problem in the manufacture of glass containers; other common names for line-overs are "shear marks" and "nit marks". This defect is a very small groove which extends radially across the sealing surface of the finish of the glass container; see Figure 1. It has been considered one of the worst and hardest to detect defects throughout the industry. In carbonated beverages, for example, the cap seal is not capable of sealing these fine grooves, and over a period of time, the carbonation gases seep out and the beverage goes flat. Food jars are another critical area. If the seal is bad due to this defect, the food can become contaminated. The baby food industry is particularly concerned with line-overs.

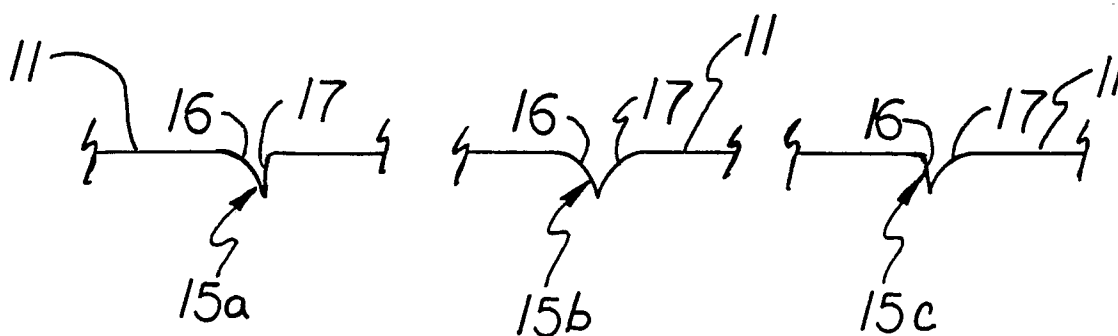
**FIG. 2A**

Figures 2A-2C are partial elevation views of a glass container finish, viewed from the interior, with three different line-over groove orientations:

Figure 2A shows a groove with a steep right wall, shallow left wall;

Figure 2B shows a groove with a symmetrical profile;

Figure 2C shows a groove with a shallow right wall, steep left wall;

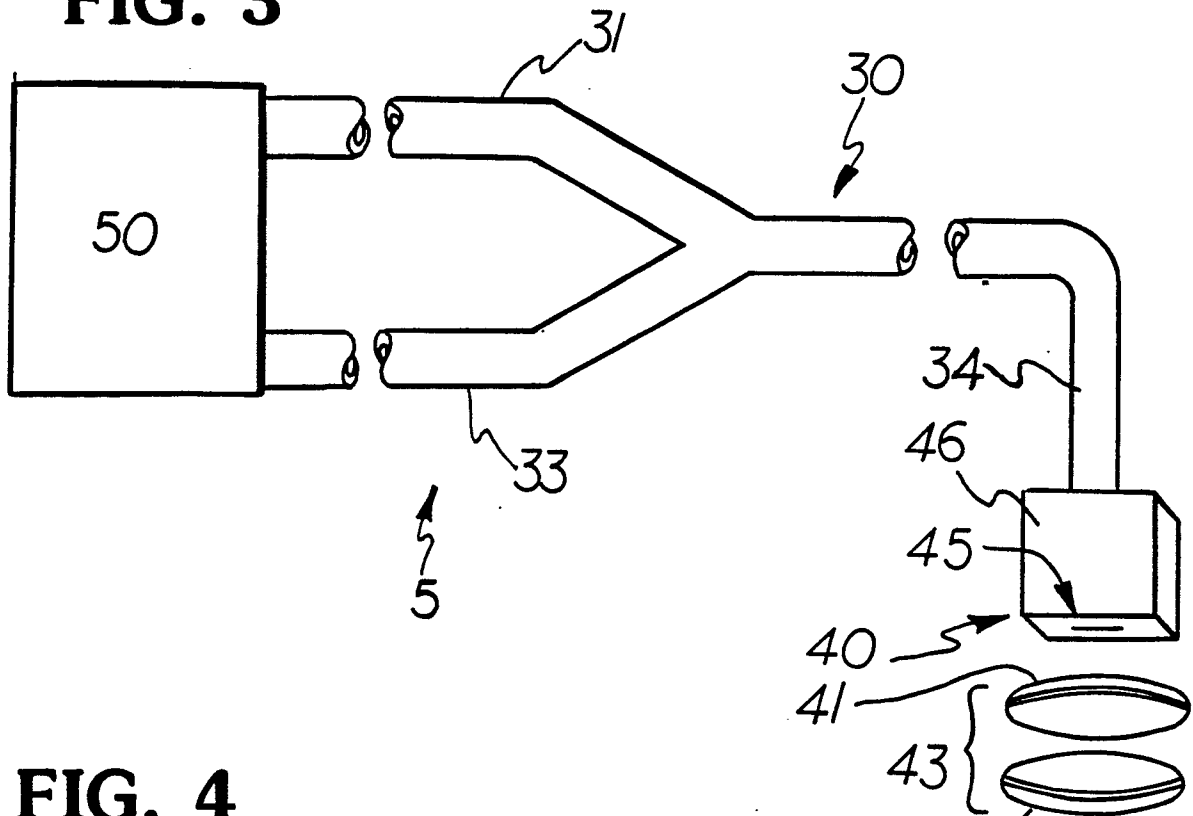
**FIG. 3**

Figure 3 is a somewhat schematic view of an overall inspection system in accordance with a preferred embodiment of the invention, scanning a bottle finish in counterclockwise rotation;

Figure 3 illustrates the construction of an inspection device 5 in accordance with the preferred embodiment of the invention. Inspection assembly 5 includes a fibre optic probe 30 trained on the finish 10 of a glass container 7. In the illustrated embodiment, container 7 is caused to rotate relative to probe 30 so that probe 30 performs a complete circumferential scan of the sealing surface 11. Fibre optic probe 30 includes bifurcations 31, 33 and a joined portion 34. Bifurcation 31 includes sender fibres; bifurcation 33 carries receiver fibres; and joined portion 34 has the sender and receiver fibres intermingled terminating at a probe end 40 at which the fibres are thoroughly intermixed in a random distribution. The probe end 40 is carried in a probe mount 46 and terminates at an elongated rectangular slit 45. Probe mount 46 is set up to align and orient the fibre optic probe end 40 over the sealing surface 11 to form an elongate image 20 directly below. 1:1 lens assembly 43, comprising lenses 41 and 42, advantageously cre-

ates a slightly out-of-focus image 20 of the probe end 40 across sealing surface 11. It desirable to provide a slightly out of focus image so that the reflections from the sealing surface return to both the sender and receiver fibres at probe end 40, rather than just to the sender fibres.

The inspection device 5 works as follows. Modulated LED light travels down the sending fibres and is imaged slightly out-of-focus by lens assembly 43 onto the sealing surface 11 of finish 10. This light is reflected back up through the lens assembly 43 onto the sending and receiving random fibre pattern 45. The receiving fibres carry the light back to photosensor 37, where as described above the photosensor signal is demodulated to create an analog signal based upon the amount of light re-

flected back from the finish. As container 7 rotates axially below probe 30, the entire sealing surface 11 is scanned by this device. The result is a signal representative of the reflection pattern of the entire sealing surface 11. As a line-over passes through the image 20, light is reflected in many different directions and very little will return through the lensing system 43. This will cause a significant drop in signal level. Dust, dirt, and rough finish areas can also reduce the light reflected back, but as illustrated below with reference to Figures 6A-6C, the use of a radially oriented long, narrow light pattern 20 markedly improves the response of the inspection system 5 to line-over defects while discriminating such defects from other causes of signal reduction.

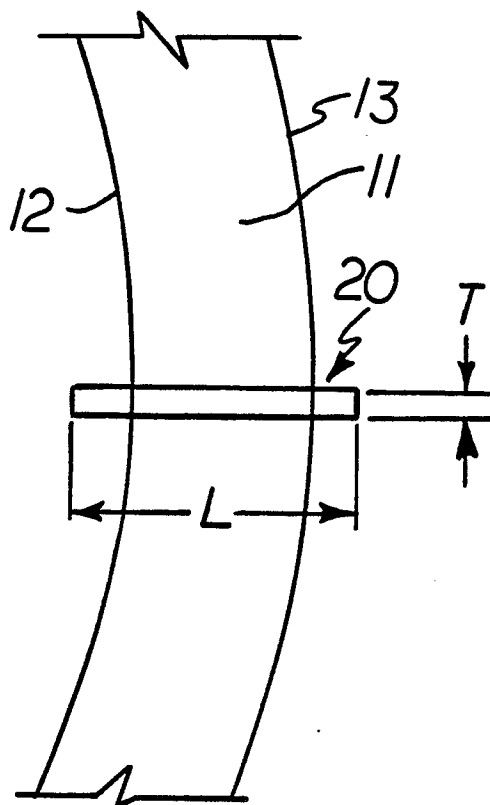
**FIG. 4**

Figure 4 is a partial plan view of a container sealing surface seen from above, showing the rectangular light image of the inspection system of Figure 3;

Now having reference to the partial plan view of the sealing surface 11 shown in Figure 4, the probe end image 20 comprises an elongate rectangle having a length L and width T. The dimension L is somewhat greater than the thickness between inner wall 12 and outer wall 13 of container finish 10. In an operative embodiment of the invention, L equalled 0.154 inches and T equalled 0.012 inches. This value of L was chosen to accommodate most common thicknesses of glass bottle finishes, and of T to yield a good signal-to-noise ratio. Rectangular image 20 is oriented with its long axis along a radius of the sealing surface 11.

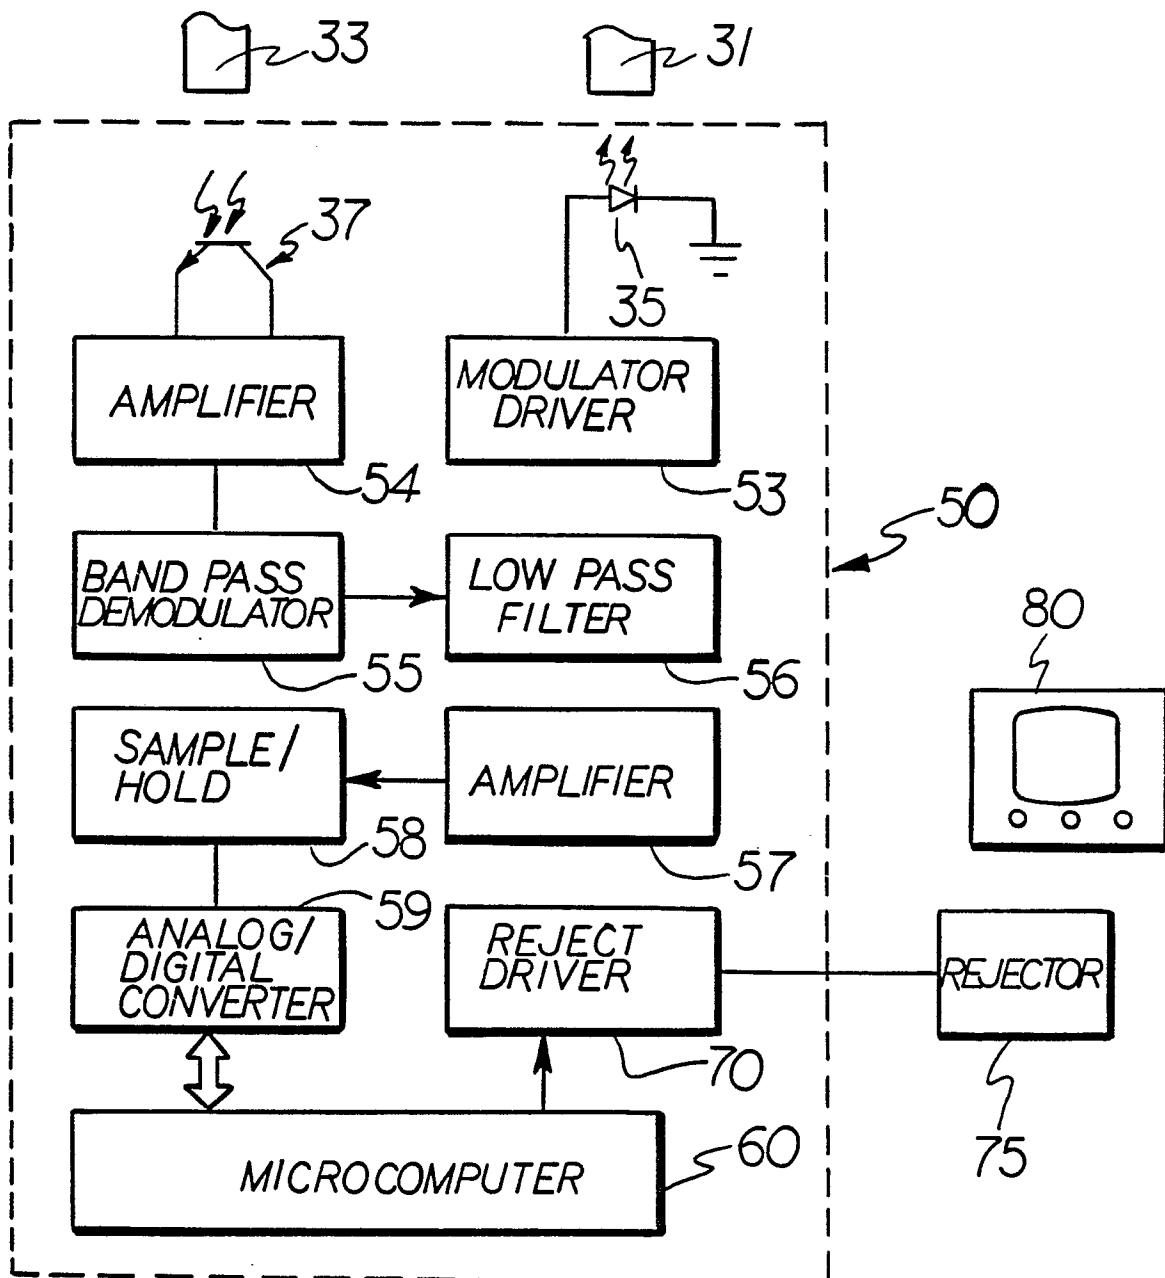
**FIG. 5**

Figure 5 is a schematic diagram of the light source, photodetector, and associated electronics, from the system of Figure 3; and

Figure 5 schematically illustrates a set of components for the signal processing electronics 50 of Figure 3. The light source for transmitting fibre 31 is a high intensity visible LED 35 in the red part of the visible spectrum. LED light source devices may be modulated at different frequencies, and provide a continuous, high-intensity output with minimum drift, over a prolonged service life. It should be understood that other light sources may be employed, taking into account the optical characteristics of the container finish 10. A photo receiver 37 is a phototransistor device which was matched in spectral response to LED 35. The phototransistor output, amplified at 54, is demodulated by band pass filter 55 calibrated to pass the modulation frequency of the red visible light LED 35. Low pass filter 56 extracts the slope signal from the modulated carrier signal, which slope signal is amplified at 57. The amplified slope signal is fed to sample/hold circuit 58 and thence to analog-to-digital converter 59 which integrates and digitalises this signal for each sample point. A microcomputer 60 analyses the integrated slope signal from circuit 50 as such signal is compiled for rotating container 7. Microcomputer 60 may in appropriate cases actuate reject device 75 via reject driver 70 to reject the container 7 when the processed information for that container indicates the presence of an unacceptable line-over defect.

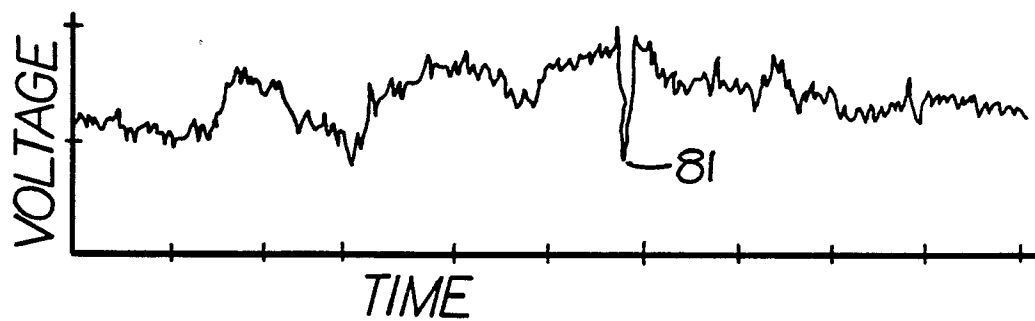
**FIG. 6A**

Figure 6A-6C are plots of a processed photodetector output signal representing the intensity of detected light, over a scan of the entire container finish:

Figure 6A shows a typical signal-to-noise wave form;

Figures 6A-6C are various plots or displays of an analog signal produced by the processing electronics 50 representing the amount of LED light reflected back through the fiber optic bundle 30 over various points of a scanning interval. The waveforms of Figures 6A-6C were displayed at an oscilloscope 80 which received the output of amplifier 57 from the circuit 50 of Figure 5. The plot of Figure 6A illustrates a typical signal-to-noise waveform including a dip at 81 caused by the passage of a line-over defect under the fiber optic probe 30. The plot of Figure 6B shows a signal reduction 83 created by a line-over defect after expanding the scale of the plot to 500 microseconds per division as compared with 10 milliseconds per division for the plot of Figure 6A. Figure 6C shows a plot taken at 2.5 milliseconds per division in which dips 85 and 87 were caused by dust particles, while signal drop 89 was caused by a line-over defect. It will be seen that the line-over defect caused a much sharper drop in signal level. The plot of Figures 6A-6B illustrate the capability of line-over inspection system 5 to selectively and repeatedly detect true line-over defects while minimizing good ware lost due to other finish marks that are not considered problems.

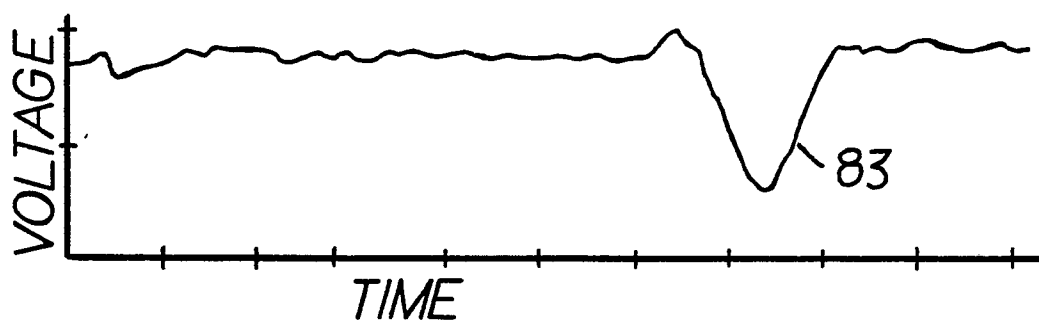
**FIG. 6B**

Figure 6B shows an expanded view of scan including a line-over defect signal; and

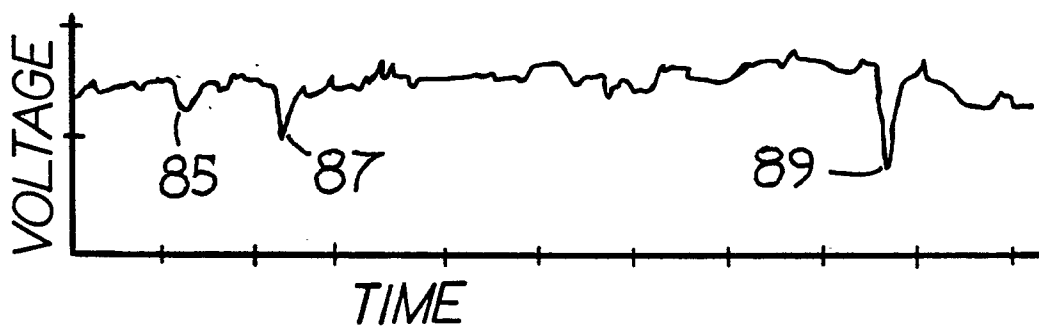
**FIG. 6C**

Figure 6C shows a wave form featuring both a line-over signal and dust signals.
