(11) **EP 0 808 913 B1**

(12) **EUROPEAN PATENT SPECIFICATION**

(54) **Method for repairing a thermal barrier coating**

(73) Proprietor: **GENERAL ELECTRIC COMPANY**
Schenectady, NY 12345 (US)

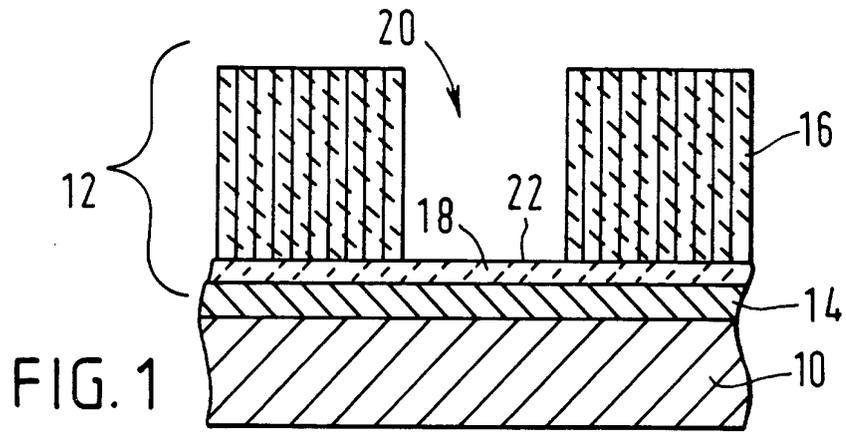
Figure 1 shows a cross-sectional representation of a component that has suffered localized spallation; and

[0018] As represented in Figure 1, the method of this invention is particularly suited for the repair of a thermal barrier coating system 12 composed of a metallic bond layer 14 formed on the surface of the article 10, and a columnar ceramic layer 16 overlaying the bond layer 14. As is the situation with high temperature components of a gas turbine engine, the article 10 may be formed of a nickel-base or cobalt-base superalloy. The bond layer 14 is preferably formed of a metallic oxidation-resistant material, so as to protect the underlying article 10 from oxidation and enable the ceramic layer 16 to more tenaciously adhere to the article 10. A preferred bond layer 14 is formed by a nickel-base alloy powder, such as NiCrAlY, or an intermetallic nickel or platinum aluminide, which has been deposited on the surface of the article 10 to a thickness of about 20 to about 125 micrometers. Preferred methods for depositing bond layers of the type described above include vapor deposition techniques for aluminide coatings and low pressure plasma spray (LPPS) techniques for a NiCrAlY bond coat, though it is foreseeable that other deposition methods such as air plasma spray (APS) or physical vapor deposition (PVD) techniques could be used. Following deposition of the bond layer 14, an oxide layer 18 such as alumina may be formed on the surface of the bond layer 14 at an elevated temperature. The oxide layer 18 provides a surface to which the columnar ceramic layer 16 can tenaciously adhere, thereby promoting the resistance of the coating system 12 to thermal shock.

[0020] As a component of a gas turbine engine, surfaces of the article 10 are subjected to hot combustion gases during operation of the engine, and are therefore subjected to severe attack by oxidation, corrosion and erosion. Accordingly, the article 10 must remain protected from the hostile environment of the turbine section by the thermal barrier coating system 12, and loss of the ceramic layer 16 will lead to premature and often rapid deterioration of the article 10. Localized spalling 20 of the ceramic layer 16 is represented in Figure 1, with the repair process of this invention being represented in Figures 2 and 3.

[0021] The repair method of this invention begins with cleaning the bond layer 14 exposed by the localized spalling 20 so as to remove oxides and any residual fragments of the ceramic and oxide layers 16 and 18. While various techniques can be used, a preferred method is to grit blast the exposed surface of the bond layer 14, such as by a technique known as pencil grit blasting. This step is selectively performed to ensure that the remaining ceramic layer 16 is not subjected to the procedure. It may be desirable to mask the surrounding ceramic layer 16 with, for example, tape masking, during the grit blasting operation. In addition to providing a level of protection to the ceramic layer 16, tape masking would also serve as a proof test for the integrity of the ceramic layer 16 immediately surrounding the spalling 20.

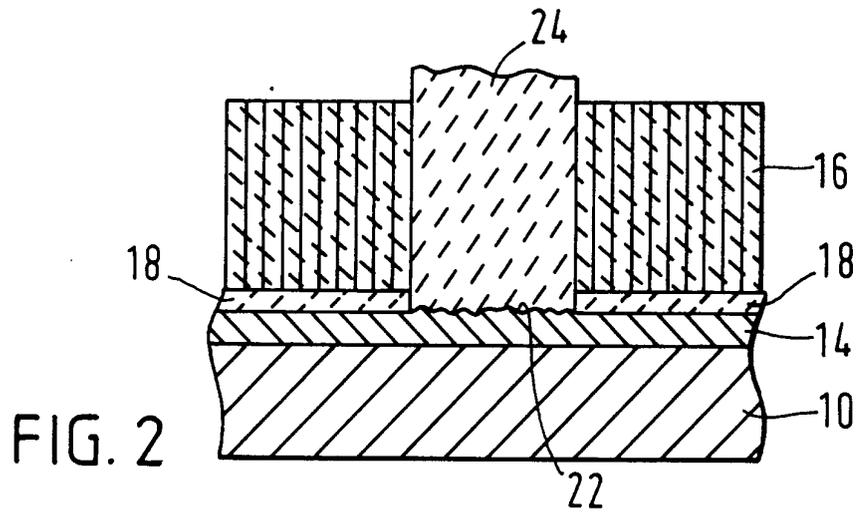
Figures 2 and 3 are cross-sectional representations of repair steps entailed in a preferred embodiment of this invention.

[0022] Once free of contaminants, the bond layer 14 is then treated such that its surface 22 becomes textured, as represented by Figure 2. Preferred treating methods include grit blasting, micromachining, photolithography, laser etching and water jet techniques. Preferred grit blasting media include alumina, though other materials could be used. Suitable micromachining techniques include the use of mechanical indentors or cutting tools, the latter being dragged over the surface of the bond layer 14 to form an array of grooves. Finally, suitable photolithographic techniques include the use of positive or negative photoresists to form masks through which a suitable etchant is applied to chemically etch the surface of the bond layer 14. A preferred technique is to use a positive photoresist and an etching solution composed of, by weight, about twenty parts of hydrofluoric acid, about fifteen parts of sulfuric acid, about five parts of nitric acid, and about sixty parts of water.

[0024] Finally, as represented in Figure 2, a ceramic material is then deposited on the textured surface 22 of the bond layer 14 so as to form a ceramic repair layer 24 that completely covers the bond layer 14. A preferred deposition method is a plasma spray technique process, though physical vapor deposition techniques can be used to deposit the ceramic material such that the repair layer 24 has a columnar grain structure. With either technique, the ceramic layer 16 is masked to prevent deposition of the repair material on the ceramic layer 16. According to this invention, the preferred repair method is to form the repair layer 24 by plasma spray, the random ceramic grain structure of which is represented in Figures 2 and 3. Generally, masking of the surrounding surface of the ceramic layer 16 is less complicated if a plasma spray deposition technique is used. For example, if any holes are intentionally present in the article 10, such as cooling holes often present in airfoils to reduce their operating temperature, fibers can be placed in the holes or a gas can be flowed through the holes in order to prevent closure by the deposited ceramic. Furthermore, physical vapor deposition techniques generally result in the entire article 10 being heated to a high temperature, whereas plasma spray techniques directly heat only the localized region being repaired on the article 10.

[0025] Due to process control limitations, the ceramic material will typically be deposited until the surface of the repair layer 24 projects above the surrounding surface of the ceramic layer 16, as shown in Figure 2. Afterwards, the surface of the repair layer 24 is polished or otherwise abraded until the repair layer 24 is substantially level with the ceramic layer 16, and the repair layer 24 merges with the ceramic layer 16 as portrayed in Figure 3.

[0023] The treatment selected should sufficiently texture the surface 22 of the bond layer 14 to yield macro surface features, resulting in an average surface roughness R_a of at least about 300 micrometers. With laser techniques, such macro surface features can be in the

form of a groove pattern that is selectively developed on the surface 22 of the bond layer 14. Laser techniques, and to a lesser extent grit blasting and water jet techniques, are also capable of producing a desirable combination of macro and micro surface features, as discussed below.
