(11) **EP 0 974 767 A2**

EUROPEAN PATENT APPLICATION

(54) Brake pad wear detector

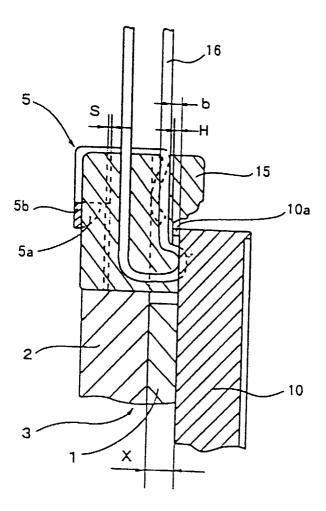
FIG. 1

Fig. 1 is a sectional view of a probe according to the present invention showing the state in which it has reached the wear limit of the lining;

[0018] A preferred embodiment is described in detail with reference to the drawings. Fig. 1 is a sectional side view of a probe 15 mounted in the cutout formed in the back plate 2 when the lining 1 has been abraded to the wear limit X. By this time, the disk rotor 10 has been abraded by not one but many pads 3 that have been replaced, so that an annular rib 10a (height = H) has formed along its outer edge. The lead wire 16 is curved to protrude by a distance b toward the disk rotor 10 at its bottom end. With this arrangement, even if the annular rib 10a is formed on the disk rotor 10, the wire will not be cut until the lining 1 is abraded to the wear limit X. If the height H is assumed to be the maximum allowable height of the rotor, the wire should be shaped to satisfy the relation b≧ H.

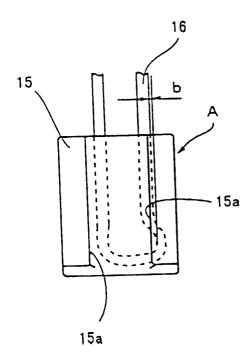
FIG. 2

Fig. 2 is a side view of a wire-cut type probe according to the present invention;

[0019] Fig. 2 is a side view of a probe 15 having a guide groove 15a. The appearance and shape of the probe 15 are identical to those of the probe shown in Fig. 5, except that its lead wire 16 has its side A facing the disk rotor 10 curved to protrude a distance b toward the rotor 10 at its bottom.

[0020] Fig. 2 illustrates the cut-wire type probe 15. But a contact type probe 17 shown in Fig. 3, which has its minus terminal grounded to the car body, will achieve the same results. Like the probe of Fig. 1, a lead wire 18 has its side A facing the disk rotor 10 curved to protrude by a distance b toward the rotor 10 at its bottom. [0021] Ordinarily, the maximum allowable limit of the height H of the rib 10a of the disk rotor 10 is set at around 1 mm. If the disk is abraded by a plurality of pads 3 that have been changed, until the height of the rib 10a grows equal to or larger than the value b, the lead wire 16 will be cut not by the frictional surface of the rotor but by its rib 10a, and a warning lamp will go on. This will tell you

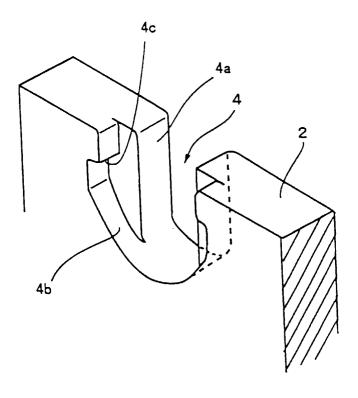
FIG. 5

[0004] Fig. 5 is an enlarged perspective view of the cutout. The cutout 4, into which the probe 101 is inserted from the outer periphery of the brake pad 3 in a radial direction of the disk rotor (not shown), has straight guide rails 4a extending in the direction of thickness of the back plate 2 and slightly narrower than guide grooves 101a formed in the probe 101 (Fig. 6). A curved cutout 4b is provided at a side of the back plate 2 opposite the lining 1 and has shoulders 4c.

Fig. 5 is a perspective view of a cutout formed in the back plate of the same;

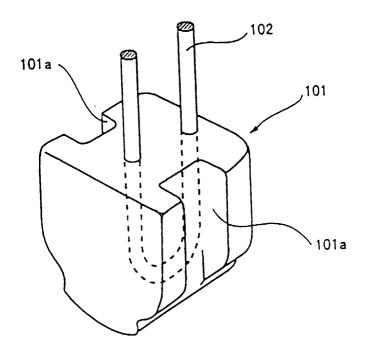
FIG. 6

[0005] Fig. 6 is a perspective view of the probe 101. A lead wire 102 for detecting the wear of the lining 1 is bent in the shape of the letter U and buried in the probe 101 which is made from e.g. a resin. The guide rails 4a of the back plate 2 (Fig. 5) are adapted to engage in guide grooves 101a formed in both sides of the probe 101. When the lining 1 gets worn to some degree by the disk rotor (not shown), the lead wire 102 will be exposed and thus abraded by the disk rotor until eventually cut. When the wire is cut, a warning lamp goes on.

Fig. 6 is a perspective view of a conventional probe; Fig. 7 is a perspective view of a conventional resilient clip;

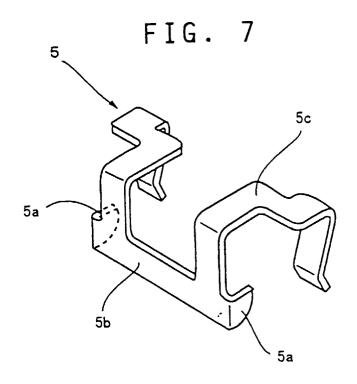
[0006] Fig. 7 is a perspective view of the resilient clip 5 for retaining the probe 101 inserted in the back plate 2. The clip 5 comprises two substantially U-shaped strips 5c connected together by a connecting strip 5b having projections 5a at both ends. The projections 5a engage the shoulders 4c and prevent the resilient clip 5 from dropping.

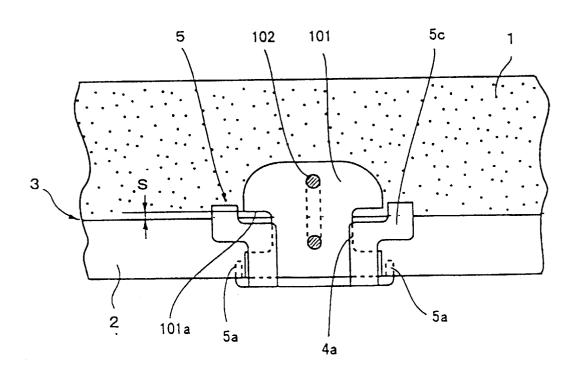
FIG. 8

[0007] Fig. 8 is a top plan view in which the cutout 4 is viewed from above with the brake pad 3, probe 101 and resilient clip 5 assembled together. In Fig. 8, to mount the probe 101 on the back plate 2, the guide grooves 101a of the probe 101 are slid along the guide rails 4a of the cutout 4 formed in the back plate 2 to engage the back plate. Then the resilient clip 5 is pressed onto the back plate 2 of the brake pad 3 so that its strips 5c engage both sides of the plate 2. The strips 5c of the

clip 5 will deflect along the tip shapes of the two projections 5a at both ends of the connecting strip 5b. When they snap in and engage the shoulders 4c of the cutout 4, they are assembled together.

[0008] In this state, the probe 101 is bound by the engagement between the shoulders 4c of the cutout 4 and the projections 5a of the clip 5, so that there is no freedom of movement in the vertical direction. Also, bound by the engagement between the guide rails 4a of the cutout 4 and the guide grooves 101a of the probe 101, there is no freedom in the groove direction. But they are formed such that clearances S (Fig. 8) are present between the back plate 2 and the side faces of the guide grooves 101a of the probe 101 in the thickness direction due to the resilience of the strips 5c of the clip 5.

Fig. 8 is a plan view of a conventional brake pad wear detector;

[0022] The probes 15, 17 of the present invention may be assembled in exactly the same manner as the conventional probe of Fig. 8, and have the same clearances S provided by the resilient clip 5. The function of the clearance S is exactly the same as in Fig. 9.

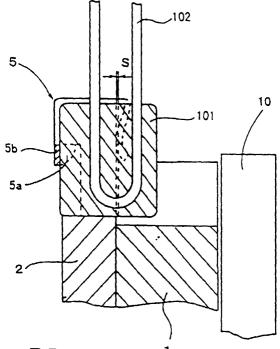
FIG. 9A

[0009] The reason why the clearances S are present is described with reference to sectional views 9A and 9B in which the probe 101 in the cutout 4 is viewed from the side. Fig. 9A shows the lining 1 when it is brand-new. Fig. 9B shows a state in which the lining 1 has been worn to the wear limit X until the lead wire 102 has been cut by the disk rotor 10, so that the warning lamp is now on. As the lining 1 is abraded, the probe 101 made of resin is brought into contact with and abraded by the disk rotor 10, which is made of cast iron.

Fig. 9A is a sectional view of a conventional probe having a brand-new lining;

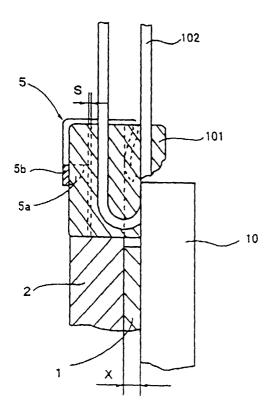
FIG. 9B 1

[0010] During this process, if there were no clearances S and thus there were no freedom of movement between the guide rails 4a of the cutout 4 and the guide grooves 101a of the probe 101, the lining 1 and the disk rotor 10 would collide impulsively against each other upon abrupt braking and the probe 101 and the rotor be exposed to shock, so that the probe 101, made from a weaker material, would be broken, making it impossible to stably detect the wear limit X. The clearances S serve to absorb such shocks. The probe 101 is thus abraded in a normal manner, so that the lead wire 102 is cut at a predetermined position.

Fig. 9B is a sectional view of a conventional probe when the lining has reached its wear limit; and

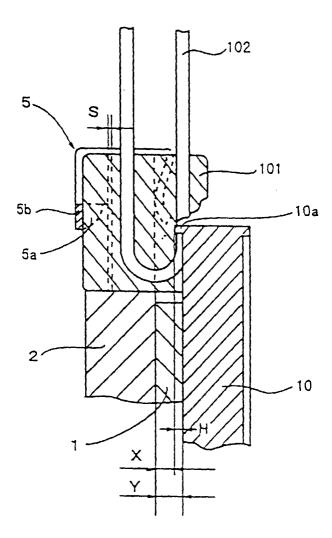
FIG.10

[0012] But when expandable brake pads are repeatedly replaced, the disk rotor will become slender as shown in Fig. 10. In order that the lining is used effectively, the lining 1 of the brake pad is usually mounted so that its outer edge will be 1-2 mm radially inside the outer edge of the rotor 10. This means that the outer annular edge of the rotor does not contact the lining, so that an annular rib 10a is formed along the outer edge of the rotor 10. When the disk rotor 10 has been abraded by the lining to the depth of H, the lead wire 102 will be cut by the rib 10a even though the thickness of the liner

1 is still Y, which is larger than the wear limit X by an amount H.

[0013] If only the brake pad is replaced repeatedly with the same disk rotor, the rib 10a will increase and thus the thickness Y of the lining when the wire is cut by the rib 10a will become larger. This means that the warning lamp goes on even though the lining 1 is still sufficiently thick and usable. When the lamp goes on, an operator will check the lining. But since the lining is still sufficiently thick, he will judge that the alarm is false and keep on using the pad instead of replacing it with a new one, not knowing the fact that the disk rotor is getting dangerously thin. When the height of the rib 10b increases to a certain value, the piston will have to move a distance beyond a point at which the piston disengages from the fluid seal member to move the lining into frictional contact with the rotor. If this happens, fluid will leak.

Fig. 10 is a sectional view of a conventional probe on which a rib has formed on the disk rotor at its outer peripheral portion.
