(11) **EP 1 072 692 A2**

(54) **Method and assembly for assessing quality of a coating process**

(57) A method for assessing quality of a coating process includes providing a facsimile assembly, the facsimile assembly having a fixture holding an audit coupon, and coating the facsimile assembly to form a coating thereon. The assembly is then disassembled, and the coating on the audit coupon is inspected.

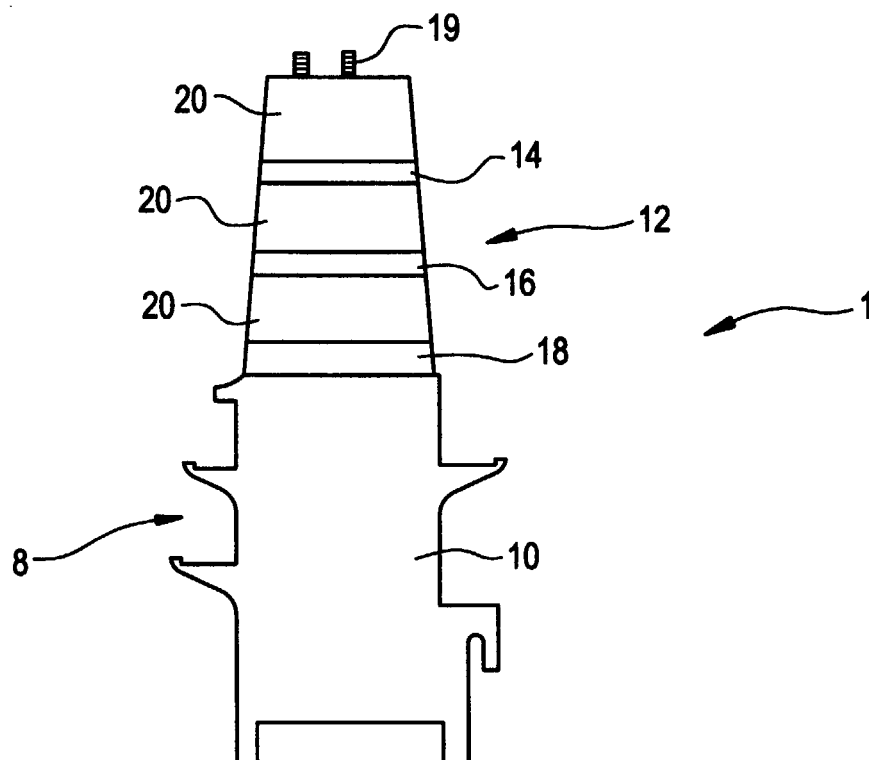
FIG. 1

Fig. 1 illustrates a facsimile assembly of an airfoil for a turbine engine;

[0010] Turning to Fig. 1, an example of a facsimile assembly 1 is illustrated, including fixture 8, which supports a plurality of audit coupons 14, 16 and 18. The fixture 8 includes base 10 and threaded rods 19, which are threaded into complementary threaded cylindrical openings (not shown) within base 10. Threaded rods 19 extend axially through the audit coupons. In addition to base 10 and threaded rods 19, the fixture 8 further includes spacers 20 which are employed to axially space the audit coupons from each other. Alternately, the coupons can be suspended on the threaded rods at specific axial positions without spacers. However, for coating processes in which the coating build-up can be affected by rebound of material from adjacent surfaces, such as thermal spray, the use of spacers more closely replicates the airfoil surface.

[0011] The fixture 8 is reusable, and is generally fabricated from a single sacrificial airfoil. Particularly, an airfoil is obtained and sectioned so as to remove portions of the airfoil corresponding to audit coupons 14, 16, and 18. The sectioning then leaves behind base 10 and spacers 20. The base 10 is then modified to receive threaded rods 19, by tapping the base or by inserting threaded cylindrical fittings. Although the distal ends of threaded rods 19 depicted in Fig. 1 are threaded for receiving a conjugate nut, the distal ends may be replaced with screw-heads or the like for driving threaded rods into the base 10. Alternatively, the threaded rods may be permanently attached to the base by use of welding or other techniques. It is noted that the particular means of attachment of the audit coupons and spacers to the base 10 is not particularly critical, provided that means of attachment does not interfere with the coating process. Particularly, it is important that the attachment means does not cover critical outer contoured portions of the audit coupons that are to be examined following the coating process, or otherwise does not affect the coating process along those portions.

[0012] The audit coupons are fabricated so as to have surface contours that closely mimic the surface contours of the sections of the airfoil that they represent, particularly, the surface contours of blade portion 12. In one embodiment, the audit coupons are fabricated by utilizing a CAD (computer-aided drawing) model of the airfoil, and manipulating the model to form three-dimensional representations of the audit coupons. The data from the computer model are then utilized to fabricate the audit coupons. Various techniques may be utilized, including machining, such as wire electro-discharge machining (EDM), as well as abrasive cutting, such as abrasive water jet cutting. During the fabrication step, the audit coupons are formed so as to have axial through holes, which align with the positions of the rods 19 of the fixture 8.

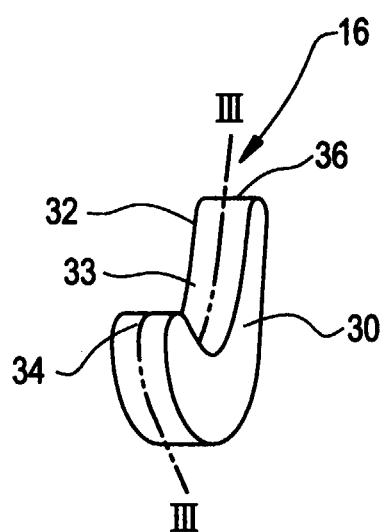
FIG. 2

Fig. 2 illustrates an audit coupon of the facsimile assembly shown in Fig. 1; and

[0015] Turning to Fig. 2, a peripheral view of audit coupon 16 of Fig. 1 is illustrated. As shown, the audit coupon 16 has a generally curved contour, including leading edge 34, trailing edge 36, and lateral peripheral edges 30 and 32. The lateral peripheral edges 30 and 32 may be chamfered to assist in preventing unwanted bridging of the coating formed according to the coating process or gaps can be inserted between the coupons and the adjacent spacers

[0016] According to the embodiment shown in the drawings, the coating is inspected along points that are interior to the lateral peripheral edges 30 and 32. Particularly, a coating is inspected along cross-section shown by line III-III'. In order to inspect the audit coupon along this cross-section, portion 33 is removed. Removal may be carried out by various techniques, such as by machining or grinding the audit coupon 16.

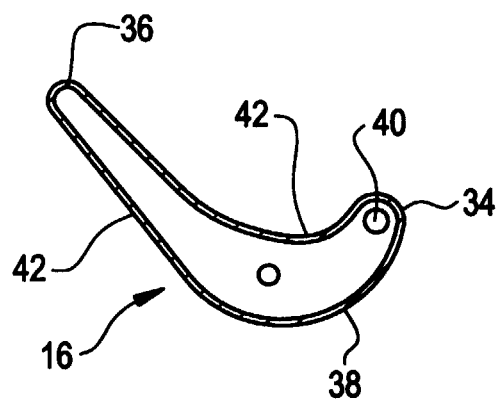
FIG. 3

Fig. 3 is a cross-section along line III-III' shown in Fig. 2.

[0017] The cross section along line III-III' is depicted in Fig. 3. As illustrated, audit coupon 16 has a coating 38, and through holes 40. The coating 38 is inspected at a number of interior inspection points 42. While two inspection points 42 are shown in Fig. 3, any number of inspection points may be employed. The particular locations of the inspection points are chosen based upon various parameters, including local surface contours, high curvature areas (small radius of curvature regions), and other critical regions of the airfoil.
