(12) **EUROPEAN PATENT APPLICATION**

(71) Applicant: **UNITED TECHNOLOGIES**  
**CORPORATION**  
**Hartford, CT 06101 (US)**

(54) **Method for repairing an apertured gas turbine component**

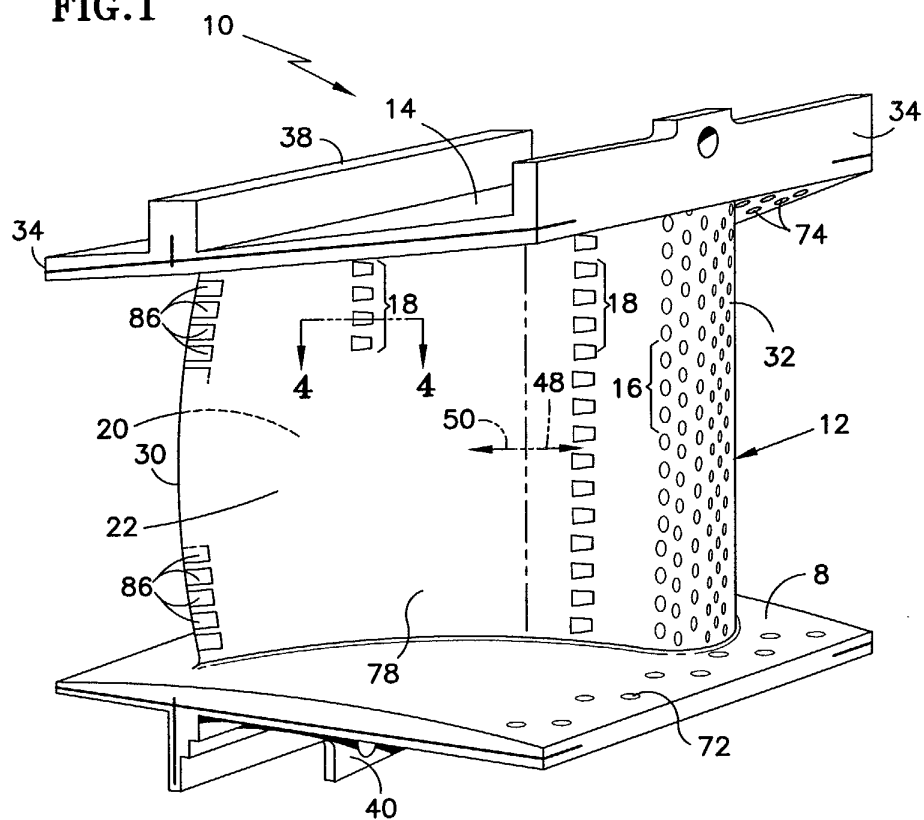
**FIG.1**

Fig. 1 is a perspective view of a typical gas turbine engine high pressure turbine vane;

**[0025]** Referring to Fig. 1, a high pressure turbine vane (article) 10 is shown. Referring also to Figs. 2 and 3, a top view and a bottom view are respectively shown for the vane 10 of Fig. 1. The vane 10 comprises an airfoil section (airfoil) 12 having at least one internal cavity 24 (Fig. 2), the internal cavity 24 having an internal surface 26 (Fig. 2). The airfoil section 12 has a convex surface 20 and a concave surface 22. The convex and concave surfaces 20, 22, respectively, are bounded by a trailing edge 30 and a leading edge 32 and together form an exterior surface 78 of the airfoil. The exterior surface 78 is exposed to the hot gas path. The trailing edge 30 of the airfoil 12 includes cooling slots 86. Also, the airfoil section 12 is bounded by an inner diameter platform (platform) 8 and an outer diameter platform (platform) 14. The inner and outer diameter platforms 8, 14 create the gas path annulus and include cooling holes 72, 74, respectively. The outer diameter platform 14 includes opposing flanges 34, at least one cover 36 (Fig. 2), preferably two, and a rail 38. The inner diameter platform 8 includes a rail 40 and a cover 42 (Fig. 3), preferably two.

**[0027]** The vane 10 lies in the hot gas path and the vane 10 is air-cooled by flowing cooling air, typically from the compressor discharge, into the internal cavities 24. Cooling air enters the internal cavities 24 through corresponding openings in the platforms 8, 14. This air cools the internal surface 26 of the airfoil 12 by convection or internal baffle impingement and cools the convex and concave surfaces 20, 22, respectively, of the airfoil 12 by film cooling. The air is directed from the internal cavities 24 and outward across the vane 10 by a plurality of cooling holes, preferably cylindrical cooling holes 16 and diffusion cooling holes (diffusion holes) 18, to help it withstand the high temperatures to which it is exposed. The cooling air is also directed across the platforms 8, 14 upon exiting the respective cooling holes 72, 74. The trailing edge 30 is cooled by air exiting through the slots 86.

**[0028]** Although Fig. 1 shows the plurality of cooling holes 16, 18 located on the concave surface 22, it is readily understood by those skilled in the art that the plurality of cooling holes 16, 18 are formed on both the convex and concave surfaces 20, 22, respectively.

**[0031]** Referring now to Figs. 1 and 4, it is noted that the vane 10 has a plurality of diffusion holes 18 which may have various geometries and predetermined air flow characteristics based on location within the vane 10. The representative diffusion hole 18, shown in Fig. 4, has a metering passage 60 in fluid communication with a diffusion passage (mouth) 52, each having a predetermined geometry. The metering passage 60 has an inlet 76 with a predetermined throat area, shown as At, where the throat area At provides a predetermined air flow requirement. Thus, the inlet 76 regulates cooling air flow into the diffusion holes 18 from the internal cavities 24. The diffusion passage 52 is axially diverging, nonregulatory and extends from the inlet 76 to an outlet 77 at the exterior surface 78 of the vane 10. The diffusion passage 52 facilitates the film cooling of the exterior surface 78 of the airfoil 12 as the cooling air exits from the diffusion passage 52 of the diffusion hole 18. The diffusion passage 52 also includes an inner shaped portion (inner diffuser portion) 80 while the metering passage 60 includes an inner metering portion 82.

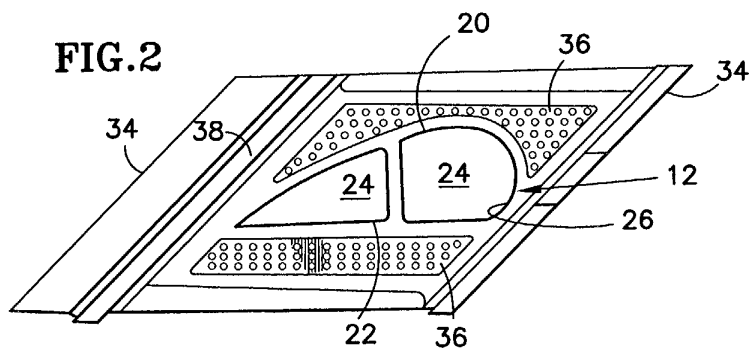
**FIG.2**

Fig. 2 is a top view of the vane of Fig. 1;

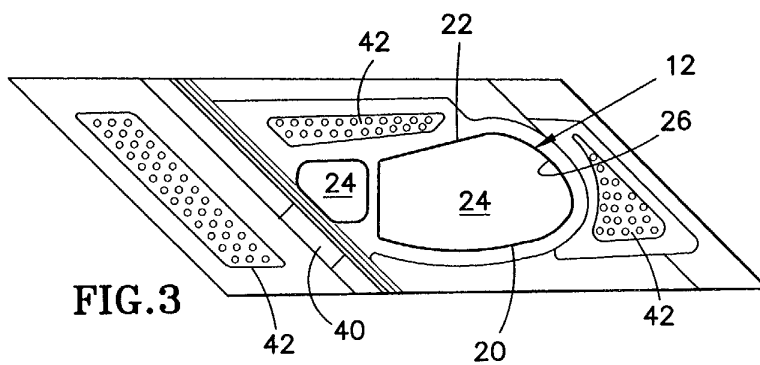
**FIG.3**

Fig. 3 is a bottom view of the vane of Fig. 1;

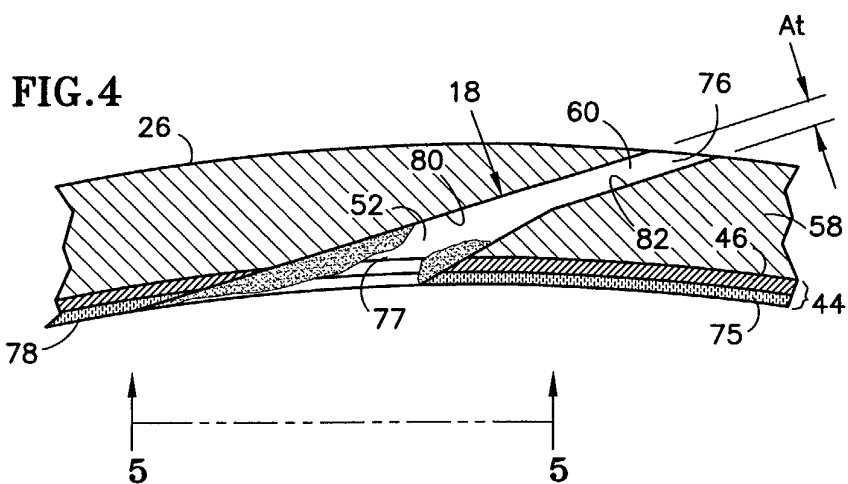
Fig. 4 is an enlarged cross-sectional view taken essentially in the direction 4-4 of Fig. 1 and illustrating the vane substrate, an existing protective coating applied to the substrate and a typical diffusion cooling hole extending through the substrate and the coating;

**[0029]** Referring to Fig. 4, a cross-sectional view of the wall thickness of the airfoil 12, and in particular the diffusion hole 18, is shown taken along the line 4-4 of

**[0030]** To further protect the vane 10 (Fig. 1) from high temperatures, the airfoil 12 and the platforms 8, 14 are coated with a protective surface coating, preferably a thermal barrier coating (TBC) system. The thermal barrier coating system 44 comprises a metallic bond coat 46 disposed over a substrate 58 of the vane 10 (Fig. 1), and a ceramic top coat 75 on top of the bond coat 46.

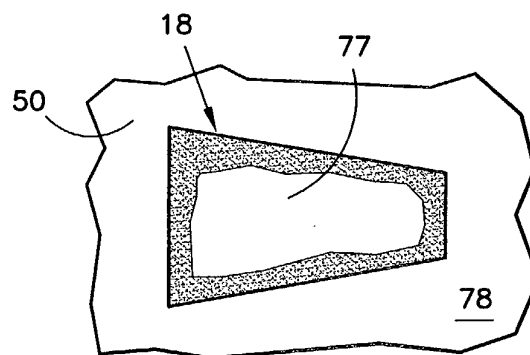
**FIG.5**

Fig. 5 is a view taken essentially in the direction 5-5 of Fig. 4 showing the diffusion hole prior to the repair of the present invention;

Fig. 1. Fig. 5 shows a view taken essentially in the direction 5-5 of Fig. 4 showing the diffusion hole 18 prior to the repair of the present invention.

**[0048]** Referring now to Figs. 1, 4 and 5, diffusion holes 18 located in region 50 may require reworking. The application of the nonoriginal metallic bond coat 46 to the entire surface 78 of the vane 10 may result in a quantity of excess bond coating accumulating in the diffusion passage 52 of the diffusion holes 18 thus reducing the area through which the cooling air passes. Since this "coatdown" phenomena, as shown in Figs. 4 and 5, affects most, if not all of the diffusion holes 18 in region 50, the effectiveness of the cooling medium is diminished and the vane's durability is compromised. The coatdown phenomenon is normally not a problem during the manufacture of original equipment vanes since the protective coatings, and in particular, the metallic bond coat, are usually applied prior to installation of the cooling holes.

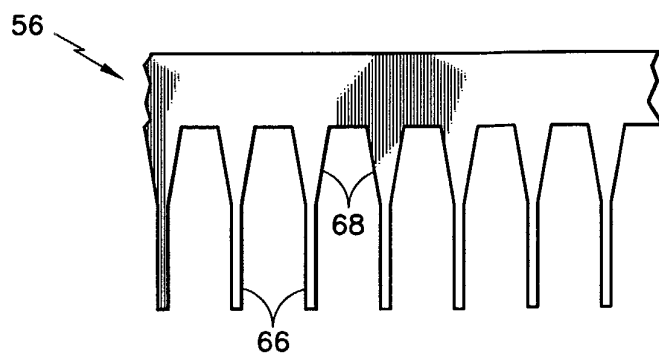
**FIG.6**

Fig. 6 is a side view of an electrode suitable for use with the repair method of the present invention; and

**[0051]** Referring to Figs. 6 and 7, electrodes 56, 62 suitable for insertion into an electric discharge machining device are shown. Referring to Figs. 1, 4, 5 and 6, the remanufacture and repair of the diffusion holes 18 in local regions 48, 50 of vane 10 using electrodes 56, 62, respectively, will now be described.

**[0052]** The electrode 56 includes a metering portion 66 and a diffuser portion 68. The electrode 62 includes a diffuser portion 70. It is noted that the geometry of the individual electrodes 56, 62, specifically the respective portions 66, 68, 70, are preselected to correspond to the required shape of the corresponding diffusion hole 18 to which it is used. In particular, the electrode 56 is chosen to restore the inner diffuser portion 80 and inner me-

**[0054]** In local region 48, the diffusion hole 18 is now remanufactured using the electrode 56. Since the repair material filled the diffusion hole 18, both the metering portion 66 and diffuser portion 68 of the electrode 56 are required to effect the remanufacture. The diffuser portion 68 of the electrode 56 corresponds in shape to the diffuser passage 52, and more specifically, the inner diffuser portion 80, of the diffusion hole 18. While, the metering portion 66 of the electrode 56 corresponds to the metering passage 60, and more specifically, the inner metering portion 82 of the diffusion hole 18.
