**EP 1 286 020 B2**

**NEW EUROPEAN PATENT SPECIFICATION**

(54) **Method for repairing an apertured gas turbine component**

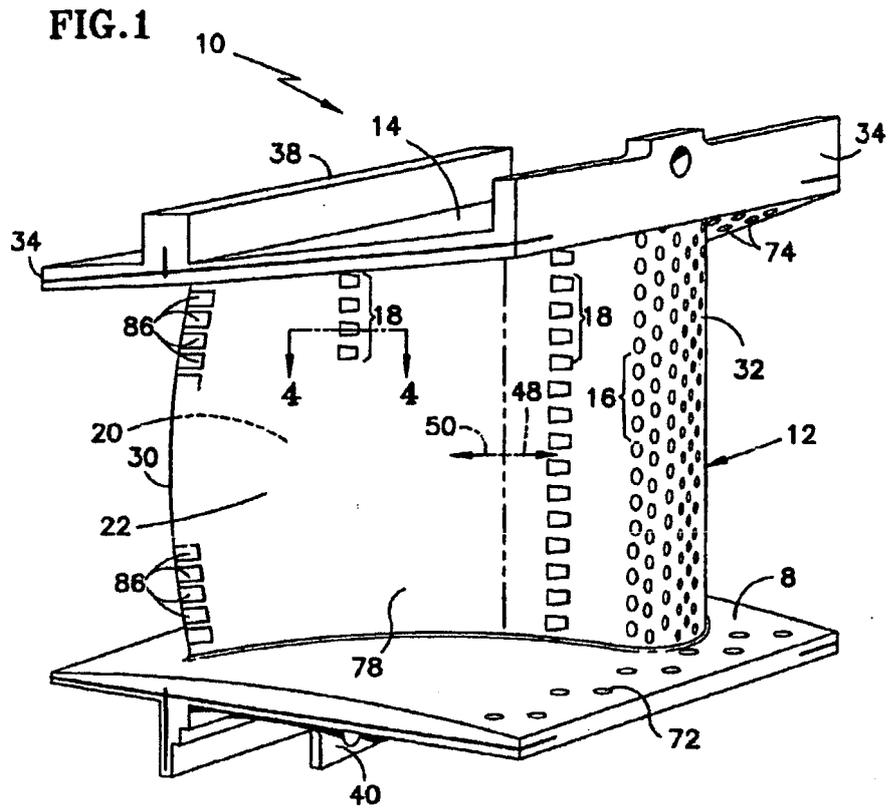
Fig. 1 is a perspective view of a typical gas turbine engine high pressure turbine vane;

[0028] Referring to Fig. 1, a high pressure turbine vane (article) 10 is shown. Referring also to Figs. 2 and 3, a

top view and a bottom view are respectively shown for the vane 10 of Fig. 1. The vane 10 comprises an airfoil section (airfoil) 12 having at least one internal cavity 24 (Fig. 2), the internal cavity 24 having an internal surface 26 (Fig. 2). The airfoil section 12 has a convex surface 20 and a concave surface 22. The convex and concave surfaces 20, 22, respectively, are bounded by a trailing edge 30 and a leading edge 32 and together form an exterior surface 78 of the airfoil. The exterior surface 78 is exposed to the hot gas path. The trailing edge 30 of the airfoil 12 includes cooling slots 86. Also, the airfoil section 12 is bounded by an inner diameter platform (platform) 8 and an outer diameter platform (platform) 14. The inner and outer diameter platforms 8, 14 create the gas path annulus and include cooling holes 72, 74, respectively. The outer diameter platform 14 includes opposing flanges 34, at least one cover 36 (Fig. 2), preferably two, and a rail 38. The inner diameter platform 8 includes a rail 40 and a cover 42 (Fig. 3), preferably two.

[0030] The vane 10 lies in the hot gas path and the vane 10 is air-cooled by flowing cooling air, typically from the compressor discharge, into the internal cavities 24. Cooling air enters the internal cavities 24 through corresponding openings in the platforms 8, 14. This air cools the internal surface 26 of the airfoil 12 by convection or internal baffle impingement and cools the convex and concave surfaces 20, 22, respectively, of the airfoil 12 by film cooling. The air is directed from the internal cavities 24 and outward across the vane 10 by a plurality of cooling holes, preferably cylindrical cooling holes 16 and diffusion cooling holes (diffusion holes) 18, to help it withstand the high temperatures to which it is exposed. The cooling air is also directed across the platforms 8, 14 upon exiting the respective cooling holes 72, 74. The trailing edge 30 is cooled by air exiting through the slots 86.

[0031] Although Fig. 1 shows the plurality of cooling holes 16, 18 located on the concave surface 22, it is readily understood by those skilled in the art that the plurality of cooling holes 16, 18 are formed on both the convex and concave surfaces 20, 22, respectively.

**[0034]** Referring now to Figs. 1 and 4, it is noted that the vane 10 has a plurality of diffusion holes 18 which may have various geometries and predetermined air flow characteristics based on location within the vane 10. The representative diffusion hole 18, shown in Fig. 4, has a metering passage 60 in fluid communication with a diffusion passage (mouth) 52, each having a predetermined geometry. The metering passage 60 has an inlet 76 with a predetermined throat area, shown as  $A_t$ , where the throat area  $A_t$  provides a predetermined air flow requirement. Thus, the inlet 76 regulates cooling air flow into the diffusion holes 18 from the internal cavities 24. The diffusion passage 52 is axially diverging, nonregulatory and extends from the inlet 76 to an outlet 77 at the exterior surface 78 of the vane 10. The diffusion passage 52 facilitates the film cooling of the exterior surface 78 of the airfoil 12 as the cooling air exits from the diffusion passage 52 of the diffusion hole 18. The diffusion passage 52 also includes an inner shaped portion (inner diffuser portion) 80 while the metering passage 60 includes an inner metering portion 82.

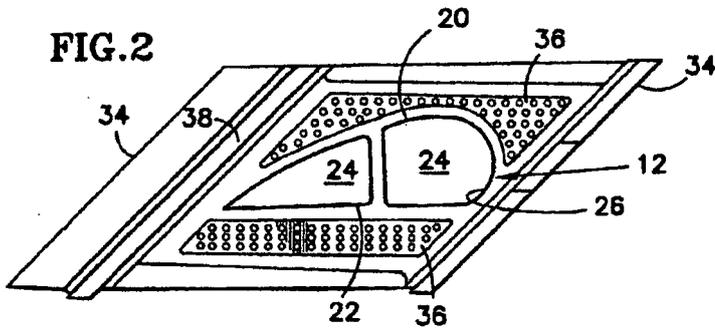
Fig. 2 is a top view of the vane of Fig. 1;

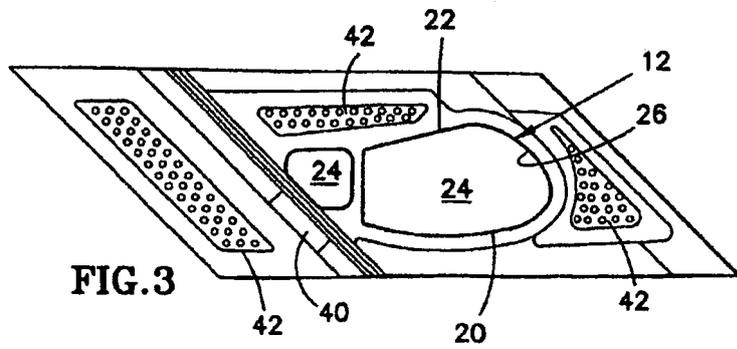
Fig. 3 is a bottom view of the vane of Fig. 1;

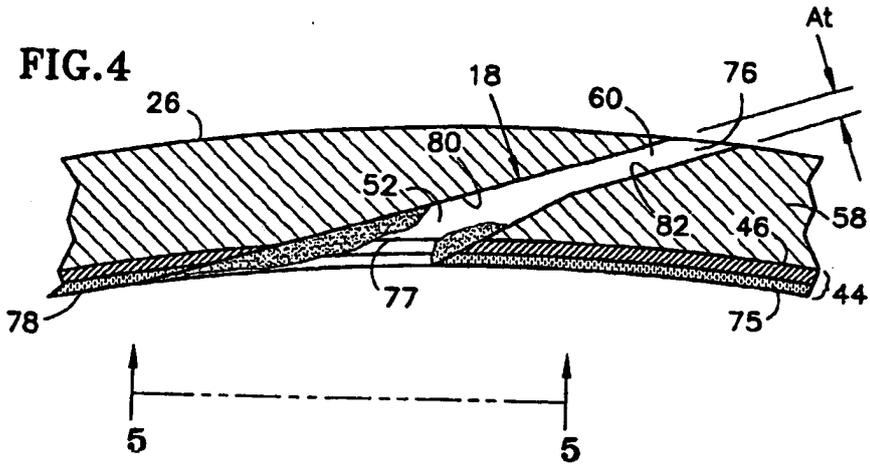
Fig. 4 is an enlarged cross-sectional view taken essentially in the direction 4-4 of Fig. 1 and illustrating the vane substrate, an existing protective coating applied to the substrate and a typical diffusion cooling hole extending through the substrate and the coating;

[0032] Referring to Fig. 4, a cross-sectional view of the wall thickness of the airfoil 12, and in particular the diffusion hole 18, is shown taken along the line 4-4 of Fig. 1. Fig. 5 shows a view taken essentially in the direction 5-5 of Fig. 4 showing the diffusion hole 18 prior to the repair of the present invention.

[0033] To further protect the vane 10 (Fig. 1) from high temperatures, the airfoil 12 and the platforms 8, 14 are coated with a protective surface coating, preferably a thermal barrier coating (TBC) system. The thermal barrier coating system 44 comprises a metallic bond coat

46 disposed over a substrate 58 of the vane 10 (Fig. 1), and a ceramic top coat 75 on top of the bond coat 46.

**[0051]** Referring now to Figs. 1, 4 and 5, diffusion holes 18 located in region 50 may require reworking. The application of the nonoriginal metallic bond coat 46 to the entire surface 78 of the vane 10 may result in a quantity of excess bond coating accumulating in the diffusion pas-

sage 52 of the diffusion holes 18 thus reducing the area through which the cooling air passes. Since this "coat-down" phenomena, as shown in Figs. 4 and 5, affects most, if not all of the diffusion holes 18 in region 50, the effectiveness of the cooling medium is diminished and the vane's durability is compromised. The coatdown phenomenon is normally not a problem during the manufacture of original equipment vanes since the protective coatings, and in particular, the metallic bond coat, are usually applied prior to installation of the cooling holes.

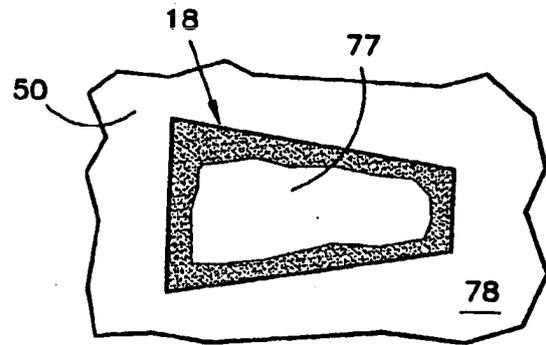
**FIG. 5**

Fig. 5 is a view taken essentially in the direction 5-5 of Fig. 4 showing the diffusion hole prior to the repair of the present invention;

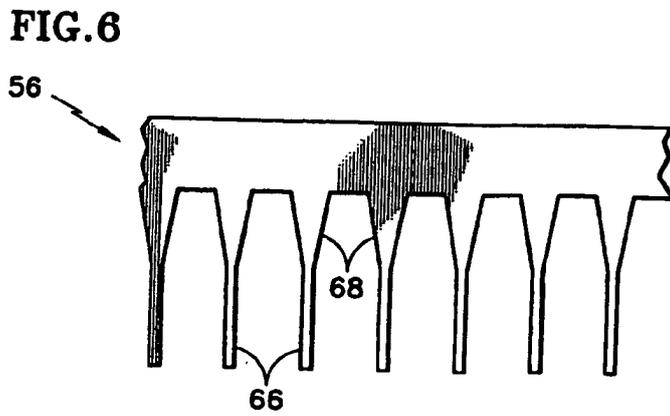
Fig. 6 is a side view of an electrode suitable for use with a remanufacturing method; and

Fig. 7 is a side view of an electrode suitable for use with the repair method of the present invention.

**[0054]** Referring to Figs. 6 and 7, electrodes 56, 62 suitable for insertion into an electric discharge machining device are shown. Referring to Figs. 1, 4, 5 and 6, the remanufacture and repair of the diffusion holes 18 in local regions 48, 50 of vane 10 using electrodes 56, 62, respectively, will now be described.

**[0055]** The electrode 56 includes a metering portion 66 and a diffuser portion 68. The electrode 62 includes a diffuser portion 70. It is noted that the geometry of the individual electrodes 56, 62, specifically the respective portions 66, 68, 70, are preselected to correspond to the required shape of the corresponding diffusion hole 18 to which it is used. In particular, the electrode 56 is chosen to restore the inner diffuser portion 80 and inner metering portion 82 of the respective diffusion hole 18 being repaired in region 48. Similarly, the electrode 62 is chosen to restore the inner diffuser portion 80 of the respective diffusion hole 18 being repaired in region 50. This ensures that after the repair is done, the predetermined air flow requirements of the respective diffusion holes 18 are met.

**[0057]** In local region 48, the diffusion hole 18 is now remanufactured using the electrode 56. Since the repair material filled the diffusion hole 18, both the metering portion 66 and diffuser portion 68 of the electrode 56 are required to effect the remanufacture. The diffuser portion 68 of the electrode 56 corresponds in shape to the diffuser passage 52, and more specifically, the inner diffuser portion 80, of the diffusion hole 18. While, the metering portion 66 of the electrode 56 corresponds to the metering passage 60, and more specifically, the inner metering portion 82 of the diffusion hole 18.

**[0058]** However, in local region 50, the diffusion holes 18 may be partially or fully clogged, as described earlier, and therefore will need to be reworked to restore the cooling effectiveness of the diffusion hole 18 as well as vane durability. This is accomplished by using the electrode 62 to remove the excessive bond coat material. The electrode 62 may be easily formed by removing a metering portion from an electrode that has a diffuser portion corresponding in shape to the diffuser passage 52, and more specifically, the inner diffuser portion 80, of the diffusion hole 18. This can be accomplished by using a cutting means, for example scissors, to remove the metering portion.
