(11) **EP 1 304 446 A1**

(54) Method for replacing a damaged TBC ceramic layer

(57) The present invention is a method for repairing a TBC ceramic top coat in local regions that have experienced a mechanical or thermally-induced spallation event leaving the underlying bond coat intact. A novel combination of groove design (i.e. spacing, pattern and depth) and laser-surface incident angles fabricated into the remaining bond coat is used to achieve spallation resistance equal to or greater than baseline after applying and maintaining a TBC ceramic patch to the localized areas of spallation. The method is particularly useful, but not limited to, repair of coating systems com-

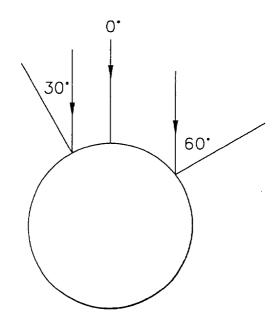
FIG. 1

Figure 1 is a representation of the Laser incidence angle on button samples;

[0028] Tests were conducted to evaluate the roles of groove spacing (2 mil or 8 mil), groove geometry (unidirectional or cross-hatched), laser incidence angle relative to the specimen surface normal (0°, 30°, 60°, as depicted in Figures 1 and 2) and bond coat geometry (new versus repaired). Two types of specimens were prepared: (1) furnace cycle test (FCT) buttons and (2) burner rig (B-Rig) pins. Specimens were comprised of 2.5 mil thick PtAl diffusion bond coat applied to a Rene N5 substrate. The bond coated substrate was then covered with 5 mil of 7YSZ ceramic top coat applied by standard EB-PVD techniques. The grooves for all tests were machined using an Excimer laser powered at about 35W, and traversing the specimens at 8 inches per minute under the beam. The various groove geometries fabricated into the burner rig pins and the FCT buttons and tested are displayed in Table 1. Specimens were compared

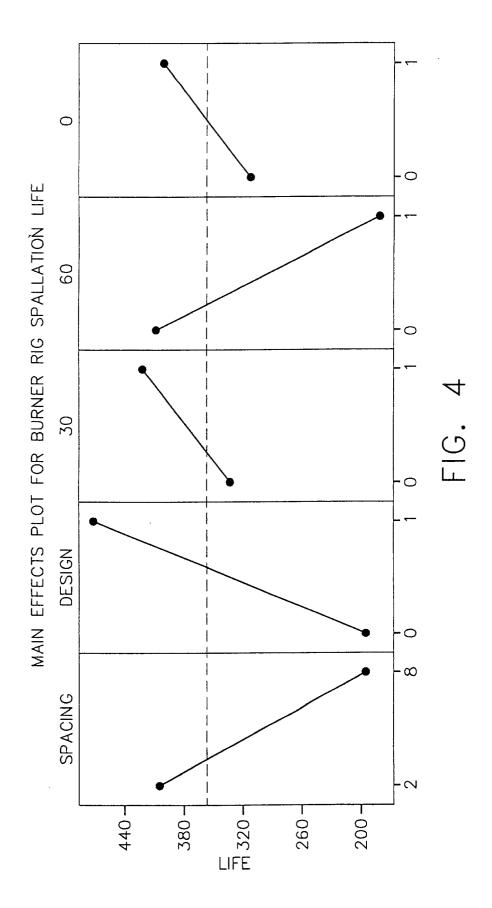
Figure 3 a main effects plot for FCT spallation life; and

Figure 4 is a main effects plot for Burner Rig spallation life.

[0030] After repair of the center-spalled FCT buttons as set forth in Table 1, the samples (both baseline and test) were exposed to FCT cycling. The number of cycles required to remove 50% of the replacement patch was used as a measure of failure. Table 2 lists the results of the furnace cycle tests. This data was analyzed using MINITAB statistical software from Minitab, Inc. to yield the Main Effects plot of Figure 3.

[0031] Baseline samples failed at about 521 ± 80.3 cycles. As can be seen in Table 2, grooves spaced at two mils out-performed both samples having grooves spaced at 8 mils and baseline samples. Fig. 3 indicates that a smaller pitch size can withstand more failures than a larger pitch size. Test results as set forth in Fig. 3 indicates that groove orientation (cross-hatched v. uni-directional) had little effect on FCT performance. However, testing indicated that groove incidence angle, which is the wall angle formed by the high energy beam, in this example a laser, with the surface of the spalled region undergoing repair, played a significant role on spallation life. Specimens grooved at a 30° angle using the laser performed much better than those grooved by a laser normal for the surface forming a straight wall (for the purposes of this discussion, 0°), although on average, both did better than baseline. Bond coat that was exposed for 80 cycles at a temperature of about 2075° F for 45 minutes prior to repair failed earlier than un-exposed bond coat. Samples having bond coat that was not exposed to FCT cycles is represented by -1 in the column labeled "BC Cond" in Table 2.

[0033] Burner rig spall pins of the same substrate and coating compositions as the button samples were prepared to provide a baseline performance of about 579 ± 159 cycles. An additional 10 pin samples were exposed to 80 FCT cycles. New and previously exposed B-Rig samples were prepared for the experiments by removing a portion of an originally applied TBC as described for the buttons and repaired as set forth in Table 1. B-Rig samples were similarly textured in the spalled regions by lasers having 0° , 30° or 60° angle of incidence with the surface, while FCT buttons were textured in the spalled regions by lasers incident at angles of 0° and 30° . After texturing, the ceramic top coat was replaced by APS techniques. The samples were tested by cycling in a Mach 0.5 flame where each burner rig cycle comprised ramping the sample between 200° F and 2075° F in 15 seconds, holding the sample at 2075° F for 5 minutes, then forced air cooling the sample in 75 seconds to 200° F. The life of the coating was determined as the number of cycles required to spall a 0.1° diameter region of the TBC. The repaired coatings were cycled in the burner rig until 50% of the repaired region was removed by spallation. The number of cycles to failure was used to quantify the life of the patch repair. Test results are displayed in Table 3. This data was analyzed using the MINITAB statistical software previously discussed, to yield the Main Effects plot of Figure 4.
