(11) **EP 1 505 168 A2**

(71) Applicant: **United Technologies Corporation**
Hartford Connecticut 06101 (US)

(54) **Turbine element repair**

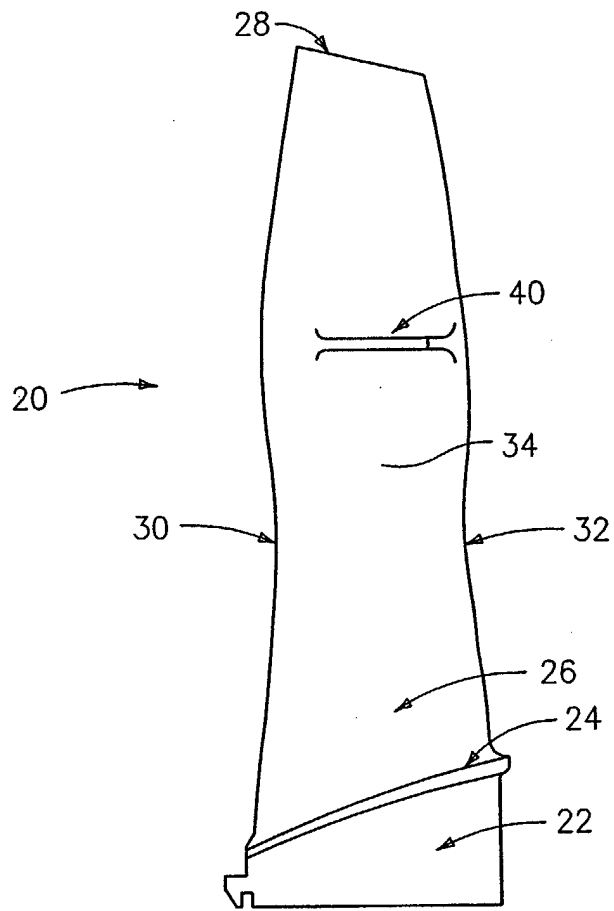
FIG. 1 is a view of an airfoil of a fan of a gas turbine engine.

[0010] FIG. 1 shows a fan blade 20 from a gas turbine engine. The blade has an inboard blade root 22 configured for attaching the blade to a disk (not shown). A platform 24 separates the blade root from an airfoil 26 extending from the platform to a tip 28. The airfoil has a leading edge 30 and a trailing edge 32 with suction and pressure sides 34 and 36 extending therebetween. In the exemplary blade, in an intermediate location along the span between the platform and tip, a midspan damper shroud projection 40 extends from each of the pressure and suction side surfaces.

[0011] The pressure and suction side projections 40 may respectively interact with the suction and pressure side projections of the adjacent blades to damp blade oscillation. The rotating mass of the midspan shroud projections along with forces from their interaction with adjacent projections subjects the blade to high stresses in areas proximate and inboard of these projections. These stresses may limit repairability of these areas relative to other less-stressed areas. It has been discovered that electron beam physical vapor deposition (EB-PVD) may be used to deposit repair material with low residual stress and with properties substantially the same as the underlying base material. The deposited material may have enhanced strength and enhanced adhesion to the base material relative to welding repair techniques. The deposition advantageously occurs in the absence of a transient liquid phase, with solidifica-

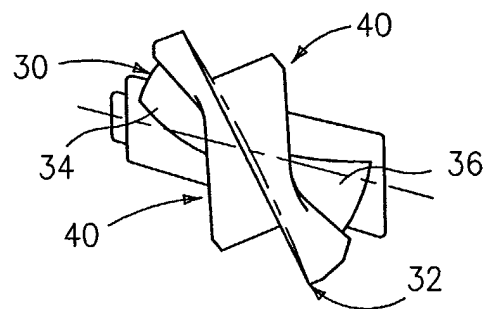
FIG. 2 is a tip-inward view of the airfoil of FIG. 1.

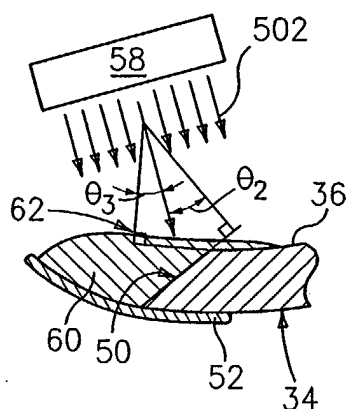
FIG. 7 is a partial sectional view of the airfoil of FIG. 6 after deposition of initial material to rebuild the airfoil.

[0014] The blade may then be positioned relative to a vapor source 58 emitting vapors along line of sight paths 502. Advantageously the source/paths are oriented so that the paths are within slight angles θ_2 and θ_3 off perpendicular to the surfaces 50 and 36. Exemplary θ_2 and θ_3 are less than 30° . Deposition from the source 58 builds up a first repair material 60. This is advantageously built up to a surface contour 62 beyond the pressure side portion of the lost original contour of the airfoil. Curvature of the surface 36 produces associated change in θ_3 along the deposition-receiving portion of such surface adjacent the base surface 50.

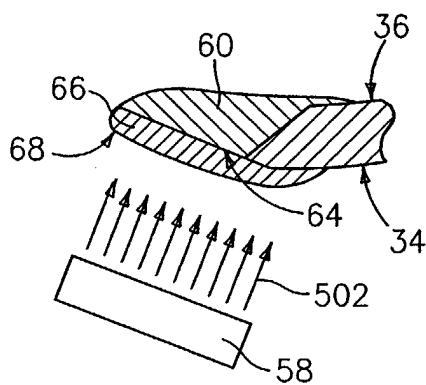
FIG. 8 is a partial sectional view of the airfoil of FIG. 7 after further machining and deposition of additional material to rebuild the airfoil

[0015] After this deposition stage, the blade may be further machined to remove the backing element 52 and create a second facet or base surface 64 extending along the deposited material 60 and the original base material. In the exemplary embodiment, this machining process further removes a previously intact leading portion of the suction side surface 34. The blade may be reoriented relative to the source 58 so that the surfaces 64 and 34 are just slightly off perpendicular to the paths 502 and a second additional material 66 deposited thereatop to reach a contour 68 beyond the suction side
