EP 1 617 014 A1

EUROPEAN PATENT APPLICATION

(54) Building panel repair

(57) Building panel repair apparatus (201) comprising a substantially planar backplate (202) for insertion through a hole in a building panel to be repaired. A front face (204) of the backplate is provided with adhesive for mounting the backplate to the rear side of a building panel. At least one flap (210) is defined in the backplate movable between an open position providing an operative with backplate positioning means to facilitate mounting of the backplate to a building panel; and a closed position providing a substrate surface for hole repair material. A method of building panel repair using the apparatus. A method of manufacture of the apparatus.

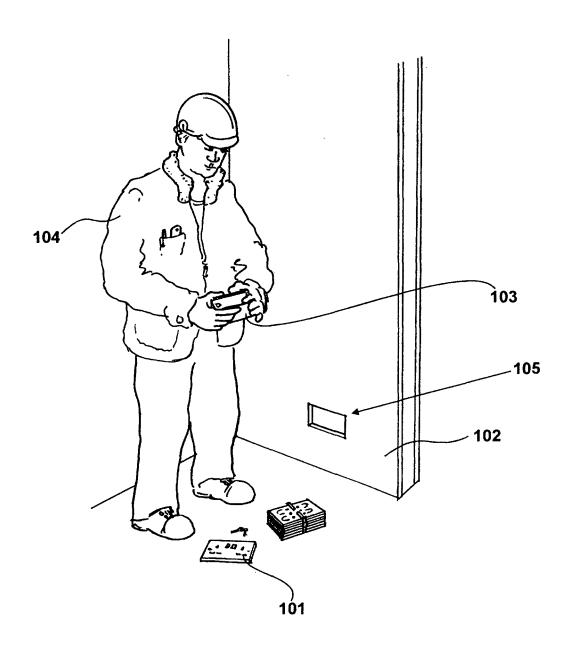
Figure 1 shows apparatus for use in building panel repair and a building panel to be repaired;

[0010] Figure 1 shows repair apparatus **101** for use in building panel repair. A building panel 102 requires repair. In this example, an electrical fitting 103 has been removed from building panel 102 by building operative 104, leaving an unwanted aperture **105**.

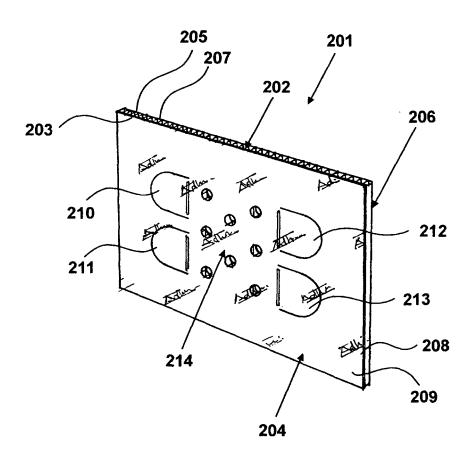
Figure 2 shows repair apparatus for use in repairing a hole in a building panel;

[0012] An enlarged view of a repair apparatus 201 is shown in *Figure 2*. Repair apparatus 201 comprises a substantially rectangular planar backplate 202. According to the present embodiment, backplate 202 is fabricated from plastic board having a twin wall structure. The structure comprises a first front wall 203, providing a front face 204, spaced apart from a second rear wall 205, providing a rear face 206, by a plurality of connecting members, known as flutes, extending between the walls 203, 205, for example connecting member 207.

[0016] The repair apparatus may also feature at least one repair material aperture. According to the present embodiment, an array of repair material apertures 214 is defined in backplate 202. In this example, the array of hole repair material apertures 214 is located substantially centrally of front face 204 with the first pair of flaps 210, 211 located to one side of the array 214 and the second pair of flaps 212, 213 located to the other side of the array 214. Thus, in this example, the flaps 210, 211, 212, 213 open inwardly towards the array of repair material apertures 214.

[0051] As shown in *Figures* 2 and 15, flaps 210, 211, 212, 213 of repair apparatus 201 are arranged substantially symmetrically about centreline 1501 of backplate 202, with each pair of flaps 210, 211 and 212, 213 located substantially centrally of each half of the backplate 202. Repair material aperture array 214 is located substantially symmetrically about centreline 1501.

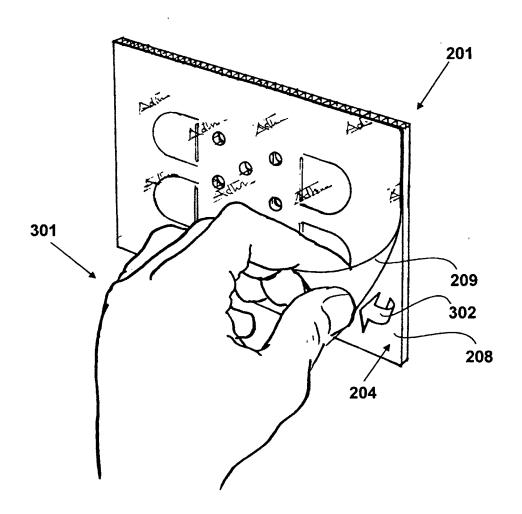
[0017] Figure 3 illustrates a first preparation step in using repair apparatus 201. The front face 204 of the backplate 202 is prepared for mounting to a building panel

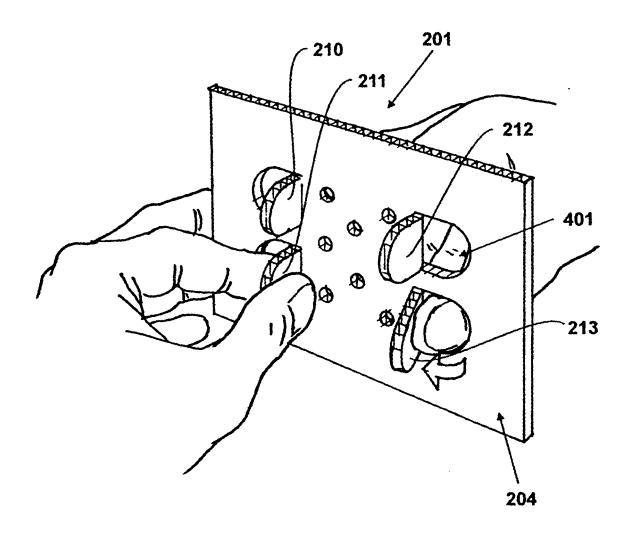
Figure 4

[0019] A second preparation step in using repair apparatus **201** is illustrated in *Figure 4*. The flaps **210**, **211**, **212**, **213** of the backplate **202** are recond to provide backplate positioning means.

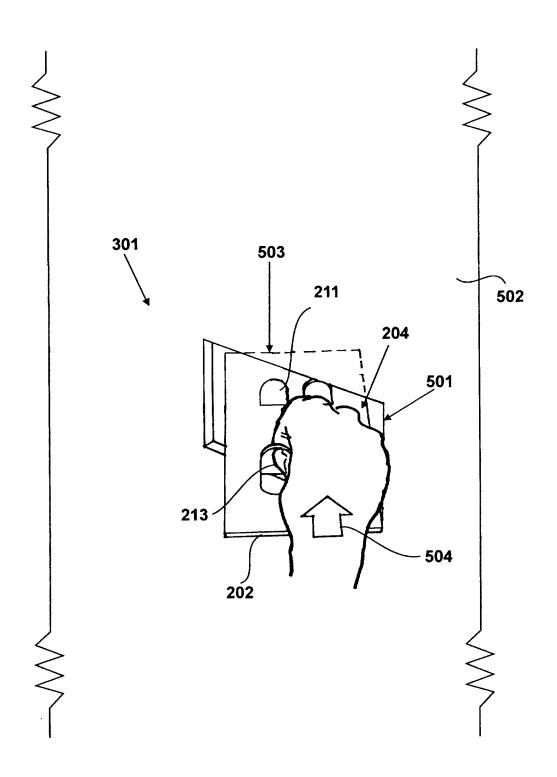
Figure 5 shows a third step in using the apparatus of Figure 2 in which the backplate is inserted through a hole in a building panel to be repaired;

[0023] Figure 5 illustrates a third step in using repair apparatus 201. The backplate 202 is inserted through a hole 501 in a building panel 502 to be repaired. In this example, building panel 502 is an internal plasterboard wall.

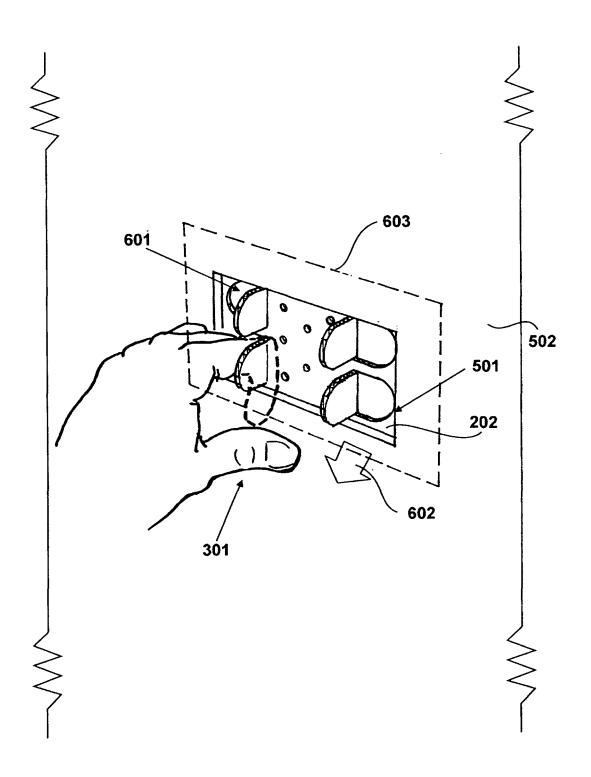
Figure 6 shows a fourth step in using the apparatus of Figure 2 in which the backplate is mounted to the building panel being repaired;

[0026] A fourth step in using repair apparatus **201** is illustrated in *Figure 6*. The backplate **202** is mounted to the building panel **502** to be repaired.

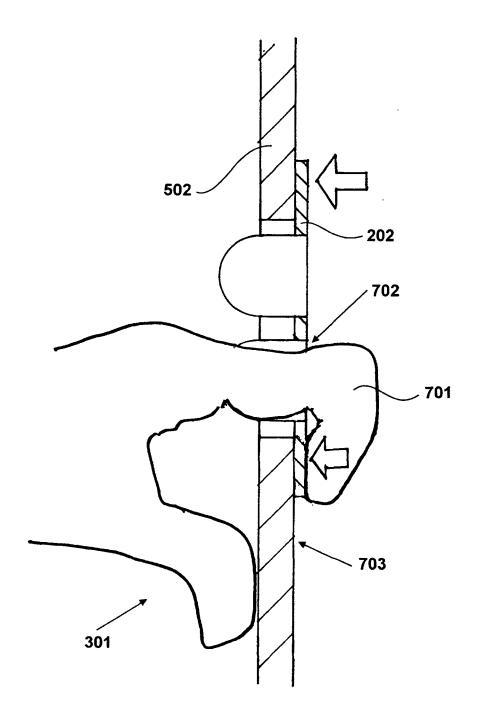
Figure 7 shows a cross-section view of the illustration of Figure 6;

[0029] A cross-section view of *Figure 6* is shown in *Figure* 7. By hooking a finger **701** through a flap aperture, for example flap aperture **702**, of backplate **202** building operative **301** can press the backplate **202** into contact with the rear side **703** of building panel **502** directly. This feature functions to increase the security of the mounting of the backplate to the building panel.

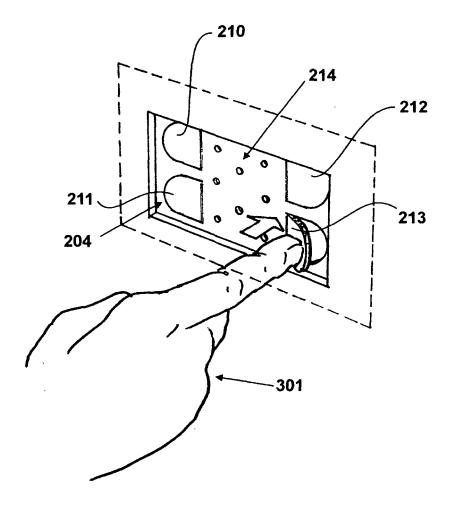
Figure 8

[0032] In *Figure 8*, a fifth step in using repair apparatus 201 is illustrated. Following installation, the flaps 210, 211, 212, 213 of backplate 202 are recond to provide a substrate surface for hole repair material. Each of the flaps 210, 211, 212, 213 is moved from the open position shown in *Figure* 4, into a closed position, preferably the fully closed position shown in *Figure* 2.

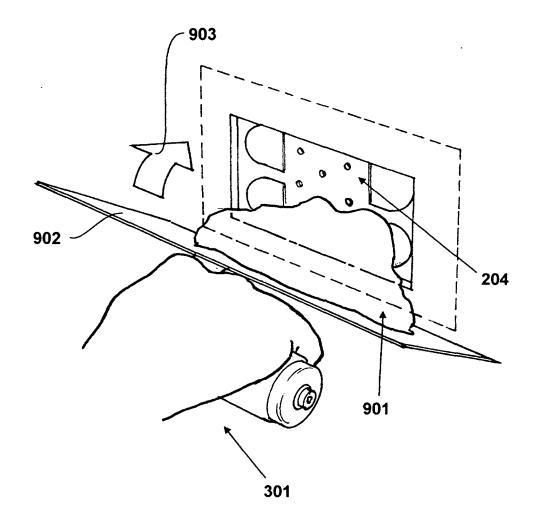
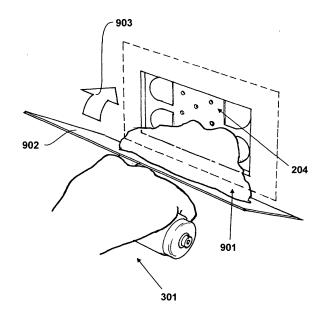
Figure 9 shows a sixth step in using the apparatus of Figure 2 in which hole repair material is applied to the mounted backplate of Figure 8;

[0038] A sixth step in using the repair apparatus 201, in which curable hole repair material is applied to the mounted backplate of *Figure* 8, is illustrated in *Figure* 9. As shown, a building operative 301 can achieve this by loading hole repair material 901 onto a trowel 902 and then applying the hole repair material 901 to the exposed area of front face 204 of mounted backplate 202 using the trowel 902; as indicated by arrow 903. In this example, hole repair material 901 is plaster of paris.

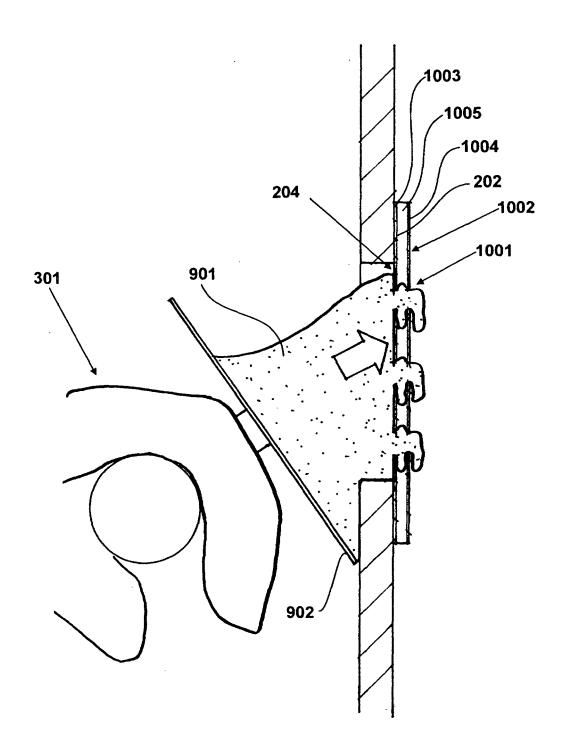
Figure 10 shows a cross-section view of hole repair material being applied to the mounted backplate of Figures 8 and 9;

[0039] Figure 10 shows a cross-section view of hole repair material being applied to the mounted backplate 202 of Figures 8 and 9. As shown, the repair material apertures of repair material aperture array 214, for example repair material aperture 1001, are each arranged to receive hole repair material 901.

[0040] As hole repair material 901 is applied to front face 204 of backplate 202, in addition to being received in repair material aperture 1001, hole repair material 901 may flow through the backplate 202 to the rear face 1002 of the backplate 202. It is then acted upon by gravity to a degree depending on the composition and consistency of the hole repair material, encouraging further flow. This feature functions to interlock the backplate with the hole repair material.

[0041] As previously described, backplate 202 has a twin wall structure. Backplate 202 has a substantially hollow construction allowing hole repair material 901 received in a repair material aperture 1001 to flow downwards between the walls 1003, 1004 under gravity. This feature functions to interlock backplate 202 with hole repair material 901. The arrangement of the connecting

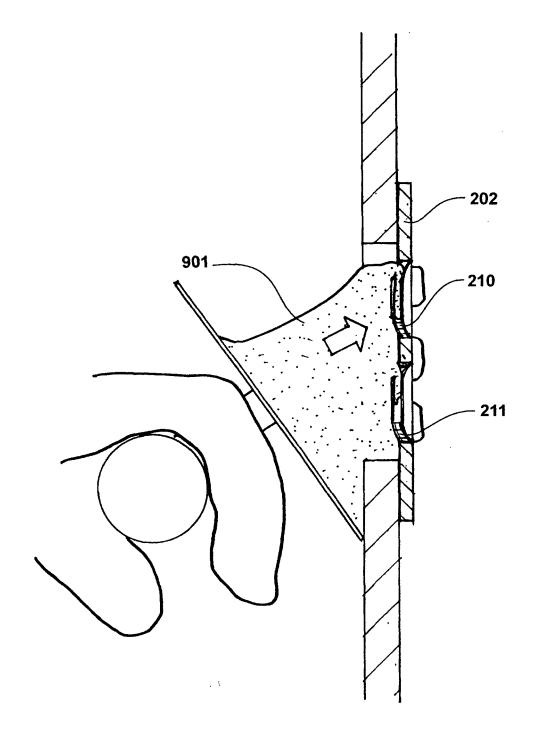
Figure 11 shows a cross-section view of hole repair material being applied to a mounted backplate;

[0042] Figure 11 shows a cross-section view of hole repair material 901 being applied to mounted backplate 202 in an alternative scenario in which the flaps 210, 211, 212, 213 are not in the fully closed position. With the flaps 210, 211, 212, 213 extending in a different plane to that of backplate 202, hole repair material 901 may flow into the gap between each flap 210, 211, 212, 213 and the backplate 202. In addition, due to the twin wall construction of backplate 202, hole repair material 901 may flow into the flaps 210, 210, 211, 213. These features function to interlock backplate 202 with hole repair material 901. Interlocking of the backplate with the hole repair material provides for a more secure repair.

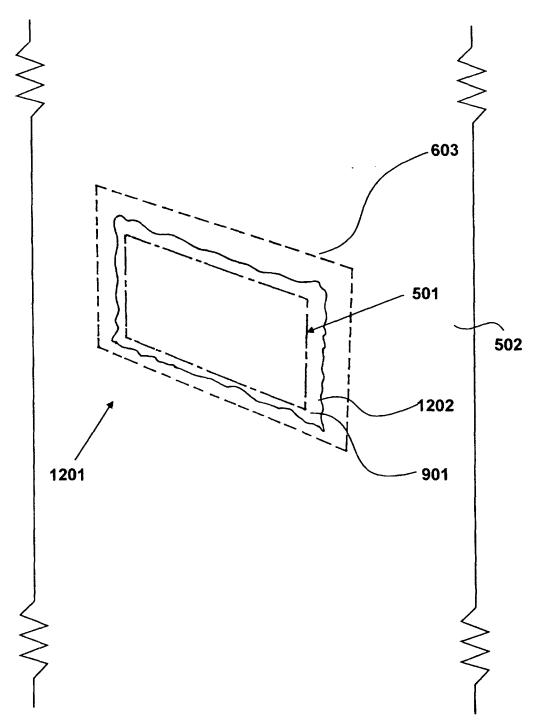
Figure 12 shows a building panel following repair using the apparatus of Fig .2;

[0043] Figure 12 shows the repair **1201** in building panel **502**, using repair apparatus **201** and hole repair material **901** in accordance with the method as described with reference to Figures 3 to 11.

[0044] Dotted line boundary 603 indicates the position of the edges of the backplate 202 relative to the hole 501 in the building panel 502. Line 1202 indicates the boundary of the applied hole repair material 901. A sufficient quantity of hole repair material 901 has been applied to the backplate 202 to fill the cavity between the front face 204 of backplate 202 and the front side of the building panel 502. Additional hole repair material 901 has been spread across the restored cavity, beyond the boundary of the hole 501 onto the front face of building panel 502 to seal the repair. A satisfactory repair can be attained using traditional plaster or patch compound. Typically, two coats of hole repair material will be expected to complete a satisfactory repair.

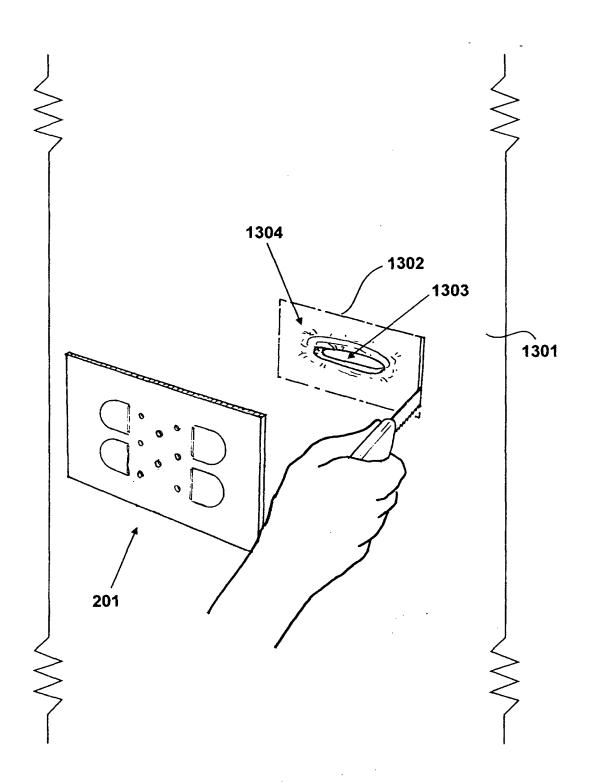
Figure 13 illustrates a second example of a repair using a repair apparatus;

[0046] Figure 13 illustrates a patch 1301 in a plaster board wall 1302 requiring repair. The patch 1301 defines an irregular shaped hole 1303. In this example, the patch 1301 represents crush damage to the wall 1301. Such damage may result from mishandling or impact, for example by a forklift truck. The paper covering of the wall 1302 has ripped, the edges of the hole 1303 are distressed and the inside face of the hole 1303 has partially collapsed around the edges. Thus, the damage has lessened the integrity of the wall strength.

[0047] To prepare the wall 1302 for repair using repair apparatus 201, at least the whole damaged area is cut out from the wall 1302. This leaves behind a larger hole, indicated by dotted line 1304, around which the wall 1302 is undamaged. The repair apparatus 201 may then be installed as described with reference to *Figures* 3 to 8.

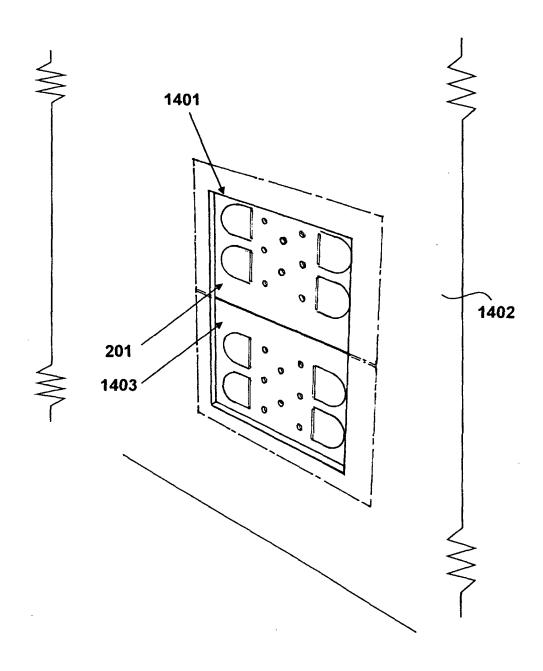
Figure 14 illustrates a third example of a repair using a repair apparatus;

[0048] Figure 14 illustrates a repair in an internal wall 1401, using repair apparatus 201. The size of the repaired hole 1402 in the wall is greater than that repairable by a single repair apparatus 201. However, repair has been achieved by using a second additional repair apparatus 1403. In this example repair apparatus 1403 is identical to repair apparatus 201.

[0049] The backplates of the two repair apparatus 201, 1403 are mounted to the wall 1401 effectively by three sides each, and are positioned to lie alongside each other to provide a substantially continuous substrate surface. [0050] Repair apparatus 201 is cond to be mounted to a wall effectively by only two sides of the backplate, allowing large holes in a building panel to be repaired using three or more repair apparatus. Such a hole may be left in a building panel following removal of, for example, an air vent or fusebox.

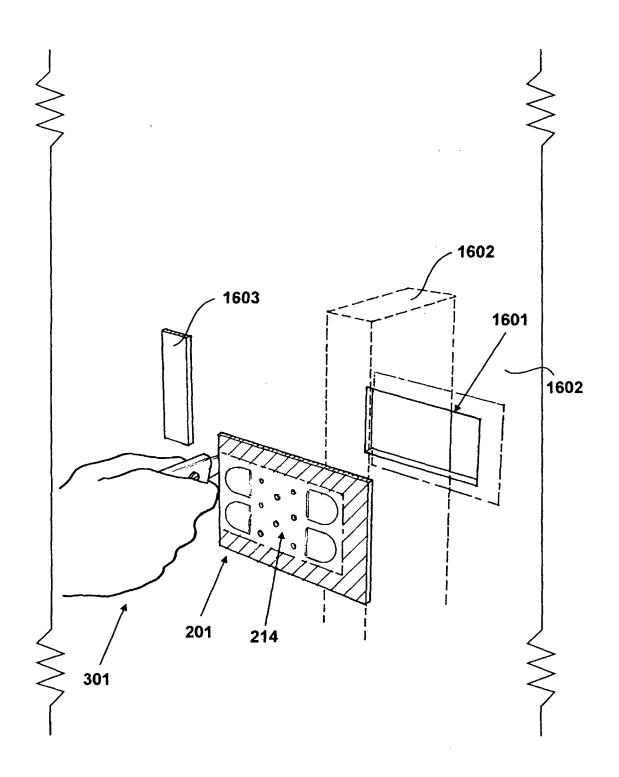
[0057] Alternatively, as illustrated in *Figure* 16, the backplate **202** of repair apparatus **201** can be cut with a knife. As described previously, substantially the whole of front face **204** is provided with adhesive. This feature enables the backplate **202** to be cut into any desired shape, and still be mountable to a building panel.

[0058] Figure 16 illustrates a hole **1601** in a plaster-board wall **1602**. Plasterboard walls are typically constructed on a timber frame, known as studding. A hole requiring repair may be formed in the wall immediately adjacent to a studding member which may potentially interfere with the installation of repair apparatus.

[0059] In Figure 16, hole 1601 is immediately adjacent studding member 1602. In this example, trimming of one side of repair apparatus 201 is required to enable installation. As shown, building operative 301 has sliced off a portion 1603 of the backplate of repair apparatus 201 to enable the repair apparatus to be mounted to the wall 1601 such that the array of repair material apertures 214 is located substantially centrally of the hole 1601. As described with reference to Figure 14, repair apparatus 201 is cond such that the mounting of the backplate following trimming is stable.

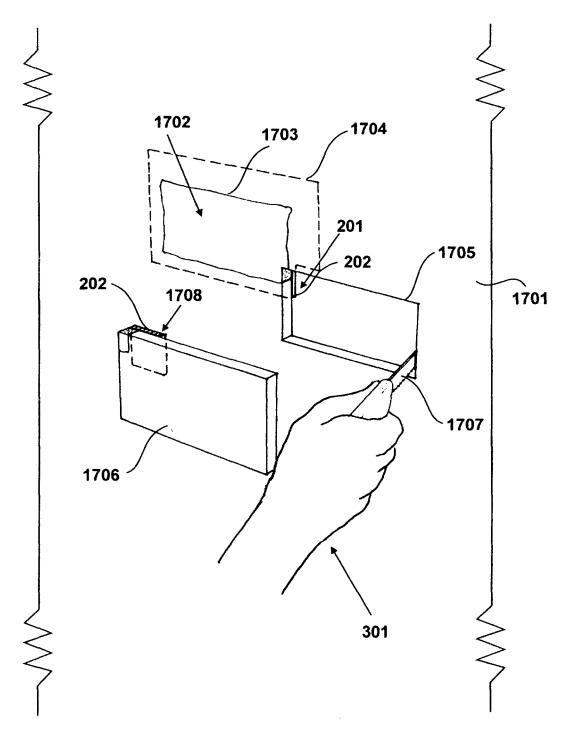
Figure 17 shows an aperture being made in a second area that overlaps a first area of a building panel that has been repaired using the apparatus of Figure 2; Figure 18 shows a cross-section view of a repair through which a mounting member has been located:

[0060] Figure 17 shows a building panel 1701 having a prior repair 1702, in which an aperture, indicated by dotted line 1703, has been repaired using repair apparatus 201, the mounted position of which is indicated by dotted line 1704. A new aperture is required in the building panel 1701, for example to allow fitting of an electrical socket. In this example, the boundary of the required new aperture, indicated by dotted line 1705, overlaps the mounted backplate 202 of the prior repair 1702. However, there is no problem in defining the new aperture since backplate 202 can be manually cut.

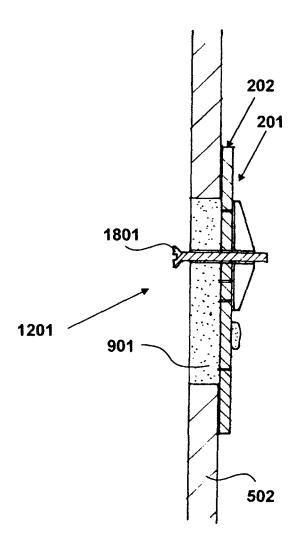
[0063] Figure 18 shows a cross-section view of repair 1201. As shown, the repair 1201 allows a mounting member, such as screw 1801, to be used in that area of the building panel. The hole repair material 901 allows penetration by a mounting member. The backplate 202 of the repair apparatus 201, which is effectively incorporated into the building panel structure, may be punctured by a mounting member such that the backplate 202 does not present a blockade to the mounting member. The integrity of the repair 1201 is sufficient to withstand, for example, a picture being mounted on the wall 502 using a mounting member installed in the repair 1201.

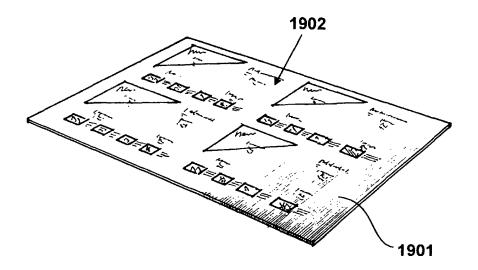
[0064] Figure 19 shows a first step in the manufacture of a repair apparatus. A backplate sheet **1901** is positioned to receive visual graphics, thereafter applied to a rearface **1902** thereof. In this example, a plurality of backplates is produced from backplate sheet **1901**.

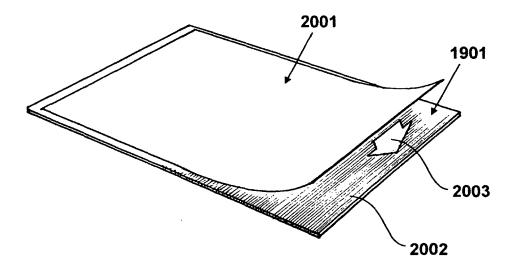
[0071] Figure 20 shows a second step in the manufacture of a repair apparatus. Adhesive 2001 is applied to the front face 2002 of backplate sheet 1901; as indicated by arrow 2003. In this illustrated example, adhesive is distributed across substantially the whole of the front face 2002 of backplate sheet 1901, either as a substantially continuous or patterned layer. In accordance with the arrangement of adhesive of repair apparatus 201, substantially the whole of the front face of each backplate produced from backplate sheet 1901 will be provided with adhesive.

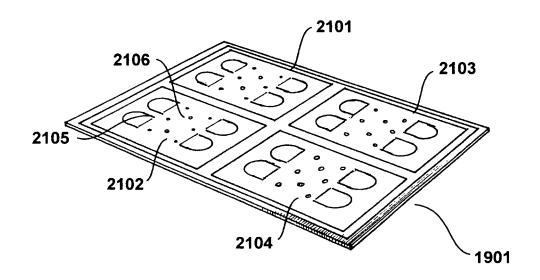
[0075] Figure 21 shows a third step in the manufacture of a repair apparatus. A plurality of backplates 2101, 2102, 2103, 2104 are defined in backplate sheet 1801. Each backplate 2101, 2102, 2103, 2104 has at least one flap, for example flap 2105, and additionally at least one repair material aperture, for example repair material aperture 2106.

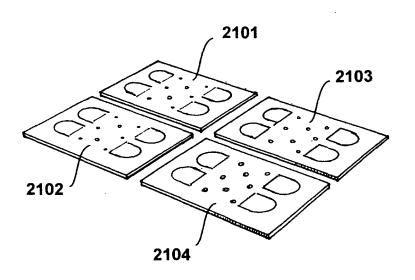
[0080] Figure 22 shows a fourth step in the manufacture of repair apparatus 201. The backplates 2101, 2102, 2103, 2104 are separated from backplate sheet 1901. This may be achieved using a suction or stamping process.

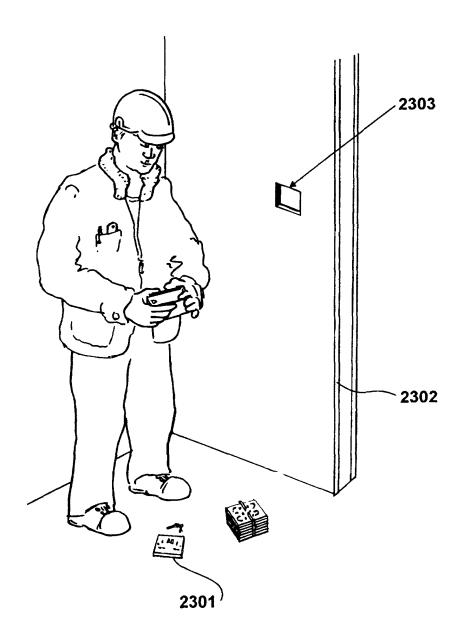
Figure 23 shows a repair apparatus having a square rectangular shape;

[0082] A repair apparatus **2301** having a square rectangular shape is shown in *Figure 23*. In a similar scenario to that shown in *Figure 1*, a wall **2302** has a hole **2303** therein requiring repair.

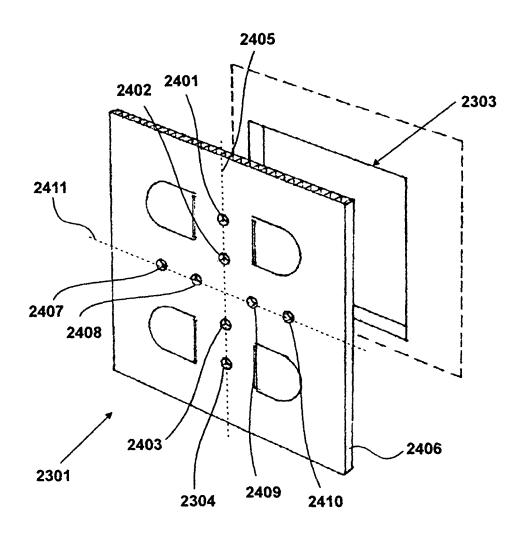
[0083] Figure 24 shows an enlarged view of repair apparatus 2301. In this example, the repair apparatus has length and width dimensions of six inches (~0.1524m) square. This size of backplate is suitable for repairing aperture 2303, which in this example has length and width dimensions of four inches (~0.1016m) square.

[0085] It can be seen from *Figure* 24 that repair material apertures **2401**, **2402**, **2403** and **2404** each lie upon the same bend axis **2405** of backplate **2406**. In this example, first bend axis **2405** is a centreline of backplate **2406**. The provision of apertures aligned along an axis introduces a line of weakness to the backplate that renders the backplate less resistant to folding, to the effect that the backplate will tend to flex along the weakened axis.

[0086] A repair apparatus may be provided with apertures aligned to form more than one bend axis. For example, repair material apertures 2407, 2408, 2409 and 2410 of repair apparatus 2301 are aligned along second bend axis 2411 of backplate 2406. Second bend axis 2411 extends in a direction perpendicular to bend axis 2405, and the bend axes 2405 and 2411 intersect. In an alternative arrangement, a repair material aperture is provided at the point of intersection of bend axes. It is to be appreciated that different arrangements of apertures may be utilised to provide different arrangements of bend axes. For example, a repair apparatus may be provided with a plurality of bend axes that do not intersect.

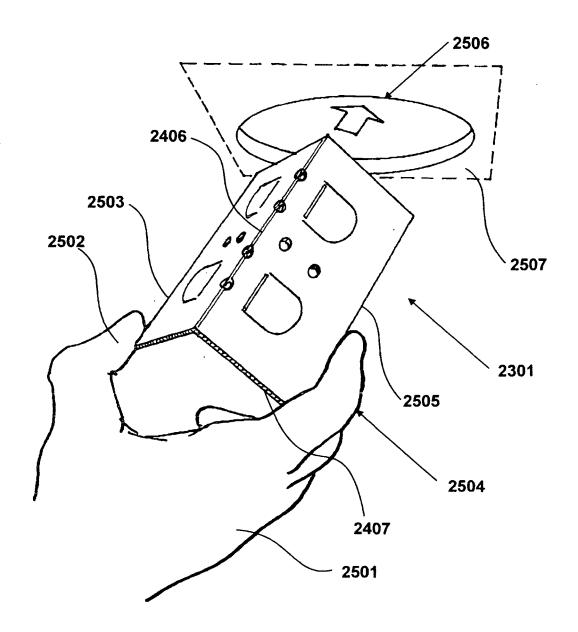
Figure 25 shows repair apparatus having flexed in response to manually applied pressure;

[0087] Figure 25 shows repair apparatus 2301 responding to manually applied pressure. Repair apparatus 2301 is being held in one hand 2501 only, gripped between the thumb 2502, which is in contact with a first edge 2503 of the backplate 2407, and the fingers 2504, which are in contact with the opposite edge 2505 of the backplate 2407. Under a squeezing action effected by hand 2501, the backplate of the repair apparatus flexes to fold along bend axis 2406, which extends between the opposite edges 2503, 2505.

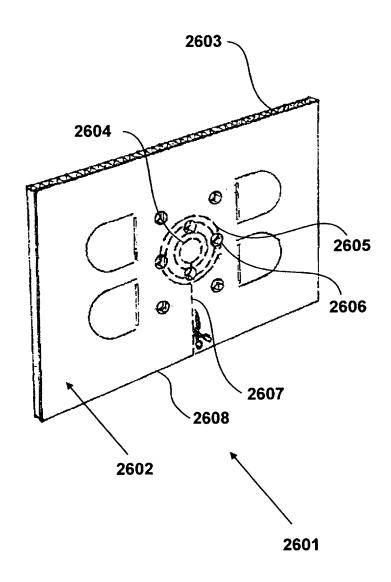
Figure 26 shows a repair apparatus having the perimeter of at least one region of the backplate delineated;

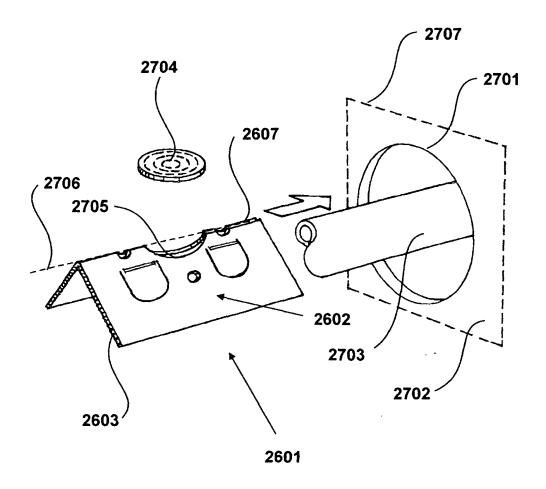
Figure 27 shows the repair apparatus of Figure 26 prepared for use in the repair of a building panel behind which an obstacle extends.
