(11) **EP 2 000 251 A1**

(71) Applicant: **Alstom Technology Ltd**
5400 Baden (CH)

(54) **Repair welding method for waterwall tubes**

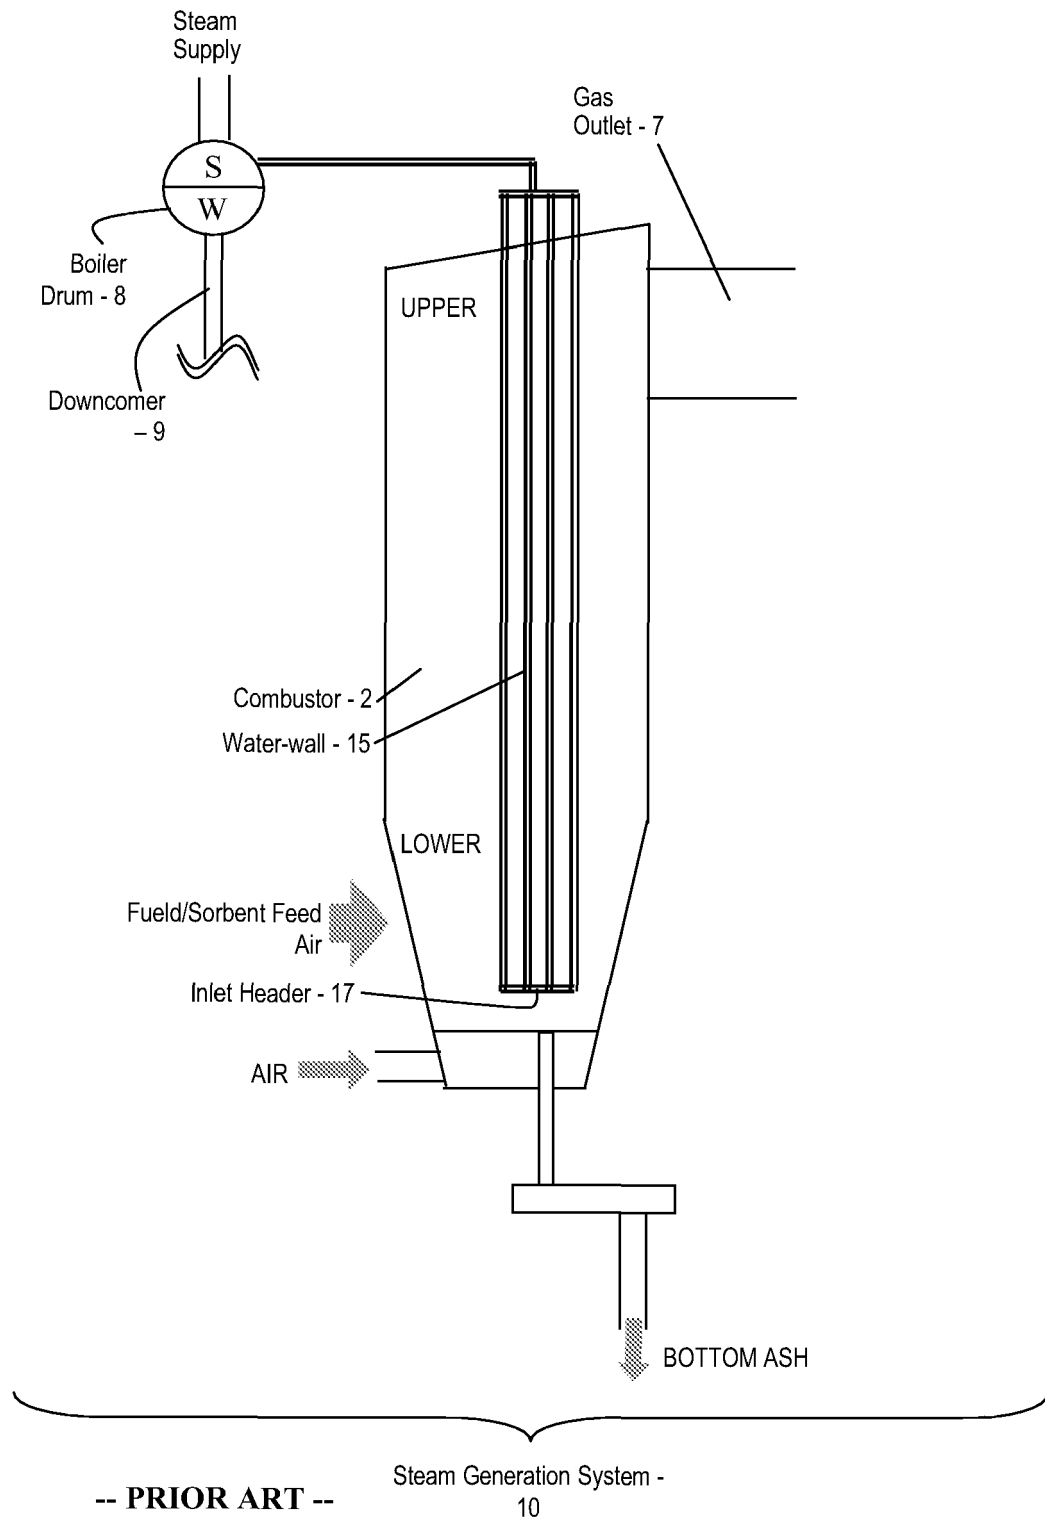
Fig. 1

[0003] Referring now to FIG. 1, there are shown aspects of an embodiment of a Steam Generation System (SGS) 10. As depicted, the SGS 10 includes a combustor 2 (also referred to as a "boiler" and by other similar terms) as well as various other components. One skilled in the art will recognize that this illustration and description present only a section of a simplified combustion system, and that this example is not limiting of combustion systems.

[0009] Still referring to FIG. 1, the prior art SGS 10 includes a boiler drum 8 which receives steam and moisture from the water-wall tubing 15 (through various components, such as a collection header). The boiler drum 8 provides for separation of water (W) and steam (S).

[0020] FIG. 1 depicts aspects of a prior art combustor having water-wall tubing;

[0004] In operation, crushed fuel (e.g., coal) and sorbent (e.g., limestone) are fed to a lower portion of the combustor 2 as bed material. Primary air is supplied to a bottom portion of the combustor 2 through an air distributor, with secondary air fed through one or more elevations of air ports in a lower portion of the combustor 2.

[0005] Combustion takes place throughout the combustor 2, which is filled with the bed material. Flue gas and entrained solids leave the combustor 2 as combustor exhaust through a gas outlet 7.

[0006] In typical embodiments, the combustor 2 generally includes two regions. A lower portion and an upper portion. The lower portion of the combustor 2 includes the fuel, a primary air distributor, secondary air ports, fuel feed ports and solids recycle ports. The density of the bed in this region is relatively high on average and typically highest at the elevation of the air distributor. The density then drops off with increasing height of the combustor 2. Physically, the lower portion is usually rectangular, tapered and formed from finned or fusion welded water-wall tubing 15. The lower portion is typically lined with refractory to protect the water-wall tubing 15.

[0007] In this simplified illustration, the water-wall tubing 15 is supplied boilerwater (e.g., water, water with cer-

tain chemicals, etc,...) by an inlet header 17. The inlet header 17 provides the boilerwater for steam generation in the water-wall tubing 15 of the combustor 2.

[0008] The upper portion of the combustor 2 is usually rectangular with vertical walls, where the walls are formed with finned or fusion welded water-wall tubing 15. The upper portion is typically unlined to maximize heat transfer to the water-wall tubing 15. The walls of the combustor 2 are cooled by circulation in the water-wall tubing 15.

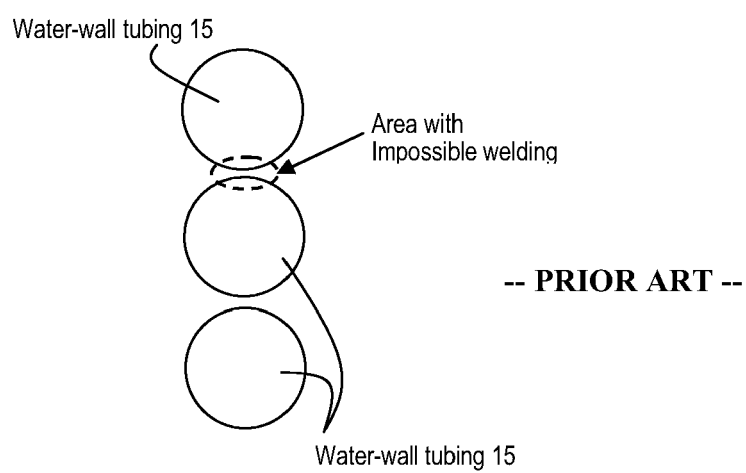
Fig. 2

[0014] FIG. 2 depicts an area where welding of water-wall tubing 15 has been impossible without disturbing other tubing.

[0021] FIG. 2 depicts an area within water-wall tubing where welding has not been possible;

[0013] Generally to weld water walls there are two welders in operation at the same time, one in the boiler and the other outside. When the space between tubes of the water-wall tubing 15 is very small, it becomes quite impossible to perform a part of the weld (the part between tubes). Accordingly, one must then pull aside one tube, perform welding on the damaged tube and then restore the tube that was pulled aside.

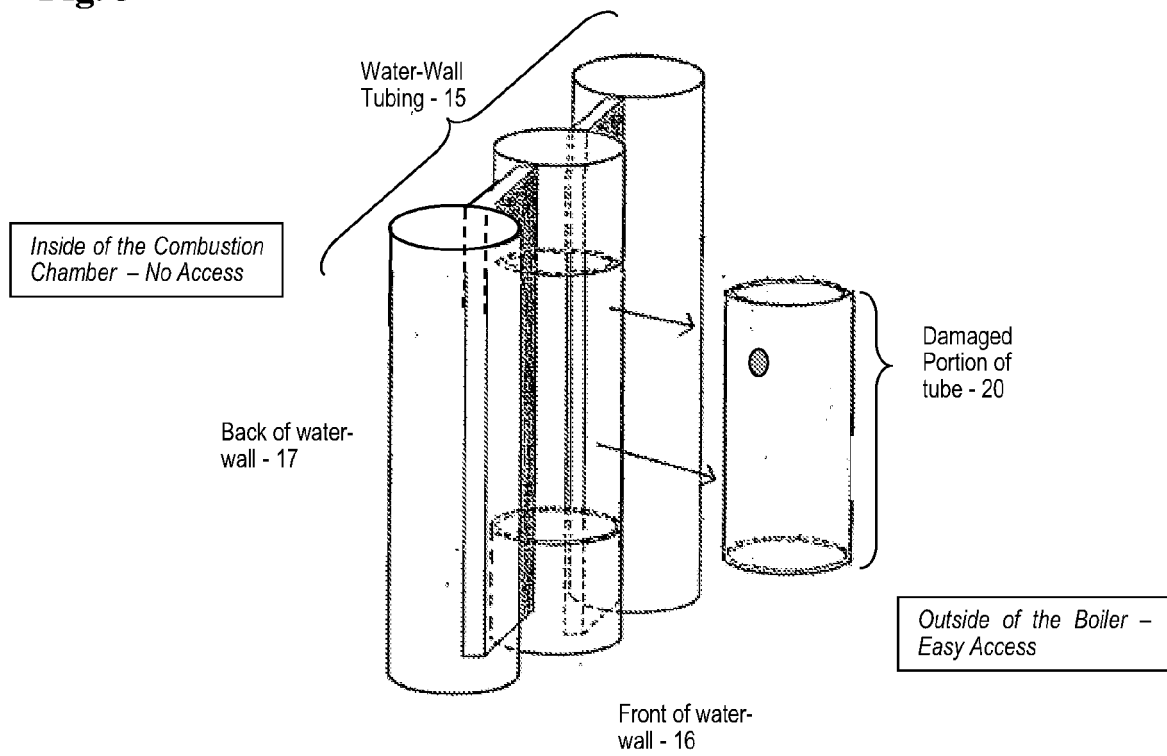
Fig. 3

[0022] FIG. 3 depicts aspects of a damaged tube of the water-wall tubing;

[0030] Referring now to FIG. 3, there is shown a portion of the water-wall tubing 15. The water-wall tubing 15 is generally characterized as having a back of the water wall 17 and a front of the water wall 16. When installed, the back of the water wall 17 is inaccessible. That is, some intermediate step, such as cutting through the water-wall tubing 15 must be performed to access the back of the water wall 17. The back of the water wall 17 is generally exposed to the combustion chamber. Typically, the back portion of the water wall tubing 15 is subject to failure due to the harsh environment. As shown in FIG. 3, a portion of a damaged tube 20 has been removed from the water-wall tubing 15. In this example, the portion of the damaged tube 20 includes a perforation. Repair of the perforation first calls for removing the portion of damaged tube 20 by conventional techniques such as with a cutting torch, a grinder and other such devices. Next, a replacement is inserted. An exemplary replacement is shown in FIG. 4.

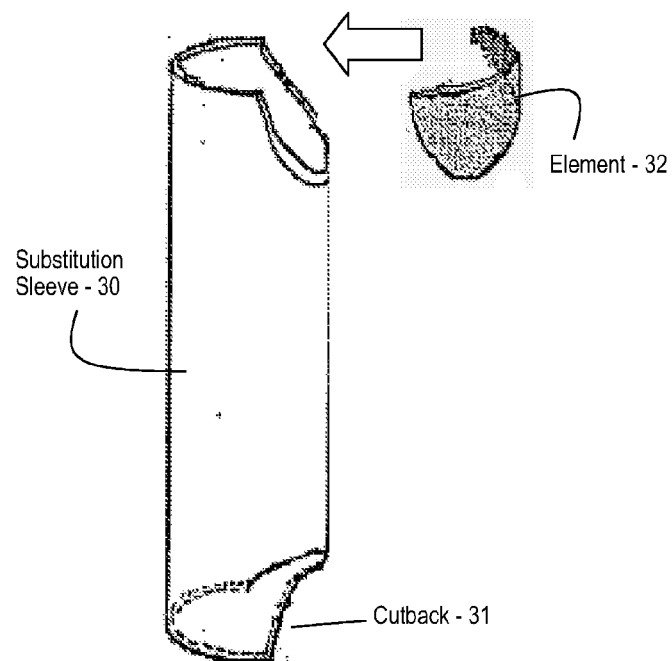
Fig. 4

[0023] FIG. 4 depicts a substitution sleeve;

[0031] In FIG. 4, aspects of an exemplary substitution sleeve 30 are shown. The substitution sleeve 30 is typically formed of material that is similar to material of the water-wall tubing 15 and is of a similar thickness. Of course, variations and improvements to materials and dimensions may be used as determined appropriate. The substitution sleeve 30 is typically of the same length as the portion of damaged tube 20, such that the substitution sleeve 30 may be welded in place of the portion of damaged tube 20. The term "similar" as used in this regard, is related to material or dimensions that of a similar appearance, availability, cost, durability, longevity, or other such aspects of the water-wall tubing 15.

[0032] Generally, the substitution sleeve 30 includes an upper and a lower cutback 31. The cutback 31 provides an access way for subsequent internal welding. An element 32 is generally provided with the substitution sleeve 30 for each of the upper and the lower cutback 31. Each element 32 serves as filler material for subsequent external welding.

[0033] The element 32 may be adapted as necessary. That is, for each element 32, aspects such as a shape, size, material, mounting features (e.g., weld points) and other such aspects may be adapted as necessary. In each embodiment, the element 32 includes a design that never requires longitudinal welding for installation.

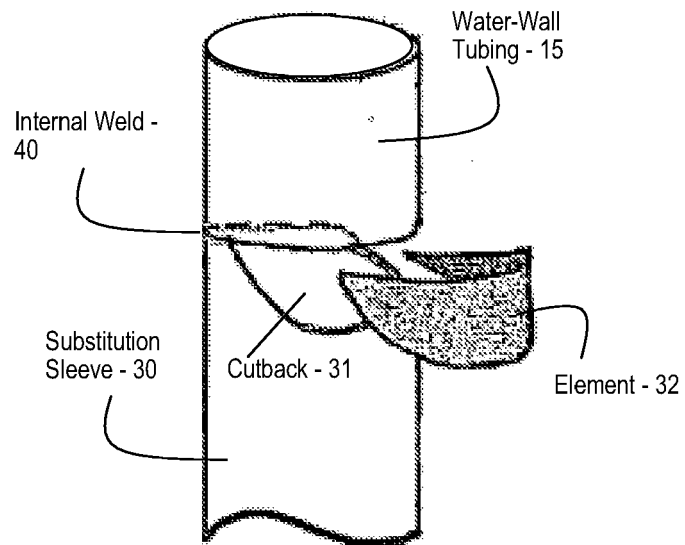
Fig. 5

[0024] FIG. 5 depicts the substitution sleeve in place within a water-wall tube;

[0034] In FIG. 5, the substitution sleeve 30 is disposed in line with the damaged water-wall tubing 15. Once aligned, an internal weld 40 is formed by a welding procedure. Advantageously, the cutback 31 provides room and accessibility for tooling for the welding procedure. Once the internal weld 40 is in place, the upper and lower elements 32 are set and an external weld 50 is performed.

cutback 31 once welded into place. As shown in FIG. 5, the element 32 is surrounded by an external weld 50. Once the internal weld 40 and the external weld 50 are in place (for the upper and lower portion of the substitution sleeve 30), the water-wall tubing 15 may be subjected to inspection or considered repaired.

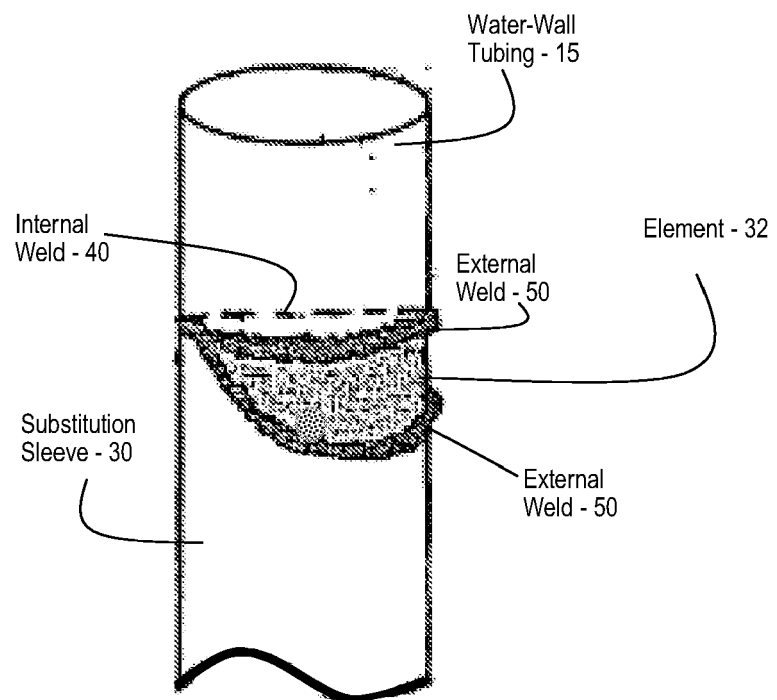
Fig. 6

[0025] FIG. 6 depicts aspects of the substitution sleeve installed into a tube of the water-wall; and

[0035] As shown in FIG. 6, the element 32 is installed into the water-wall tubing 15. Each element 32 provides an adequate supply of material necessary for filling the

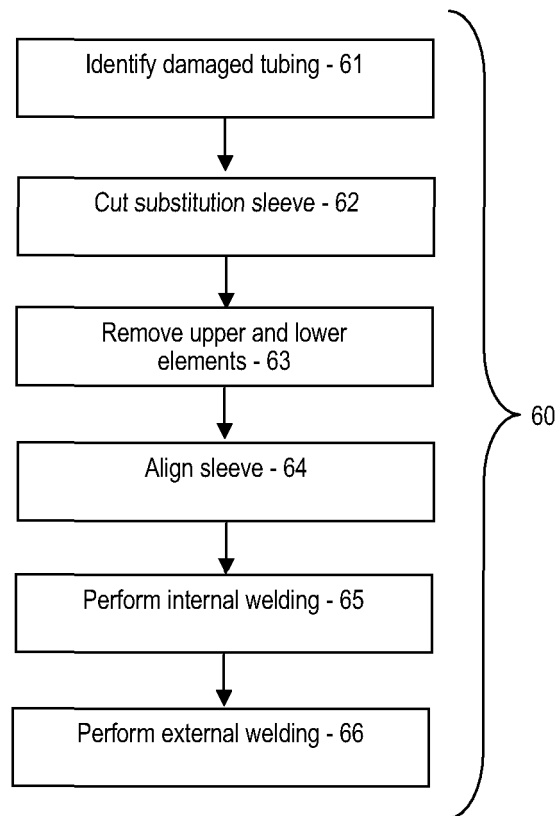
Fig. 7

[0026] FIG. 7 depicts an exemplary method for repairing water-wall tubing.

[0039] In FIG. 7, an exemplary repair method 60 is provided. In a first step 61, repair personnel identify and remove a length L of damaged tubing. In a second step 62, the personnel cut a substitution sleeve 30 of length L. In a third step 63, upper and lower elements 32 are removed from the substitution sleeve 30. In a fourth step 64, the substitution sleeve is aligned in a blank section of the water-wall tubing 15 (that is, a section where the damaged portion has been removed). In fifth step 65, personnel perform internal welding to provide the interior weld 40 which couples the substitution sleeve 30 to the back of the water-wall tubing 15. In a sixth step 66, the upper and lower elements 32 are placed and external welding is performed to provide the external weld 50. Once the external weld 50 is completed, the water-wall is repaired (or sealed). Of course, some of these steps may be omitted, performed out of order, added to, or otherwise modified for performing a repair.

[0038] In some embodiments, repair personnel make the substitution sleeve 30, the cutback 31 and the element 32 in the field from blank stock. That is, a section of material is available to the personnel. Once an extent of the damaged portion of tubing 20 is determined, the personnel cut appropriately sized materials. Accordingly, FIG. 7 depicts an exemplary method for performing a repair.
