(12) **EUROPEAN PATENT APPLICATION**

(21) Application number: **09175067.9**

(54) **Inspection tool for wire rope**

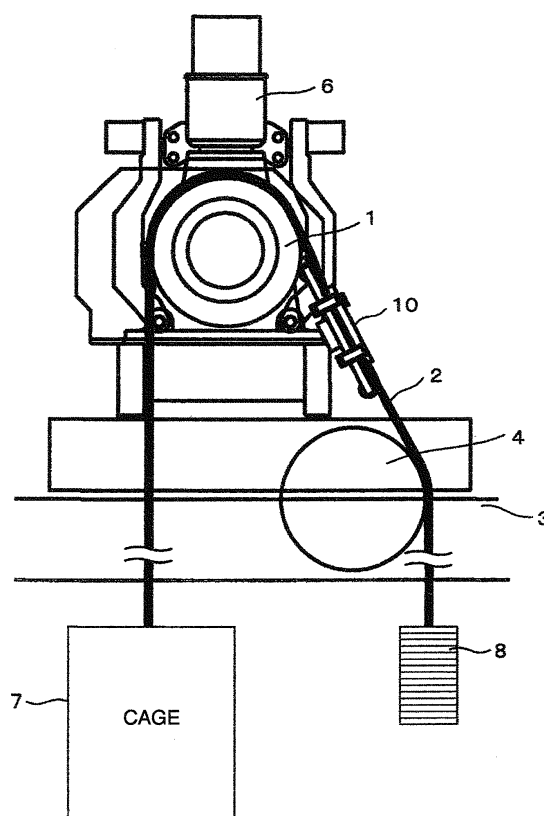
**FIG. 1**

(57) In an inspection tool (10) for an elevator wire rope for detecting a leakage flux by magnetizing a part of a rope (2) used for an elevator and measuring damage of the rope (2), a curvature portion is formed by pushing and curving the rope in a longitudinal direction and a leakage flux is detected by magnetizing the curvature portion.

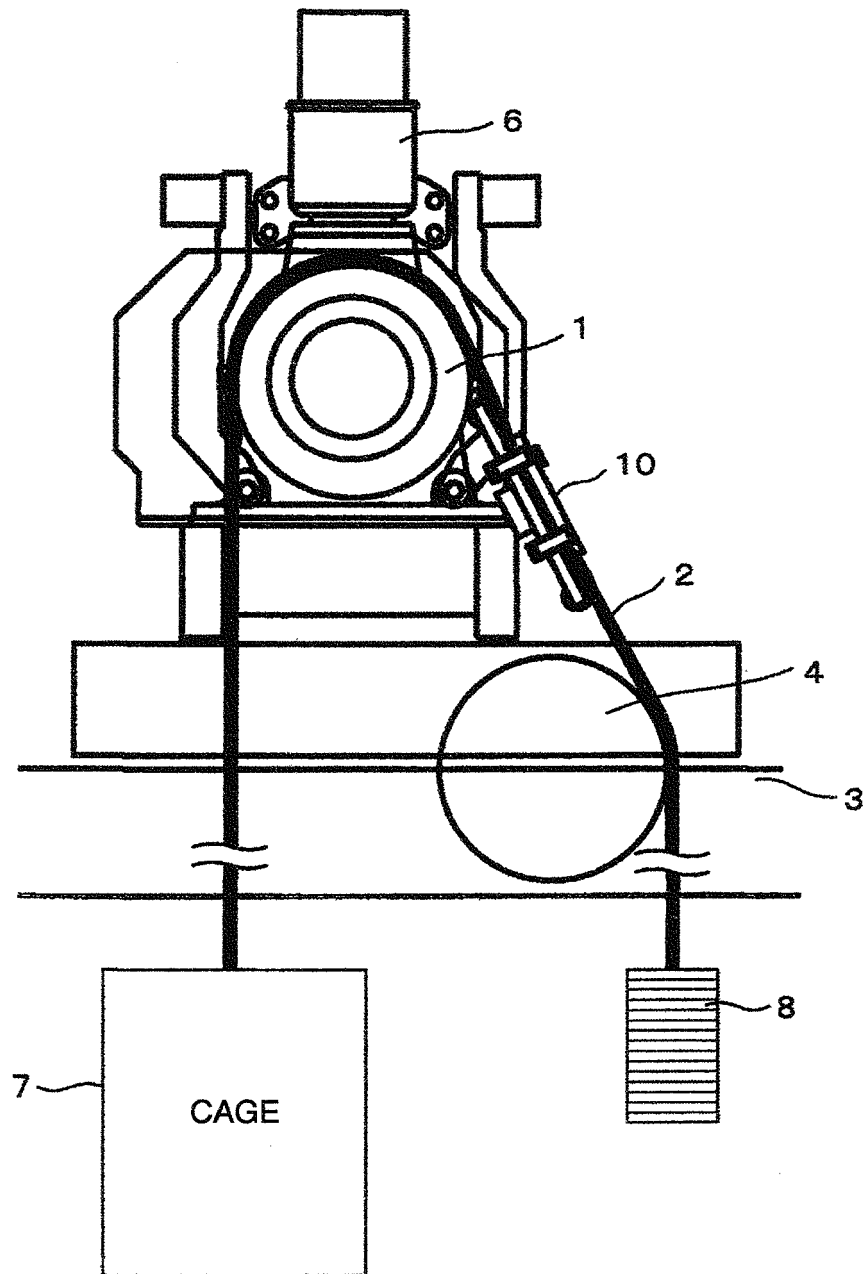
FIG. 1

Fig. 1 is a side view showing an overall appearance of an elevator according to one embodiment of the invention;

[0010] An elevator includes a cage 7, a rope 2, hoisting machine 6 having a sheave 1 for hoisting the rope 2 and a counterweight 8 as shown in Fig. 1. A rope tester includes a magnetizer for magnetizing the rope 2, a flux sensor for detecting a leakage flux resulting from damage of the rope 2 and a slide plate for keeping constant the distance between the rope 2 and the flux sensor. During strand breakage inspection of the rope 2, the slide plate and the rope 2 come into contact with each other and a measurement surface measures a surface opposite to the contact surface of the sheave 1 and the rope 2.

**[0014]** An inspection worker fits the inspection tool 10 between the sheave 1 and a deflector sheave 4 in an elevator machine room situated at an upper part of the elevator path and inspects breakage of the strand of the rope. The inspection tool 10 includes a rope tester 21, a guide shoe 23 having a certain radius of curvature, a push mechanism 41 and a guide roller 22a, 22b and mitigates an impact.

**[0015]** As the push mechanism 41 pushes the guide shoe 23 in a substantial vertical direction of the rope 2, the rope is forcibly curved. Therefore, the between-ends distance can be increased when the strand is broken. Because the leakage flux of the damage portion is substantially proportional to the damage volume (degree of damage), the damage volume can be increased by increasing the between-ends distance when the strand is broken and the leakage flux from inside the rope can become greater. In consequence, the detection signal of the flux sensor 30 increases and detection of the damage inside the rope becomes easier.

**[0016]** The construction of the rope tester 21 will be explained in further detail. The rope tester 21 is a magnetizer for magnetizing the rope 2, including a flux sensor 30 and a slide plate 42 so disposed as to oppose the guide shoe 23. The slide plate 42 has a U-shaped groove having a radius of curvature substantially equal to that of the guide shoe 23 in the longitudinal direction. The rope 2 slides and travels between the guide shoe 23 and the slide plate 42. The rope tester 21 uses permanent magnets 44a and 44b as magnetization unit and permanent magnets 44a and 44b having different poles are arranged in the longitudinal direction of the rope 2.

**[0017]** To insure sufficient magnetization of the rope 2 for measuring the leakage flux at the curvature portion, ferromagnetic bodies 43a and 43b are provided to the upper surface of the permanent magnet 44a and 44b and the shape of these ferromagnetic bodies 43a and 43b is in conformity with that of the slide plate 42. The flux sensor 30 is arranged at a substantial intermediate point of both permanent magnets 44a and 44b and detects the leakage flux at the lower part of the curvature portion of the rope 2. It is sufficient if the permanent magnets 44a and 44b used as the magnetization unit have magnetization force to a degree such that the leakage flux occurs from the damage of the rope 2. Alternatively, electromagnets, for example, may be used as the magnetization unit

**[0021]** Referring to Fig. 2, a shoe structure is employed as a member for forming the curvature portion but the guide may be the one that can curve the rope 2 to a curvature similar to that of the shoe structure. For example, the guide may well be a curvature guide roller having a plurality of rollers. This guide portion can insure smooth travel of the rope 2 owing to the rotation of a plurality of guide rollers even when a rope having a high coefficient of friction is used or when friction occurs as the rope 2 is pushed.

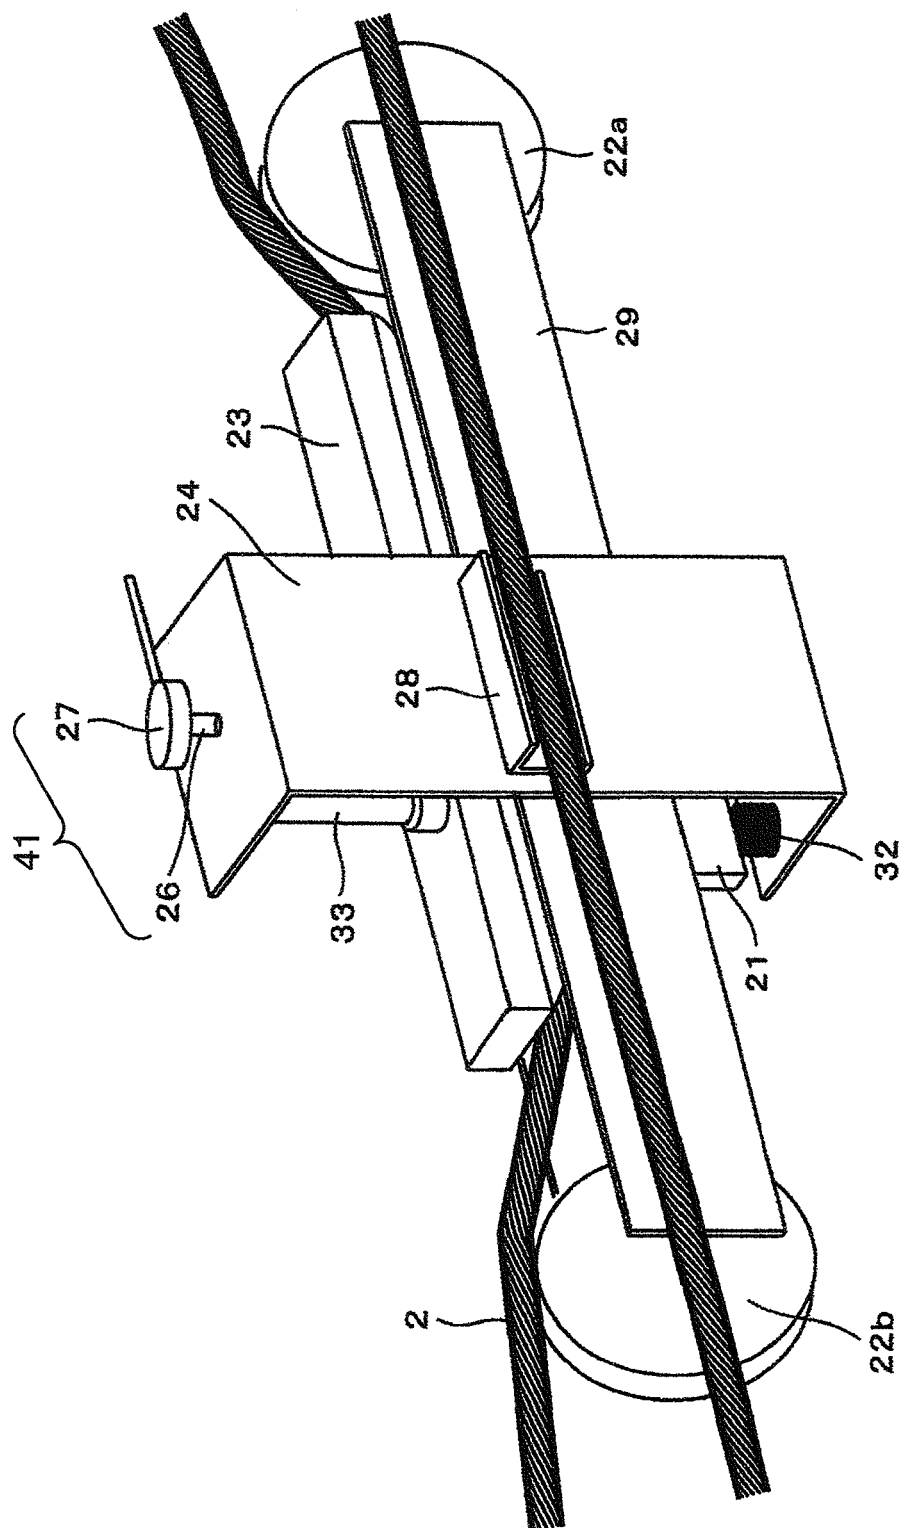
FIG. 3

Fig. 3 is a perspective view showing the rope inspection tool according to one embodiment of the invention; and

**[0022]** The rope curving mechanism of the inspection tool includes the support base 24, the push mechanism 41, the guide shoe 23, the guide roller 22a, 22b and the guide roller 22a, 22b support portion 29 as shown in Fig. 3. The support base 24 is fixed to the side surface of a guide roller 22a, 22b support base 29. The guide shoe 23 is interconnected by the support base 24 and a translation guide 33 so that its upper surface can be guided substantially in the vertical direction. For example, two linear bushes are arranged on the upper surface of the guide shoe 23 in the longitudinal direction of the rope 2 and are interconnected to the support base 24. The push mechanism 41 is arranged substantially at the center of the guide shoe 23 and up-down motion of the push mechanism 41 substantially feeds the upper surface of the guide shoe 23 in the vertical direction, pushes it to the rope 2 with the guide roller 22a, 22b as the supporting point and forms the curvature portion profiling the radius of curvature of the guide shoe 23.

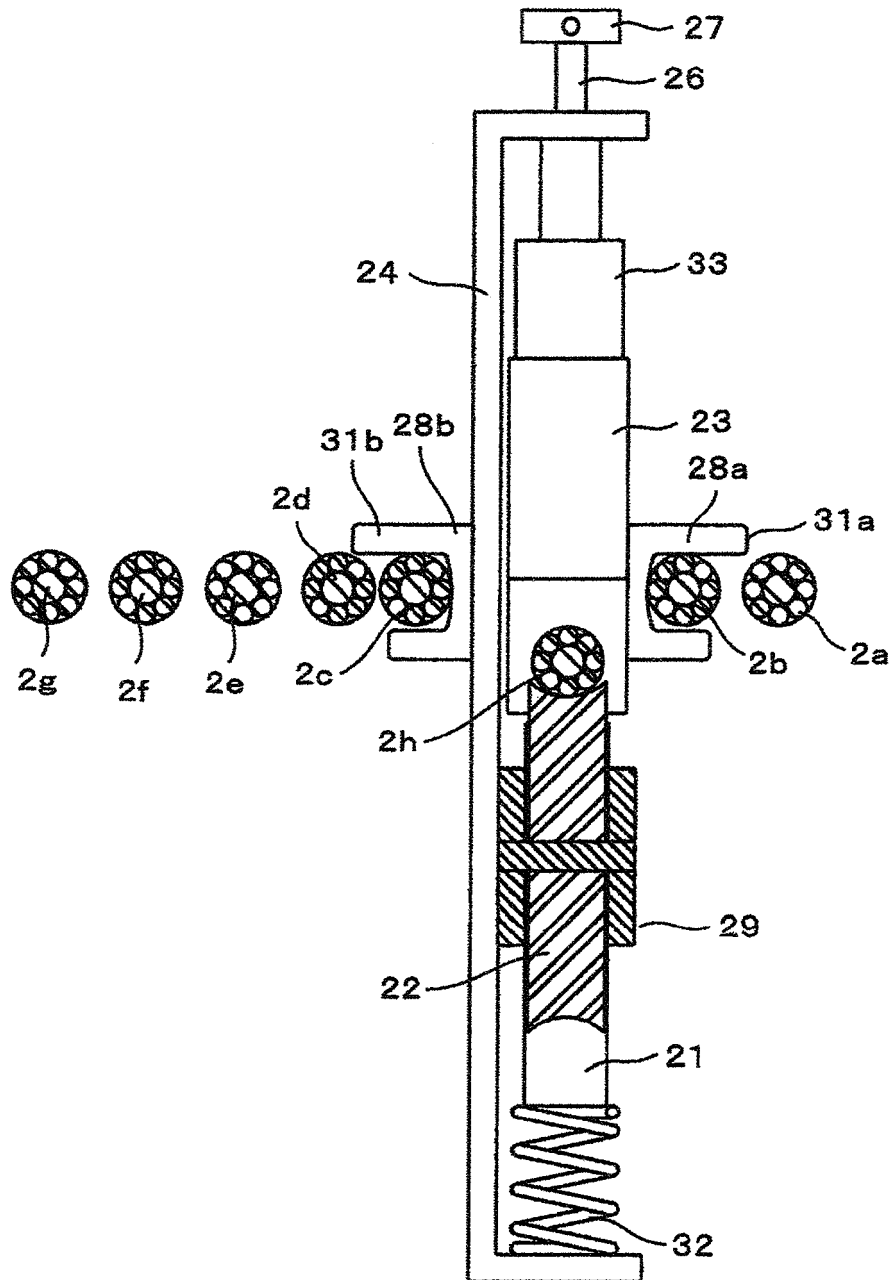
FIG. 4

Fig. 4 is a sectional side view showing a rope inspection tool according to one embodiment of the invention.

**[0023]** The slide guide portion 28 is formed of a material having a high sliding factor and has a shape having a bracket shaped section as shown in Fig. 4. A cage of

the elevator is suspended by a plurality of wire rope and the gap between adjacent pairs of ropes is small. Since the inspection tool according to the invention measures one rope among a plurality of ropes, the adjacent ropes 2b and 2c may come into contact with the support base 24 and with the guide shoe 23 when the inspection tool is installed between the sheave 1 and the deflector sheave 4 in the machine room. Therefore, the slide guide portion 28 is provided to the side surface of the inspection tool to guide the rope 2 in the longitudinal direction.

**[0024]** The shape of the contact surface between the slide guide portion 28 and the rope 2 is decided in such a fashion as to have a certain curvature and to lower the surface pressure when these members come into mutual surface contact. Therefore, uncontrolled movement of adjacent ropes in the vertical direction can be suppressed during measurement. Because the weight of the inspection tool can be supported by adjacent ropes 2b and 2c at the swell portions 31a and 31b during the measurement, the inspection tool need not be supported by hand and the working factor can be improved.
