(11) **EP 2 868 427 A2**

(71) Applicant: **Siemens Energy, Inc.**  
**Orlando, FL 32826-2399 (US)**

(54) **Braze alloy compositions and brazing methods for superalloys**

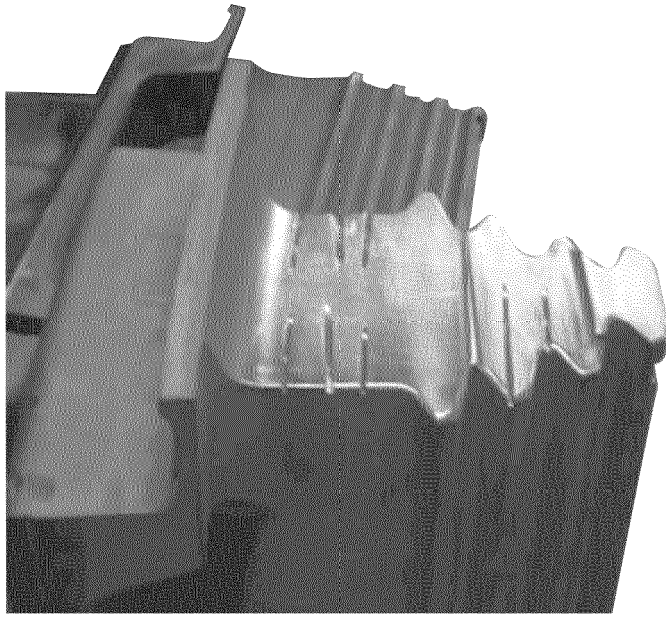
FIG. 3

Fig. 3: Photomicrograph of typical cracks created for braze tests;

**[0027]** Two methods of surface preparation were combined for this test. A mechanical cleaning of the area was performed, using carbide blend tools to create a simulated crack approximately 0.050" (inches) in width by approximately 0.050" in depth. A typical example is shown in Fig. 3. Following the mechanical cleaning and the creation of the simulated cracks, the blade material was subjected to a vacuum cleaning furnace cycle according to the procedures given in Fig. 2.

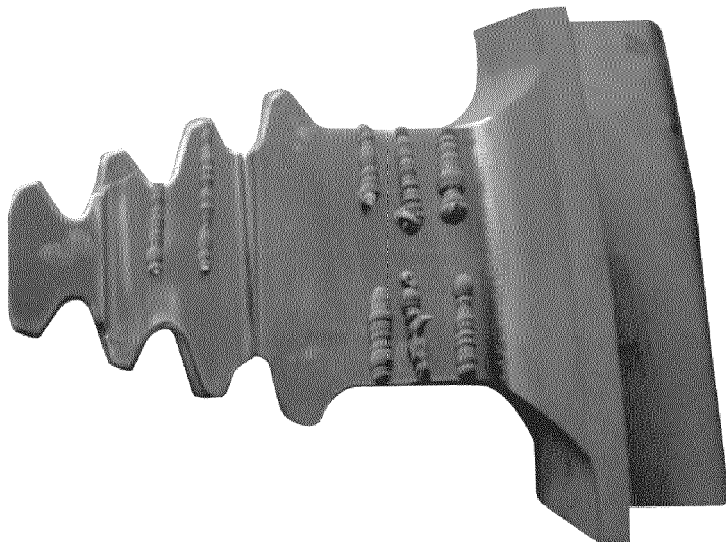
FIG. 4

Fig. 4: Photomicrograph of typical cracks created for braze tests following the introduction of paste into the cracks by regulated compressed air behind a piston forcing the paste through an application needle, which was used to work the paste into the cracks as required. The paste comprises a liquid binder mixed with a braze alloy;

ratios 509A/509B of 50/50, 60/40, 70/30 and then combined with liquid binder in the amount of about 10% - 15% by volume to form a paste. The paste was then worked into a plastic cartridge with regulated compressed air behind a piston to force the paste through an application needle that was used to work the paste into the cracks as required. Stop off can be applied as required to the base material around the braze to assure that the alloy does not run outside the intended repair zone. A typical result of this alloy-application, crack-filling step is shown in Fig. 4.

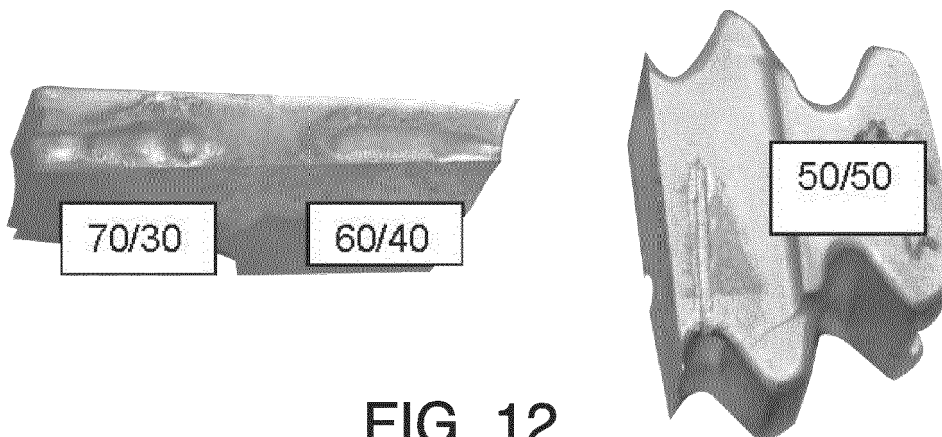
FIG. 12

Fig. 12: Re-melt Evaluation. Photomicrograph following a solution heat treat cycle after completion of the braze furnace cycle to evaluate the affect on the braze of possible normal repair processes following brazing. Three

mixtures of MarM/A/B are depicted (left to right), 70/30, 60/40, 50/50;

**[0033]** The three different mixtures considered in this Example-A, MarM509A/B (Examples-04, -05, -06 of Fig. 1) were subjected to a typical solution heat treat cycle after the braze was completed in order to determine if the braze alloy would likely be affected if the component so brazed were later subjected to a normal repair process. The remelt percentage was calculated by comparing the alloy height following solution heat treatment to the alloy height following the braze process but before the solution heat treatment. For 50/50 (MarM509A/B) more than 100% remelt was observed. The alloy returned to its liquid state and ran off the workpiece resulting in a depression below the level of the original surface. For 60/40 (MarM509A/B), approximately 50% alloy height loss was observed. For 70/30 (MarM509A/B), approximately

30% alloy height loss was observed. A photomicrograph of these results is provided in Fig. 12.

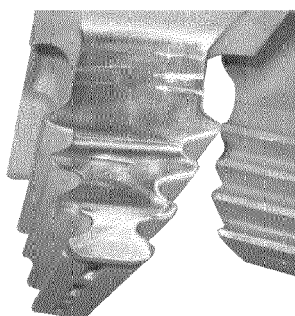
FIG. 14

Fig. 14: Photomicrograph of cracks created in samples for braze test;

**[0038]** The braze surfaces were prepared using a mechanical cleaning method with carbide blend tools to create a simulated crack approximately 0.050" in width by approximately 0.050" in depth. No vacuum cleaning furnace cycle was performed after the mechanical cleaning operation. One blade was cleaned using a fluoride ion cleaning (FIC) furnace with HF gas to prepare the surface for braze. Figs. 14, 15, 16 show typical blades at various stages in the surface preparation process.

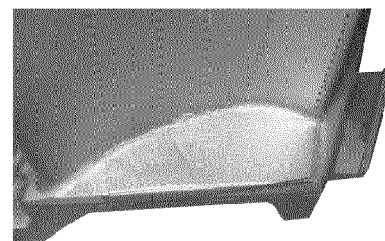
FIG. 16

Fig. 16: Photomicrograph of cracks created in samples for braze test following FIC cleaning and brazing;

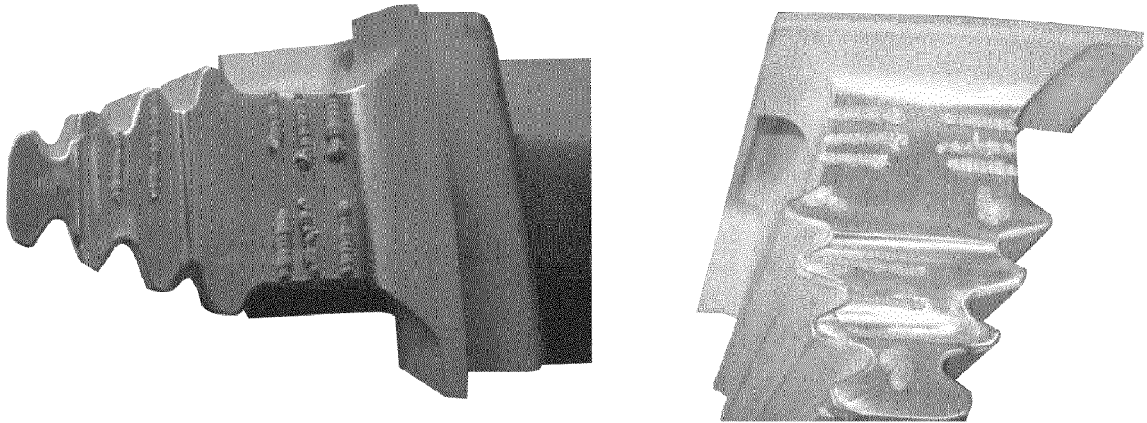
FIG. 17

Fig. 17: Alloy Application. Photomicrograph of typical cracks created for braze tests following the introduction of paste into the cracks by regulated compressed air behind a piston forcing the paste through an application needle, which was used to work the paste into the cracks as required. The paste comprises a liquid binder mixed with a braze alloy;

**[0042]** Each paste was worked into a plastic cartridge with regulated compressed air behind a piston to force the paste through an application needle that was used to work the paste into the cracks as required. Stop off can be applied as required to the base material around the braze to assure that the alloy does not run outside the intended repair zone. Fig. 17 shows typical blades following the step of alloy application.

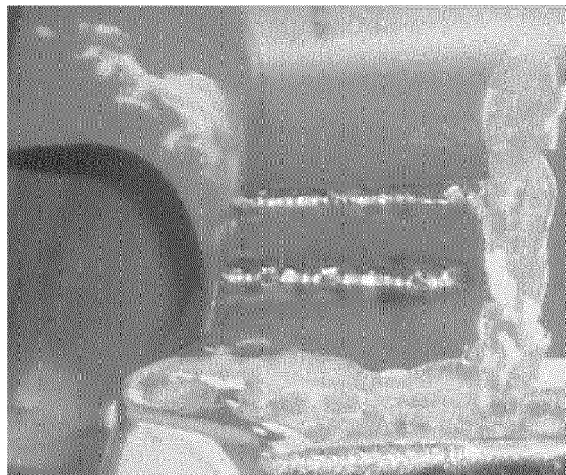
FIG. 20

Fig. 20: Photomicrograph after completion of braze furnace cycle for the 70/30 alloy mix MarM509A/B;

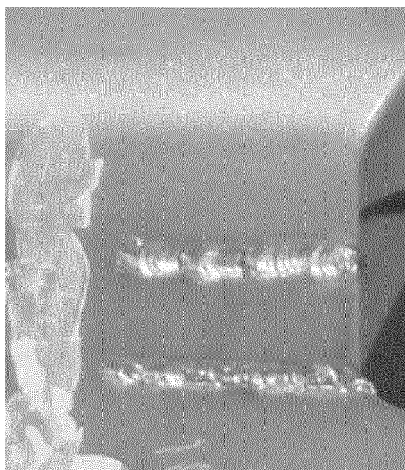
FIG. 21

Fig. 21: Photomicrograph after completion of braze furnace cycle for the 80/20 alloy mix MarM509A/B;

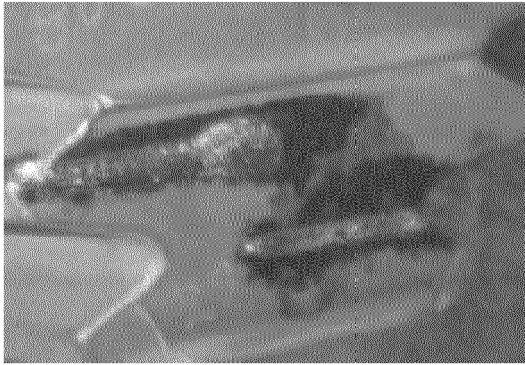
FIG. 22

Fig. 22: Photomicrograph after completion of braze furnace cycle for the 60/40 alloy mix CM247/BRB;

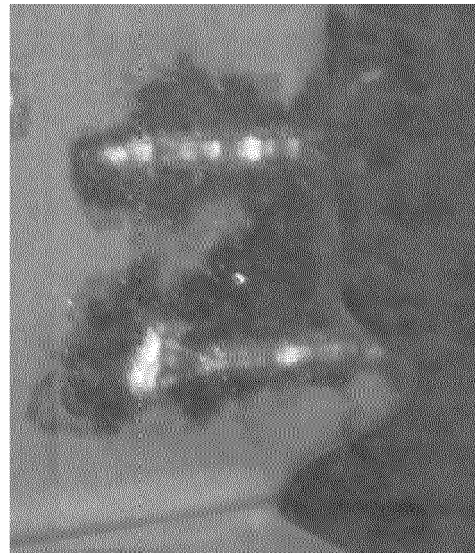
FIG. 23

Fig. 23: Photomicrograph after completion of braze furnace cycle for the 70/30 alloy mix CM247/BRB;

Fig. 23 is a photomicrograph of results obtained with the 70/30 alloy mixture. This mixture has a good smooth appearance at the edges with some alloy flow from the repair area.

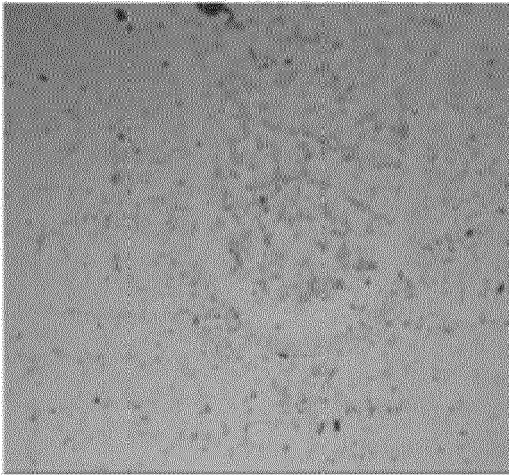
FIG. 25

Fig. 25 is a photomicrograph of results obtained with the 60/40 braze mixture. The photomicrograph apparently shows good flow into the base material providing a smooth transition from the braze alloy. The interface appears to be acceptable but with a hint of being hot. Porosity was similar to the casting material and below about 1% of the measured volume of the repair area.

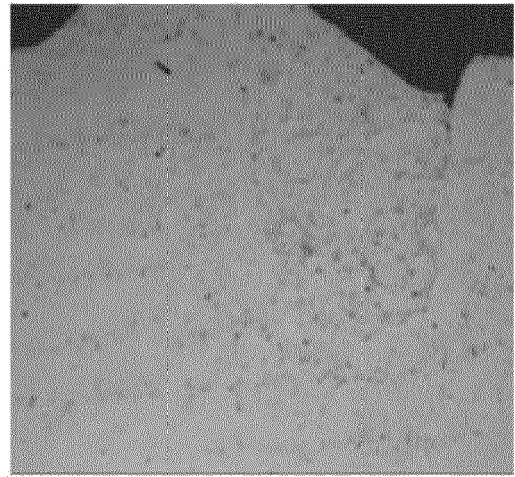
FIG. 26

Fig. 26 is a photomicrograph of results obtained with the 70/30 braze mixture. The photomicrograph shows excellent flow into the base material, providing a smooth transition from the edges. The interface is excellent. The porosity is similar to the casting material and below about 1% of the measured volume of the repaired area. The right edge of the braze was apparently missed and not filled during the application of the alloy.

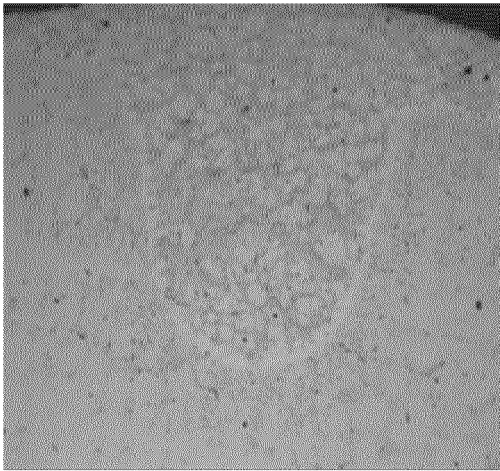
FIG. 28

Fig. 28 is a photomicrograph of results obtained with the 60/40 braze mixture. The photomicrograph apparently shows good flow into the base material providing a smooth transition from the braze repair area. The interface appears to be acceptable but with a hint of being hot. Porosity was similar to the casting material and below about 1% of the measured volume of the repair area.

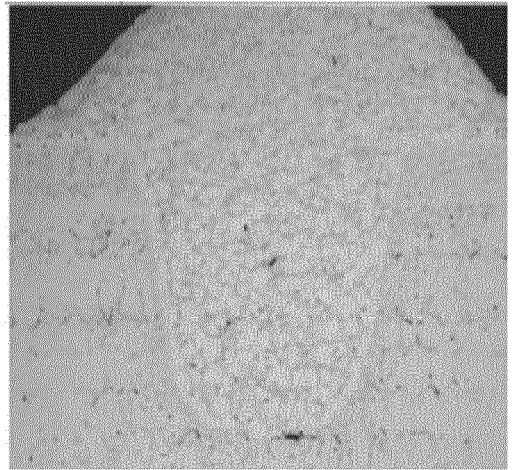
FIG. 29

Fig. 29 is a photomicrograph of results obtained with the 70/30 braze mixture. The photomicrograph shows excellent flow into the base material, providing a smooth transition from the braze repair area. The interface is excellent. The porosity is similar to the casting material and below about 1% of the measured volume of the repair area.

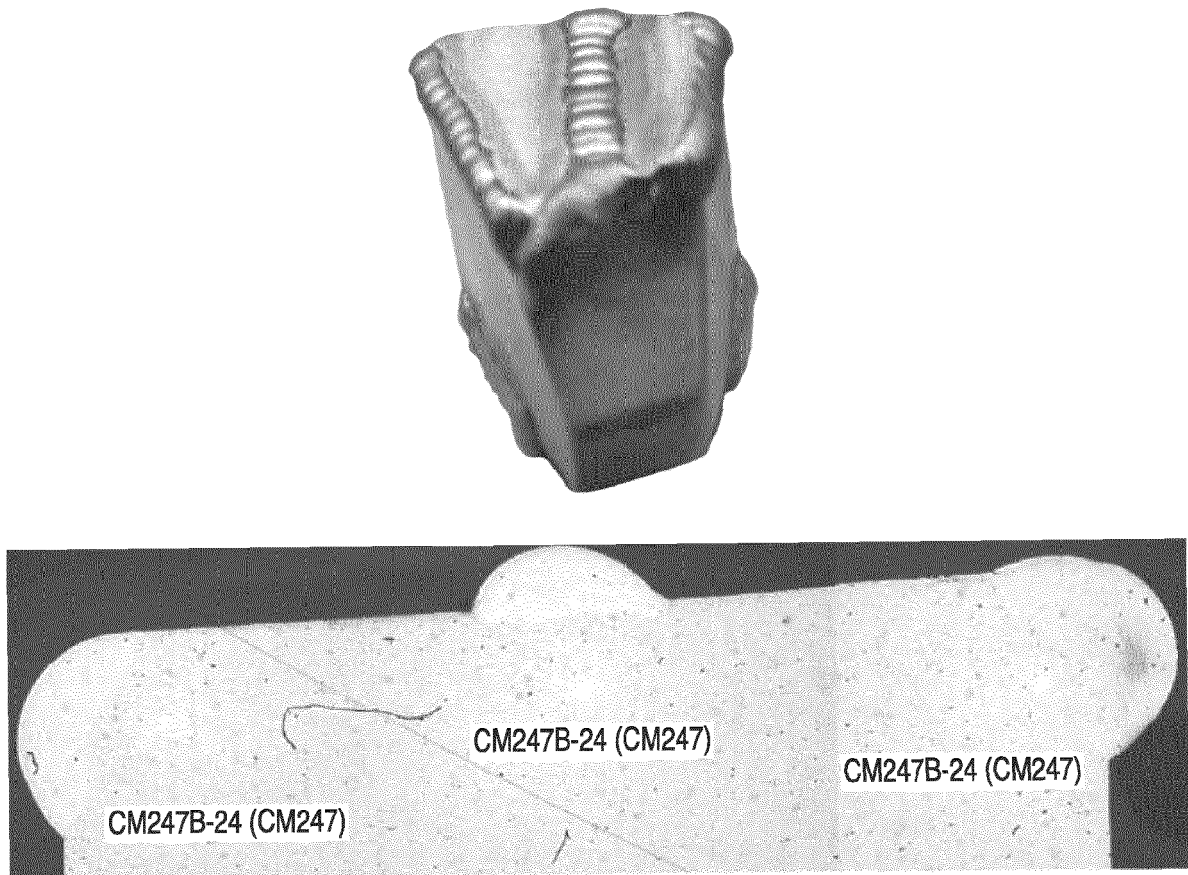
FIG. 31

Fig. 31: Perspective and cross sectional photomicrograph following a solution heat treat cycle (2250 deg. F) after completion of the braze furnace cycle to evaluate the affect on the braze of possible normal repair processes following brazing of CM247/BRB on a CM247 substrate with IN625 filler material;

**[0053]** An evaluation was done on CM247/BRB (Example B-24) to observe the effect of a post braze weld repair using IN625 filler material. The test was completed after a post weld solution cycle. However, no age heat treat was performed. No cracks were observed at the interface or surrounding areas, and the welder performing the work reported that this weld seemed to be similar to that of a weld of the base alloy. See Fig. 31.

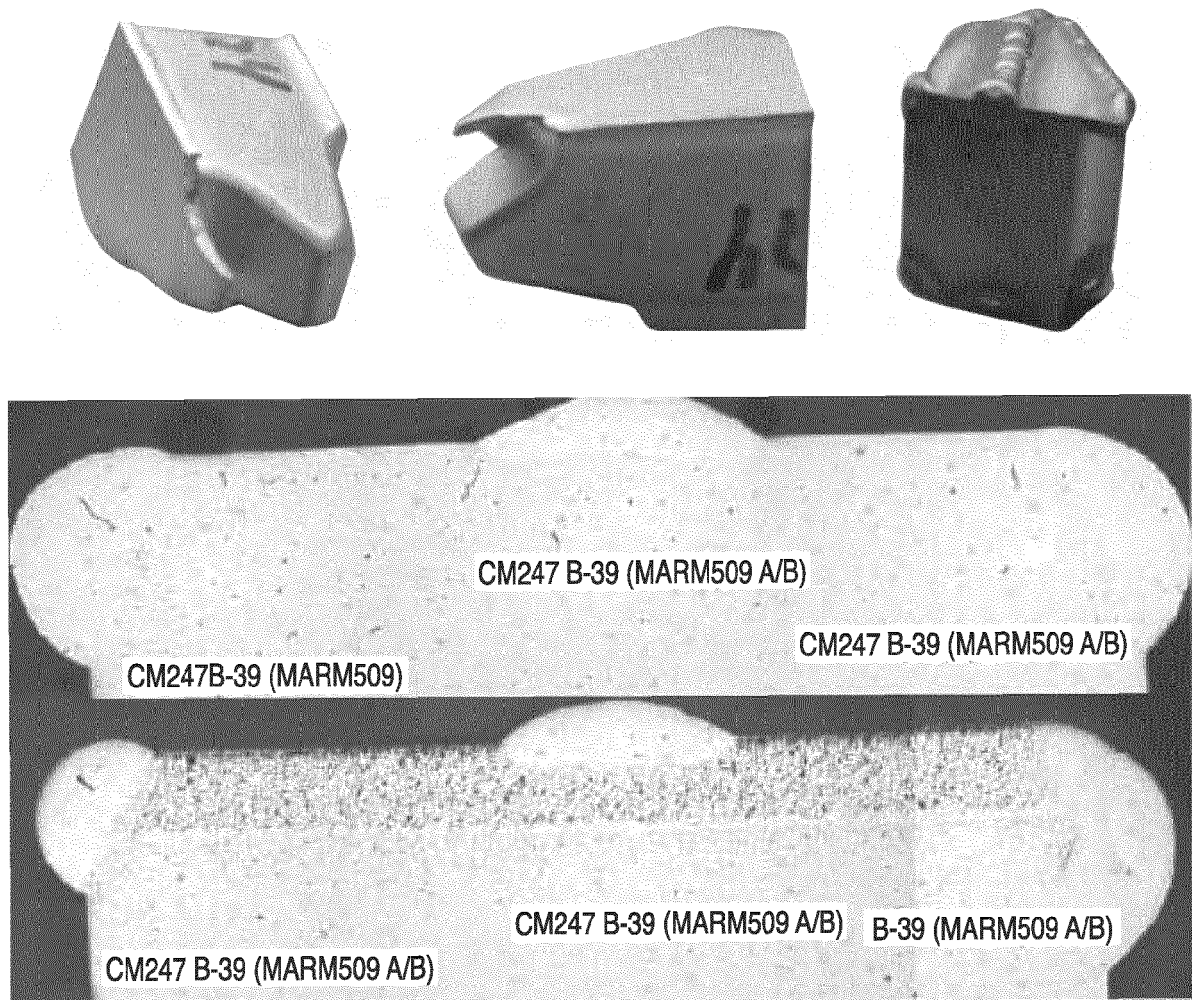
FIG. 32

Fig. 32: Photomicrograph following a solution heat treat cycle (2250 deg. F) after completion of the braze furnace cycle to evaluate the affect on the braze of possible normal repair processes following brazing of MarM509A/B on a CM247 substrate with IN625 filler material. In the drawings and in the specification, "MarM509 or "509" is an abbreviation of MarM509A or 509A respectively; and

**[0054]** An evaluation was done on MarM509/A/B (Example B-39) to observe the effect of a post braze weld repair using IN625 filler material. The test was completed after a post weld solution cycle. However, no age heat treat was performed. No cracks were observed at the interface or surrounding areas, and the welder performing the work reported that this weld seemed to be similar to that of a weld of the base alloy. See Fig. 32. Therefore, the 70/30 mixture is considered to be advantageous on the basis of the following tests and/or observations:
