**EP 3 401 268 A1**

**EUROPEAN PATENT APPLICATION**

(54) **DIAGNOSTIC STEP FOR A PASSENGER CONVEYOR**

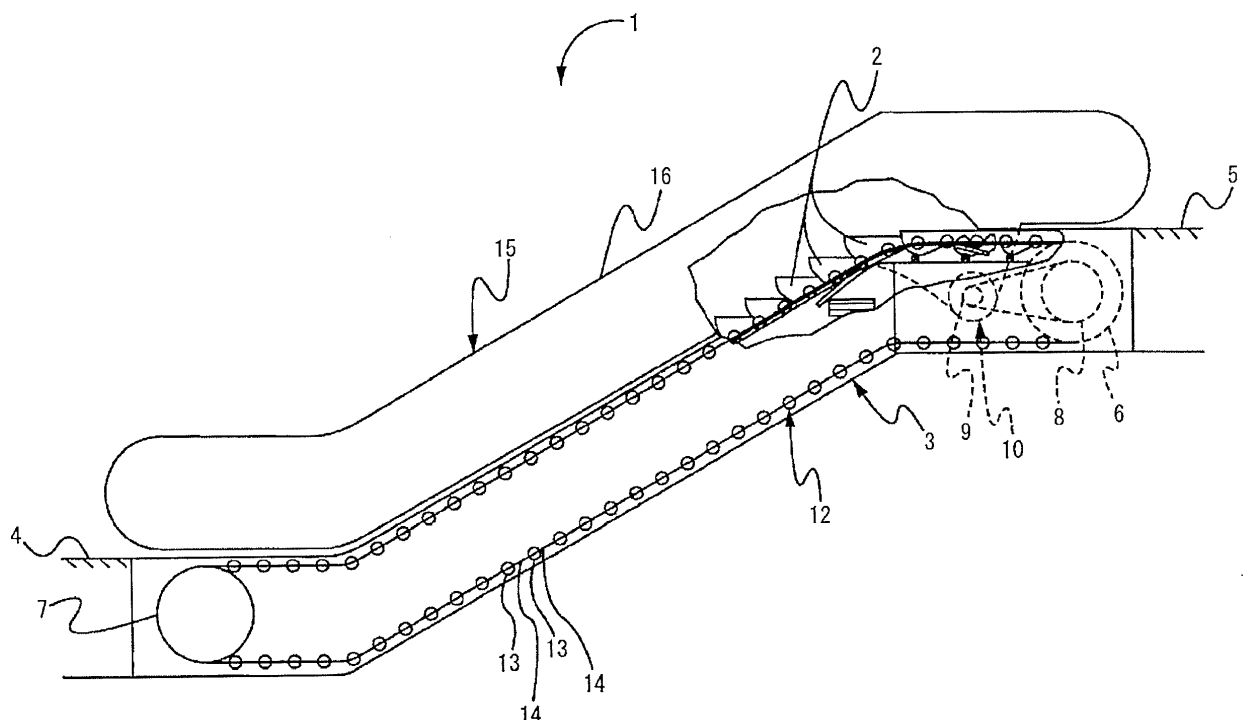
**Fig. 1**

(57) A diagnostic step for a passenger conveyor comprises at least one camera for shooting at least one lateral side of the interior space of the passenger conveyor, at least one directional microphone pointed to said at least one lateral side of the interior space of the pas-

senger conveyor and an analyzer unit which receives image data from the camera and sound data from the directional microphone and transmits the data to an outside network.

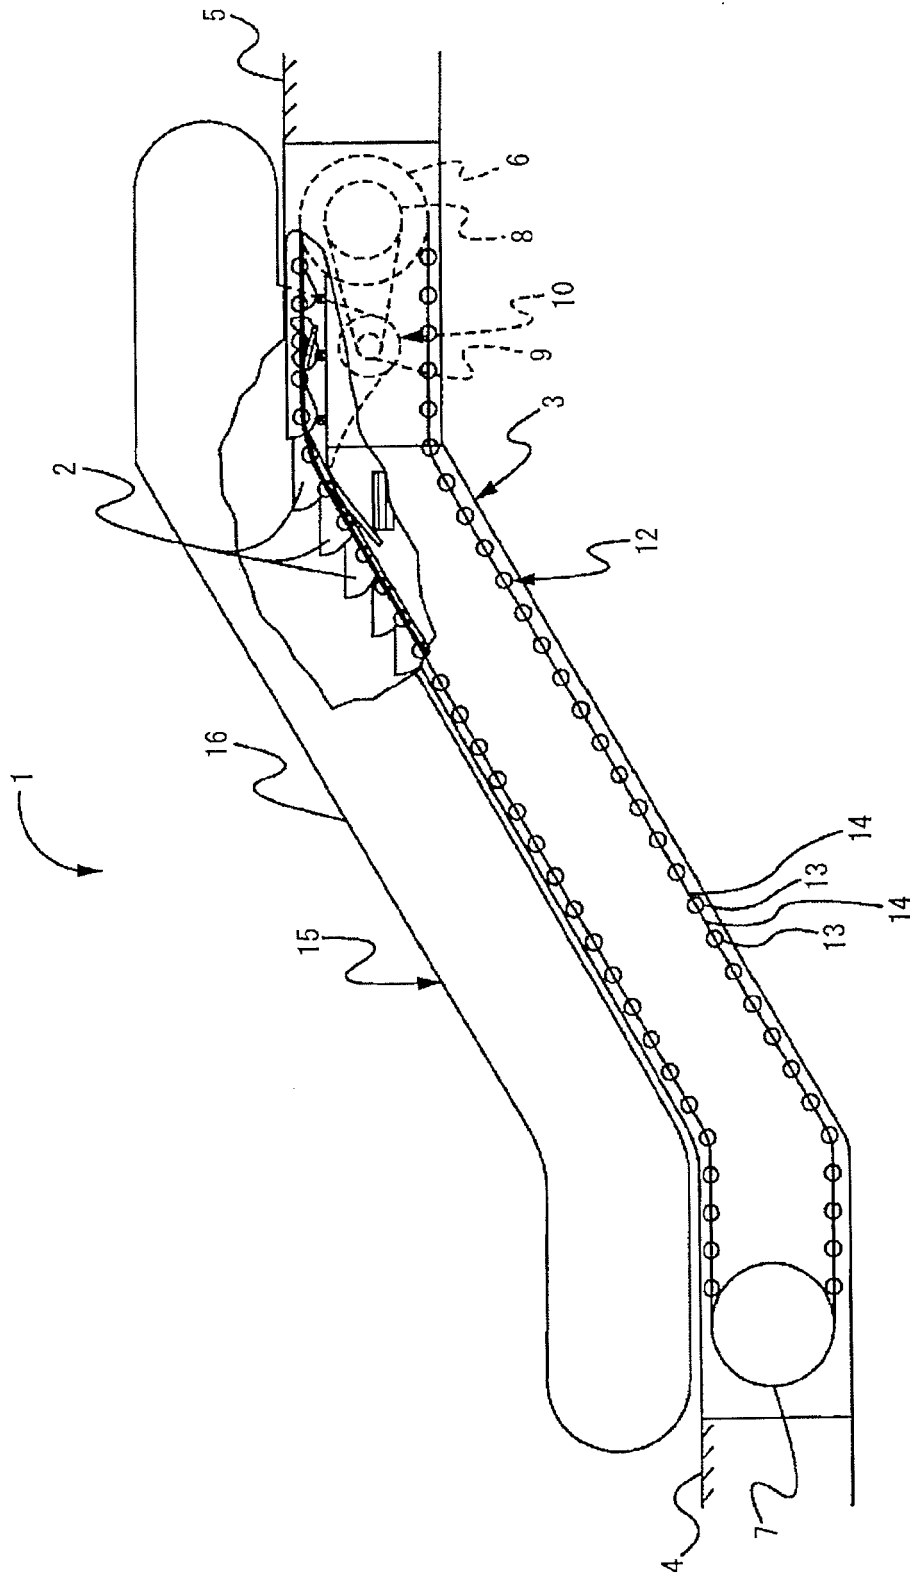
Fig. 1 is a cross-sectional diagram of an escalator.

**[0022]** Fig. 1 schematically shows a passenger conveyor 1 in which the diagnostic device of the present invention may be used. In this example, the passenger conveyor 1 is an escalator including a plurality of escalator steps 2 that travel around a loop for carrying passengers between landings at different levels within a building.

**[0023]** The example passenger conveyor 1 of Fig. 1 comprises a truss 3 installed between a lower landing 4 and an upper landing 5. A first sprocket wheel 6 is rotatably supported at an upper end of the truss 3 and a second sprocket wheel 7 is rotatably supported at a lower end of the truss 3. A drive system (not shown) rotates the first sprocket wheel 6 as well as a handrail drive sprocket 8. The handrail drive sprocket 8 is coupled to a pulley 9 which forms part of a handrail drive system 10.

**[0024]** The escalator steps 2 are coupled to a step chain 12 which may include a plurality of rollers 13 connected by a plurality of links 14. The step chain 12 and the escalator steps 2 are driven by the drive system via the first sprocket wheel 6. A typical step chain 12 includes a pair of parallel endless loops on both lateral sides of the escalator steps 2. The loops are connected together by transverse axles (not shown) that pass between and help support the escalator steps 2. Thus, while only a single loop is illustrated in Fig. 1, it will be understood that the escalator includes dual loops, and each step chain 12 is driven around respective sprocket wheels 6, 7 positioned in the interior space of the truss 3 on each lateral side thereof.

**[0025]** An endless handrail 15 passes around a balustrade assembly 16. While only a single handrail 15 is illustrated in Fig. 1, it will be understood that a pair of endless handrails 15 are supported on a respective bal-

ustrade assembly 16 on both lateral sides of the escalator steps 2 and are each driven by a respective handrail drive system 10 positioned in the interior space of the truss 3 on each lateral side thereof.

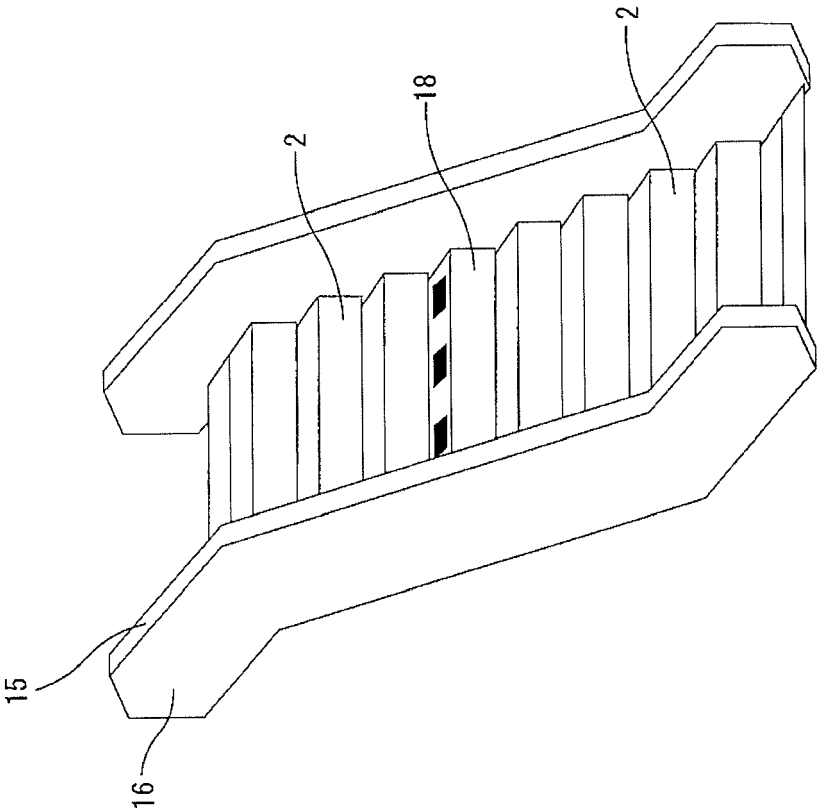
Fig. 2 is a schematic view of an escalator with the

diagnostic step of the present invention installed thereon.

**[0026]** Fig. 2 shows an example diagnostic device 18 of the present invention in the form of a step. The diagnostic step 18 may be simply installed on the escalator during maintenance or repair by removing a single escalator step 2 and attaching the diagnostic step 18 in place of the removed escalator step 2.

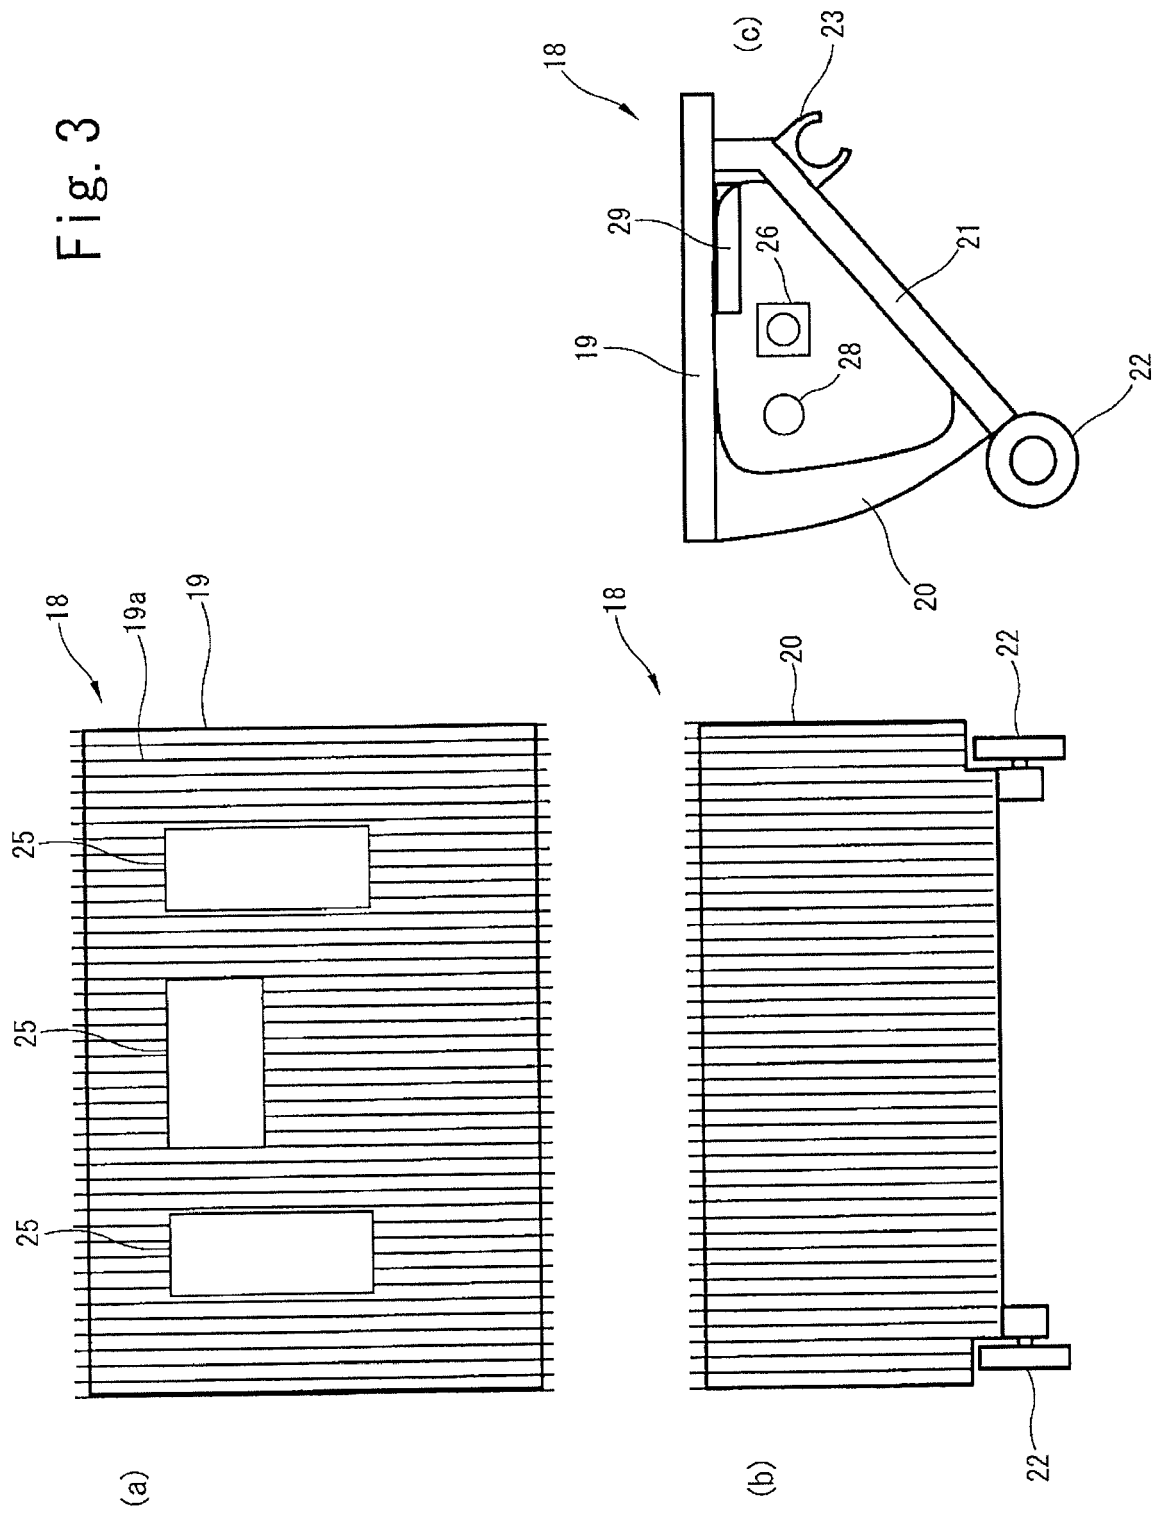
Fig. 3

Fig. 3(a) is a plan view, Fig. 3(b) is a front view and Fig. 3(c) is a side view of the diagnostic step of Fig. 2.

**[0027]** As shown in Fig. 3, the diagnostic step 18 may have a configuration which resembles escalator step 2 and includes a tread portion 19 joined to a riser portion 20 and step arms 21 (only one shown in Fig. 3) connecting the tread portion 19 to the riser portion 20 as known in the art. The step arms 21 are connected to each other by an axle 24 (Fig. 4) and may each comprise rollers 22 on one end for riding on a rail and support members 23 on the other end for engaging a transverse axle such that the diagnostic step 18 may be driven around the loop together with the escalator steps 2 when it is installed on the escalator. Fig. 3(a) shows a plan view, Fig. 3(b) shows a front view and Fig. 3(c) shows a side view of the diagnostic step 18.

**[0028]** The outer surface 19a of the tread portion 19 corresponds to the surface of escalator step 2 which receives the foot of a passenger and faces generally upward during the advance path. The tread portion 19 includes at least one maintenance window 25 (three in this example) for access to the inner side of the diagnostic step 18.

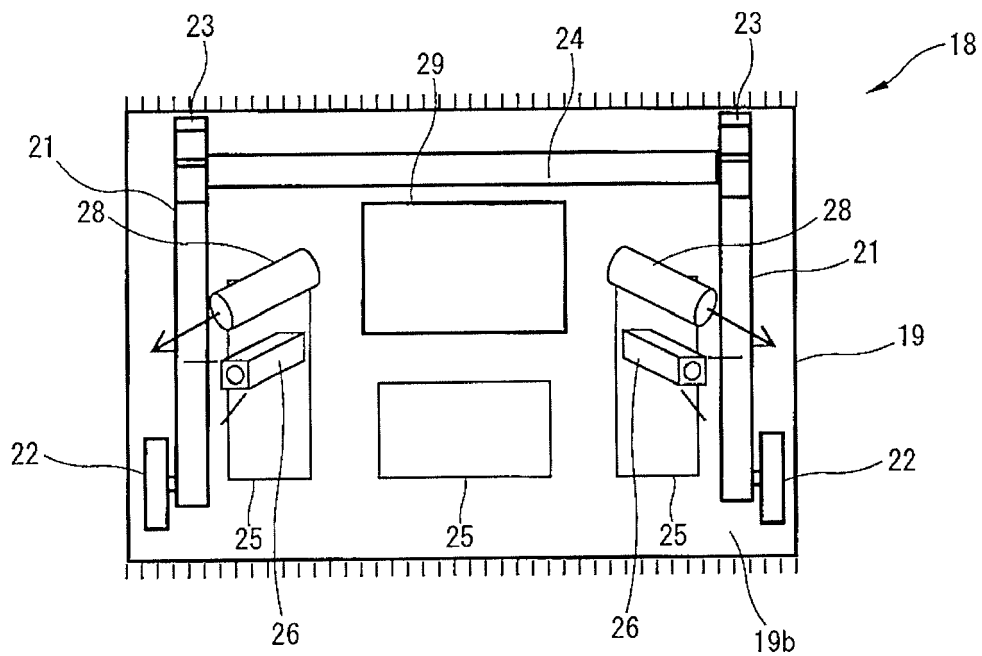
Fig. 4 is a bottom view of the diagnostic step of Fig. 2.

**[0029]** The diagnostic step 18 includes at least one camera 26, at least one directional microphone 28 and an analyzer unit 29 in the space defined by the tread portion 19, riser portion 20 and step arms 21. In the embodiment shown in Fig. 4, the diagnostic step 18 includes two cameras 26 and two microphones 28. Each camera 26 may be attached to the inner surface 19b of the tread portion 19 such as by brackets and may be adjustable to shoot different directions. Each camera 26 may include a LED light. In this embodiment, one camera is adjusted to shoot one or a plurality of components positioned on one lateral side (ex. the left-hand side of Fig. 2) and one camera is adjusted to shoot one or a plurality of components positioned on the other lateral side (ex. the right-hand side of Fig. 2) of the interior space of the truss 3. The directional microphones 28 may also be attached to the inner surface 19b of the tread portion 19 such as by brackets and may be adjustable to point to different directions. In this embodiment, one microphone 28 is adjusted to point to one or a plurality of components on the right-hand side and one microphone 28 is adjusted to point to one or a plurality of components positioned on the left-hand side of the interior space of the truss 3.

**[0030]** In this way, the cameras 26 and the microphones 28 may collect images or sounds of components positioned on the left-hand side and on the right-hand side separately. Such components may include compo-

nents such as the handrail drive system 10 or sprocket wheels 6, 7. The cameras 26 and the microphones 28 may be adjusted through the maintenance windows 25 after installing the diagnostic step 18 onto the escalator.

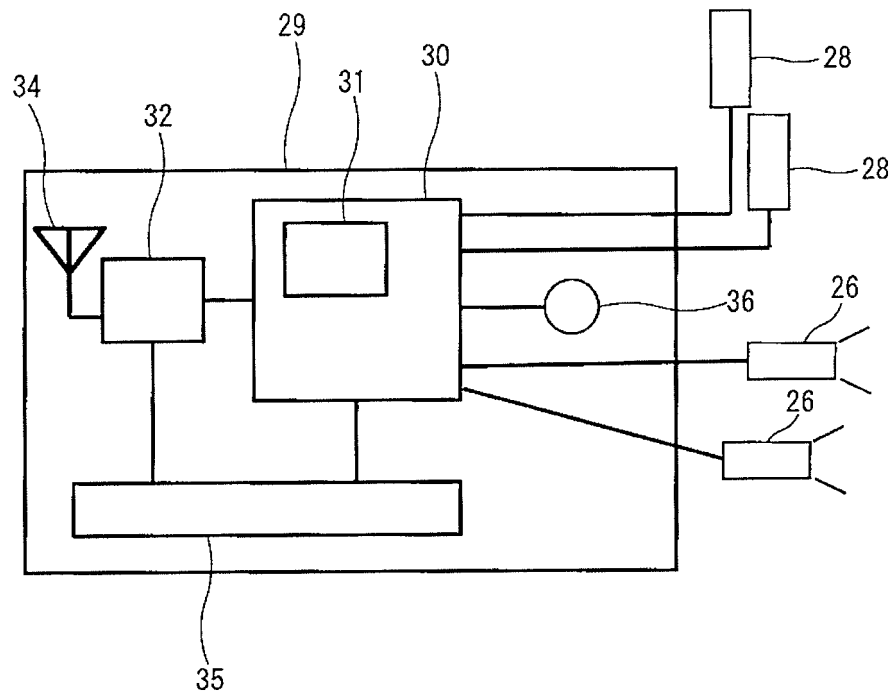
Fig. 5 is a detailed view of the analyzer unit of Fig. 4.

**[0031]** The analyzer unit 29 may be attached to the inner surface 19b of the tread portion 19. A detailed view of the analyzer unit 29 is shown in Fig. 5. The analyzer unit 29 may comprise a printed-circuit board 30 including a memory 31, a wireless network interface device 32 such as a 3G modem, WiFi interface etc. including an antenna 34 and a battery 35 for providing power to all of the components included in the diagnostic step 18. The directional microphones 28 and cameras 26 are connected to the printed-circuit board 30 to provide sound data and image data. An acceleration sensor 36 may also be connected to the printed-circuit board to provide acceleration data. The printed-circuit board 29 receives the analog data or digital data from the cameras 26, microphones 28 and sensor 36, converts analog data to digital data as necessary and stores such data in the memory 31. The sound data and image data are synchronized. The printed-circuit board 29 may further analyze such data. Data and analyzed results may be provided to a wireless network 38 (figures 7 to 9) via the wireless network interface device 32.

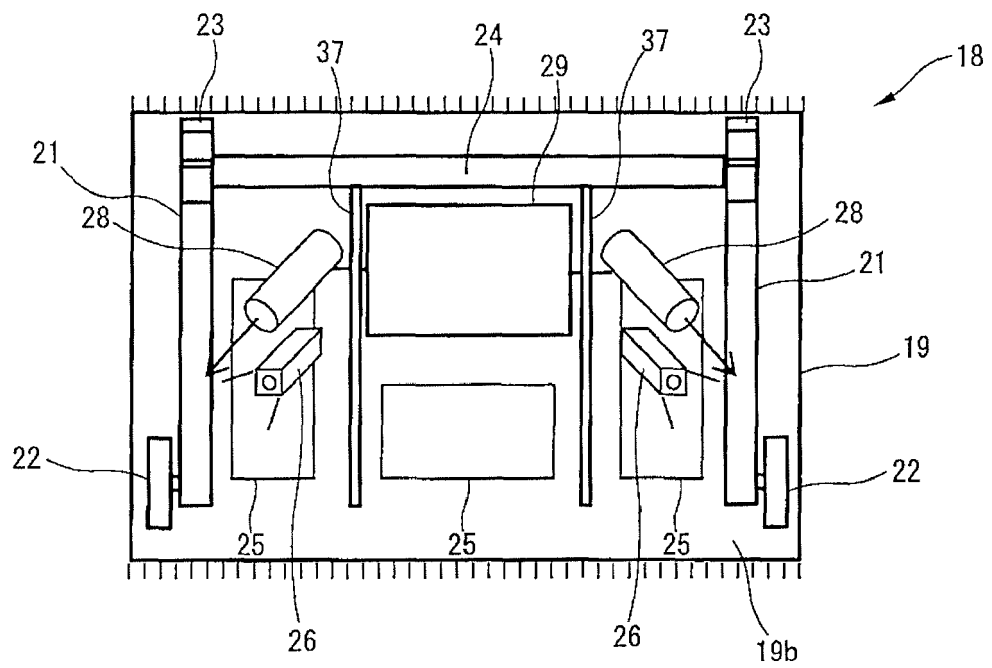
Fig. 6 is a bottom view of another embodiment of the diagnostic step of the present invention.

**[0033]** Fig. 6 shows a further embodiment in which partitions 37 are provided on the inside surface 19b of the tread portion 19 to separate sounds emanating from the right-hand side of the truss and sounds emanating from the left-hand side of the truss to allow a more precise collection of sounds. Two partitions 37 are provided in this embodiment. However, one partition 37 may be sufficient to separate sounds in other embodiments.

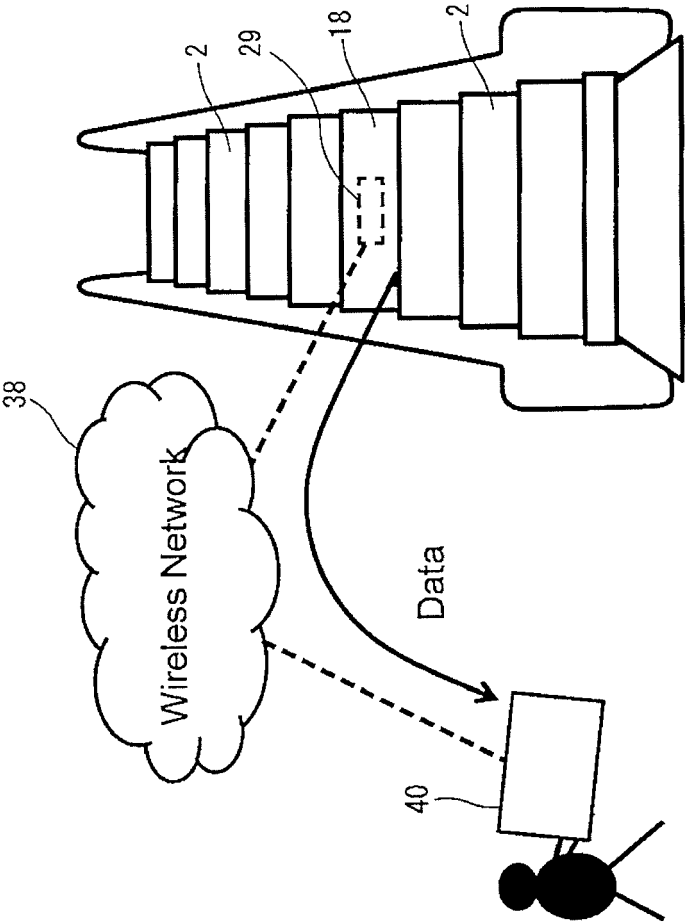
Fig. 7 is a schematic view of a wireless network connecting the analyzer unit and a personal computer.

**[0034]** With reference to Fig. 7, data may be transmitted to a personal computer 40 which may be in the form of a tablet, smart phone etc. via the wireless network 38. A service engineer may listen to the sounds emanating from the left-hand side of the truss 3 while viewing the corresponding image of the components positioned on the left-hand side of the truss 3 causing the sounds. The sounds and image may be switched to the right-hand side after checking the left-hand side. This allows the service engineer to easily find out which components, components positioned on the left-hand side or components positioned on the right-hand side, are causing abnormal sounds, in spite of sound reverberations inside the truss 3 and also allows the service engineer to visually check the components causing the abnormal sounds at the same time. This greatly shortens the time to determine the cause of failure or malfunctions associated with the escalator and does not require stopping the escalator and gaining access to the space beneath the escalator

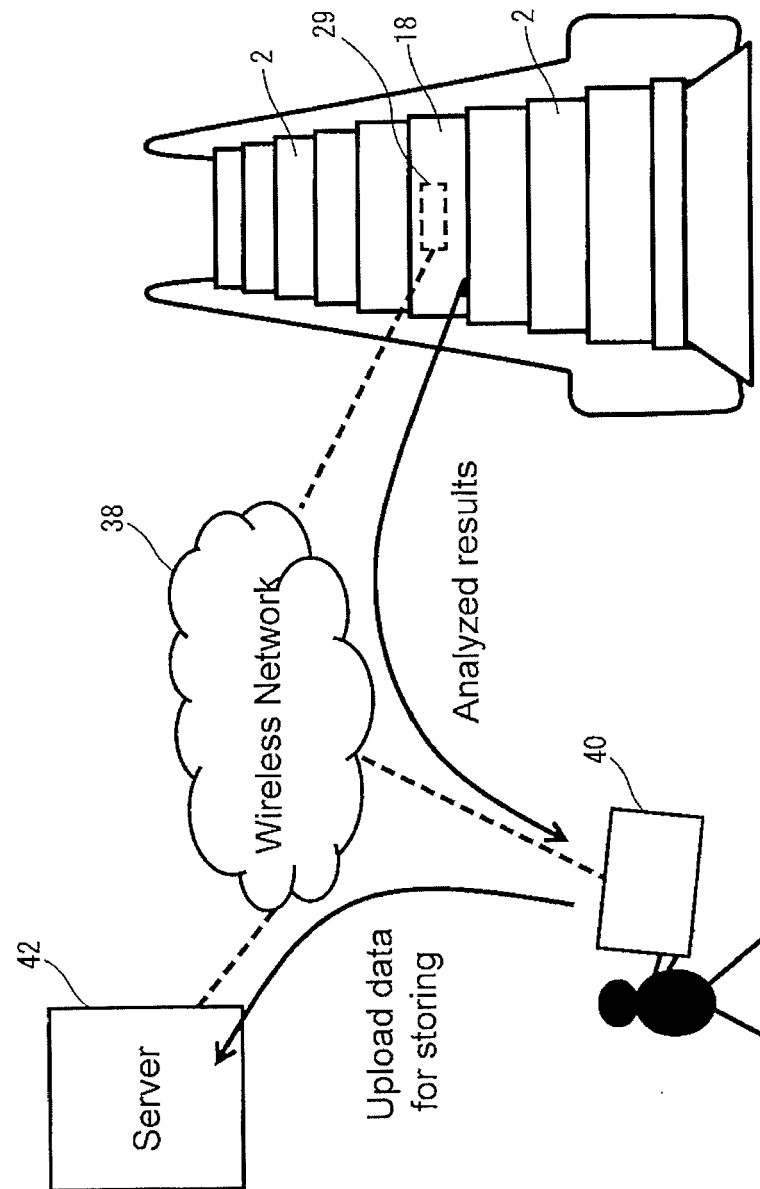
Fig. 8 is a schematic view of a wireless network connecting the analyzer unit, a personal computer and a server.

**[0035]** Fig. 8 shows another embodiment in which the analyzer unit 29 analyzes data from the microphone 28, camera 26 and/or sensor 36 and the analyzed results are transmitted to the personal computer 40 of the service engineer. The analyzed results may include the detection of abnormal sounds with corresponding images and may allow the service engineer to immediately determine the cause of failure or malfunctions associated with the escalator. The service engineer may upload such results to a server 42 for storage. The server 42 may be remote from the site and the stored data may be used for preventive maintenance. This process is carried out via a wireless network 38.

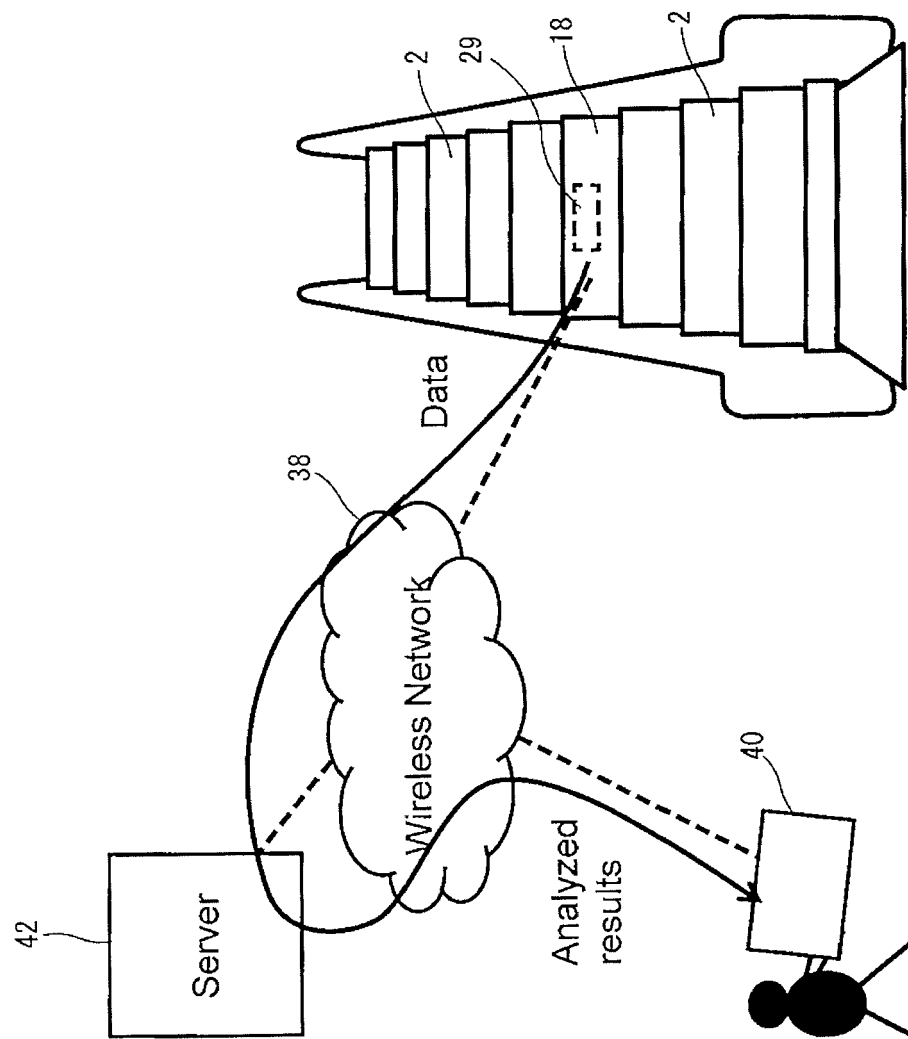
Fig. 9 is a schematic view of another example wireless network connecting the analyzer unit, a personal computer and a server.

**[0036]** Fig. 9 shows a further embodiment in which data and/or analyzed data is transmitted to a server 42. The server 42 may be remote from the site. The data is stored and may be further analyzed in the server 42. The stored data may be used for preventive maintenance. The server 42 may provide the further analyzed results to the personal computer 40 of the service engineer. This process is also carried out via a wireless network 38.
