EP 3 480 042 A1

(54) **VEHICLE DOOR AND METHOD OF PRODUCTION OF VEHICLE DOOR**

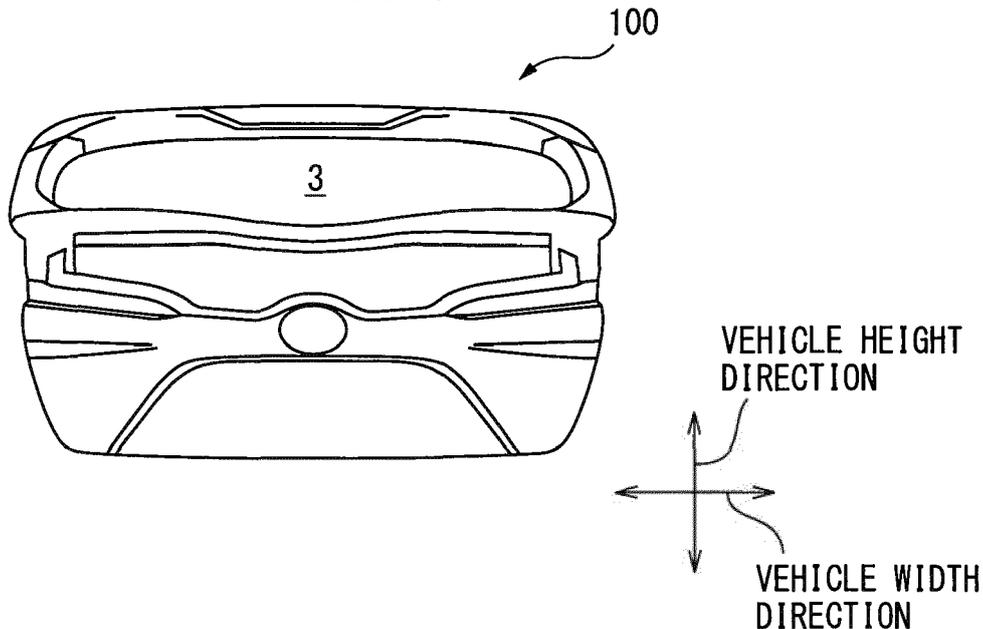
FIG. 1

(57) A vehicle door 100 comprising a first panel 1 and a second panel 2 bonded to a panel bonding part 11 of the first panel 1, wherein the first panel 1 is provided with a plurality of ribs 13, sticking out from the panel bonding part 11 so as to cross the adhesive coated on the first panel 1 or the second panel 2, along the coating direction of the adhesive, and each rib 13 is provided with a

non-visible part 131 which is bonded to the second panel 2 and which is covered by the second panel 2 and can no longer be viewed from the outside and a visible part 132 which extends from the non-visible part 131 in a direction crossing the adhesive and which is not covered by the second panel 2 and can be viewed from the outside.

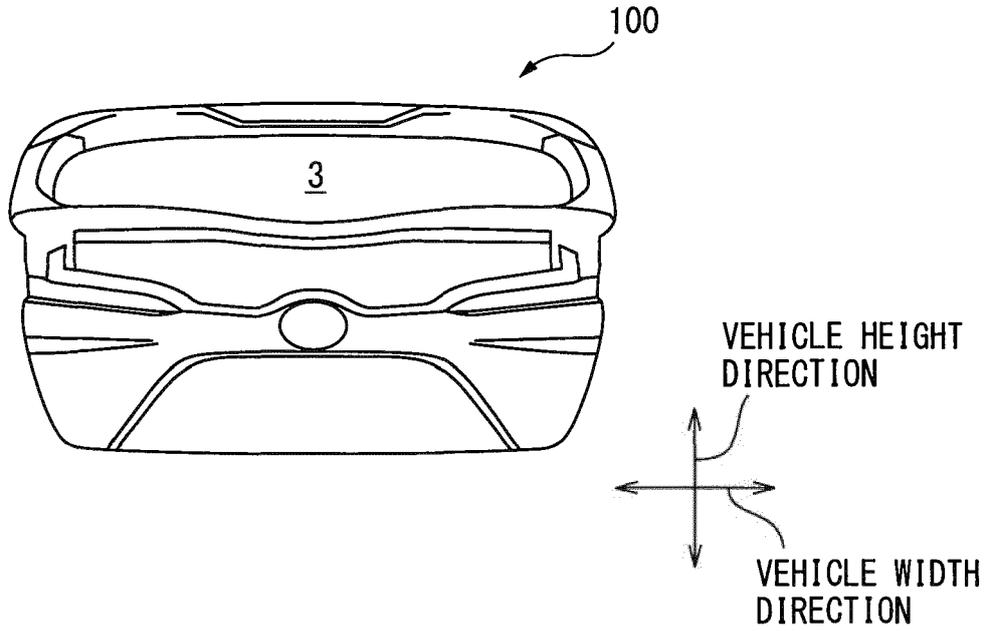
[FIG. 1] FIG. 1 is a front view of a vehicle door according to one embodiment of the present disclosure.

[0012] FIG. 1 is a front view of a vehicle door 100 according to one embodiment of the present disclosure.

[0013] A vehicle door 100 according to the present embodiment is a liftgate type back door attached to the body of a vehicle at its rear side and opening and closing up and down in the vehicle height direction about the vehicle width direction as the axial direction.

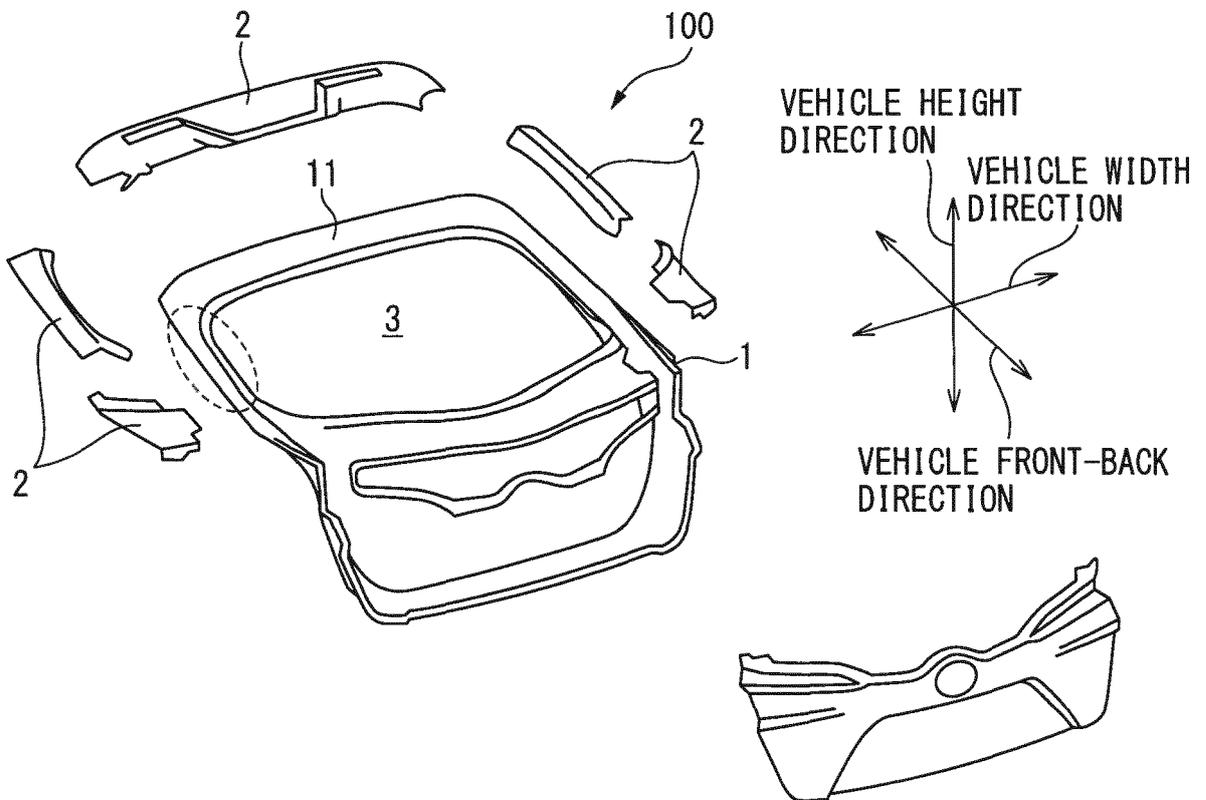
[FIG. 2] FIG. 2 is a disassembled perspective view of a vehicle door.

[0014] FIG. 2 is a disassembled perspective view of a vehicle door 100.

[0015] As shown in FIG. 2, the vehicle door 100 is provided with an inner panel 1 and outer panels 2. Note that FIG. 2 illustrates five outer panels 2. In explaining the main parts of the disclosure, these do not have to be particularly differentiated, so below for convenience in explanation, the outer panels 2 will not be particularly differentiated in the explanation.

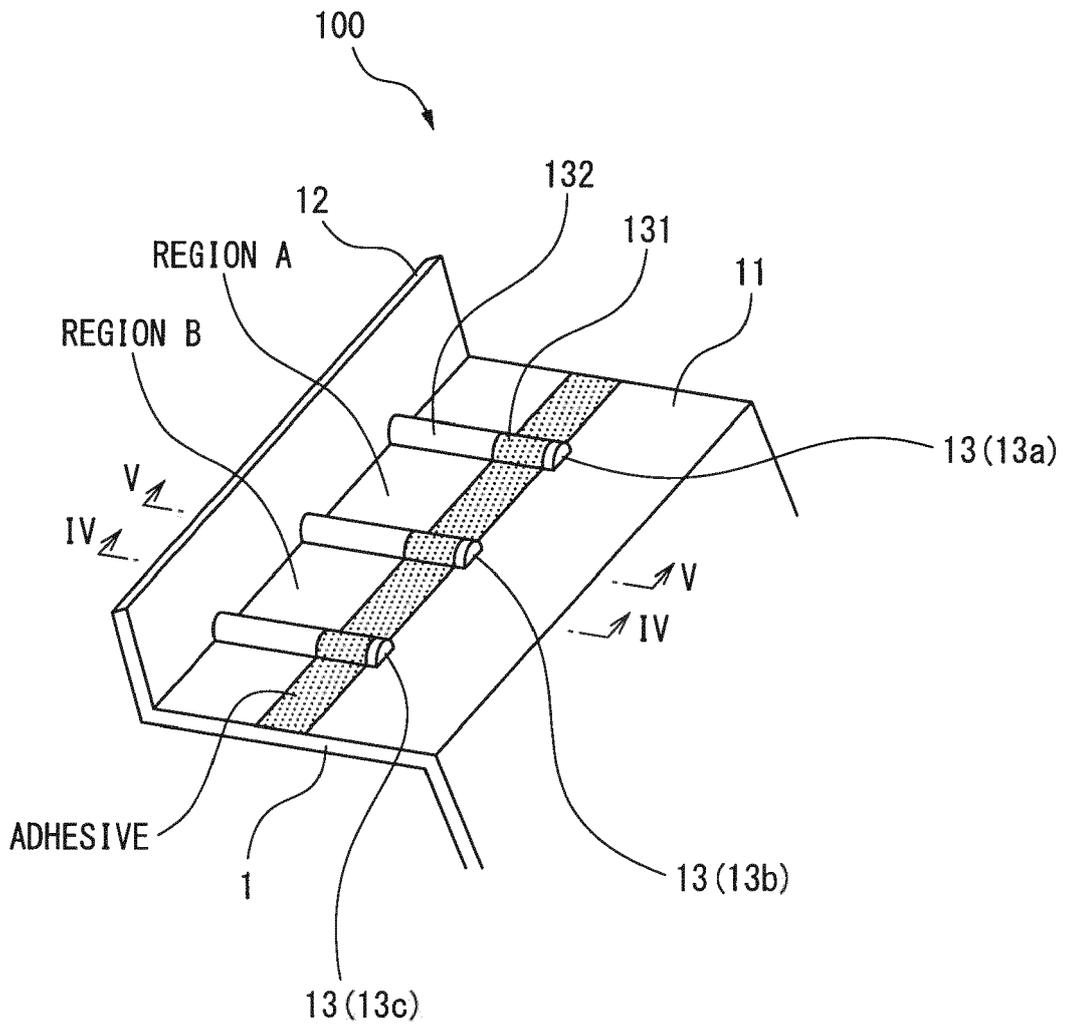
[FIG. 3] FIG. 3 is a view showing simplified a peripheral edge part of an inner panel of a vehicle door according to the present embodiment and showing the part surrounded by broken lines in FIG. 2.

[0027] FIG. 3 is a view showing simplified the peripheral edge part 11 of the inner panel 1 of the vehicle door 100 according to the present embodiment and partially shows the part surrounded by broken lines in FIG. 2.

[0028] As shown in FIG. 3, the peripheral edge part 11 of the inner panel 1 of the vehicle door 100 according to the present embodiment is formed with a flange 12 and ribs 13.

[0029] The flange 12 is a wall-shaped portion sticking out from the surface of the peripheral edge part 11 so as to extend substantially in parallel to the coating direction of the adhesive along the outer edge of the peripheral edge part 11.

[0030] The ribs 13 are portions which stick out in line shapes from the surface of the peripheral edge part 11 so that parts (non-visible parts 131 explained later) cross the adhesive coated on the surface of the peripheral edge part 11, or the facing surface of the outer panel 2 facing the peripheral edge part 11. A plurality are formed at constant intervals in the coating direction. In the present embodiment, the ribs 13 are formed so as to extend in line shapes in a direction perpendicular to the coating direction of the adhesive. Further, the ribs 13 extend up to the outer edge side of the peripheral edge part 11 so that a repair worker can view the parts not crossing the adhesive (visible parts 132 explained later) from the outside even after bonding the outer panel 2 and are formed so

[0036] For example, if referring to the three ribs 13 illustrated in FIG. 3 as the first rib 13a, second rib 13b, and third rib 13c for convenience in explanation, the clearance between panels formed after bonding the outer panel 2 can be divided into the region A formed sectioned off at the outer edge side of the peripheral edge part 11 by the first rib 13a and the second rib 13b and the adhesive and the region B formed sectioned off at the outer edge side of the peripheral edge part 11 by the second rib 13b and the third rib 13c and the adhesive.

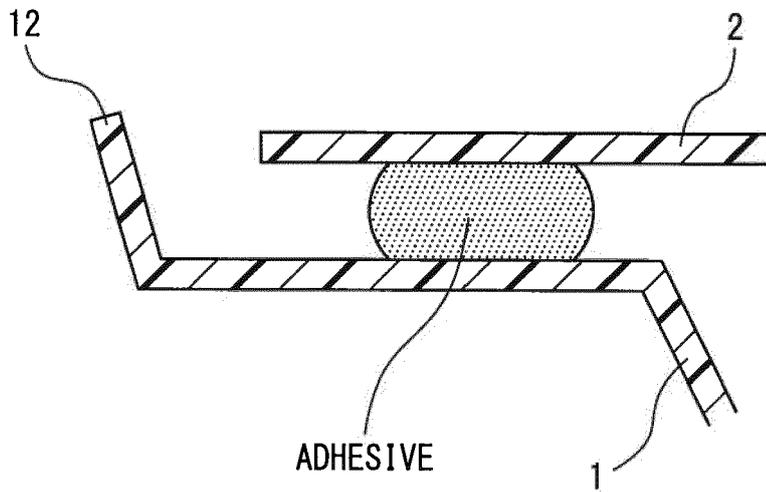
[FIG. 4] FIG. 4 is a cross-sectional view of a vehicle door according to the present embodiment along the line IV-IV of FIG. 3 in the state with the outer panel bonded.

[0031] FIG. 4 is a cross-sectional view of the vehicle door 100 according to the present embodiment along the line IV-IV of FIG. 3 in the state with an outer panel 2 bonded. FIG. 5 is a cross-sectional view of the vehicle door 100 according to the present embodiment along the line V-V of FIG. 3 in the state with the outer panel 2 bonded.

[0033] Further, as shown in FIG. 4, at a part where no rib 13 is formed, the clearance between the peripheral edge part 11 of the inner panel 1 and the outer panel 2 is sealed by an adhesive. Further, as shown in FIG. 5, at a part where a rib 13 is formed, the clearance between the rib 13 and the outer panel 2 is sealed by an adhesive.

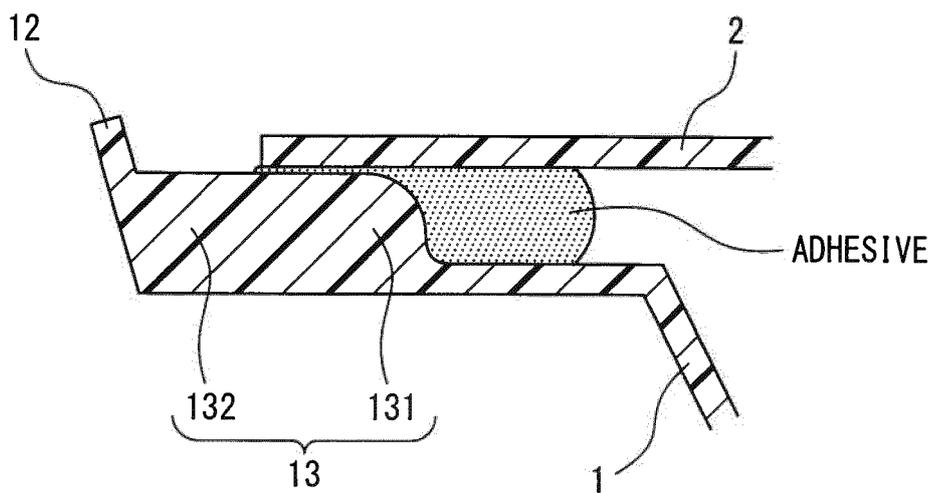
[FIG. 5] FIG. 5 is a cross-sectional view of a vehicle door according to the present embodiment along the line V-V of FIG. 3 in the state with the outer panel bonded.

[0032] As shown in FIG. 5, the outer panel 2 is bonded to the inner panel 1 so that the part of a rib 13 not crossing the adhesive (portion extending up to outer edge side of peripheral edge part 11, that is, later explained visible part 132) can be viewed by a repair worker from the outside even after bonding the outer panel 2.

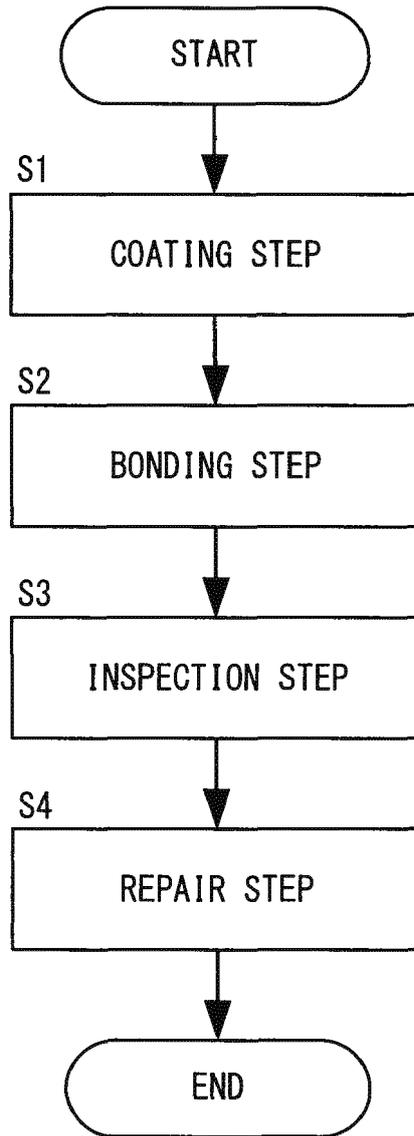
[FIG. 9] FIG. 9 is a flow chart for explaining a method of production of a vehicle door according to the present embodiment.

[0041] Next, the method of production of the vehicle door 100 according to the present embodiment will be explained. FIG. 9 is a flow chart for explaining the method of production of the vehicle door 100 according to the present embodiment.

[0042] At a coating step of step S1, the peripheral edge part 11 is coated with an adhesive so as to cross parts of the ribs 13 formed at the peripheral edge part 11 of the window-use opening 3 of the inner panel 1 (non-visible parts 131). Alternatively, the adhesive is coated at the facing surface of the outer panel 2 forming the part facing the peripheral edge part 11 at which the ribs 13 are formed.

[0043] At the bonding step of step S2, when the peripheral edge part 11 of the inner panel 1 is coated with the adhesive at step S1, the peripheral edge part 11 is bonded with the outer panel 2 so that the parts of the ribs 13 not crossing the adhesive (visible parts 132) can be seen from the outside. On the other hand, when the facing surface of the outer panel 2 is coated with the adhesive at step S1, the outer panel 2 is bonded with the peripheral edge part 11 so that the adhesive crosses the ribs 13 and parts of the ribs 13 (visible parts 132) can be viewed

[0044] At the inspection step of step S3, any water leakage from the clearance between the inner panel 1 and the outer panel 2 divided by the ribs 13 into a plurality of regions along the coating direction of the adhesive is inspected for. If water leakage is confirmed, the routine proceeds to step S4.

[0045] At the repair step of step S4, the region where water leakage is confirmed in the plurality of regions of the clearance between panels divided by the ribs 13 is repaired. Specifically, water leakage is repaired by recoating a repair-use adhesive along the entrance to the clearance between panels from the visible part 132 of the one rib 13 of adjoining ribs 13 defining the region where water leakage is confirmed to the visible part 132 of the other rib 13.

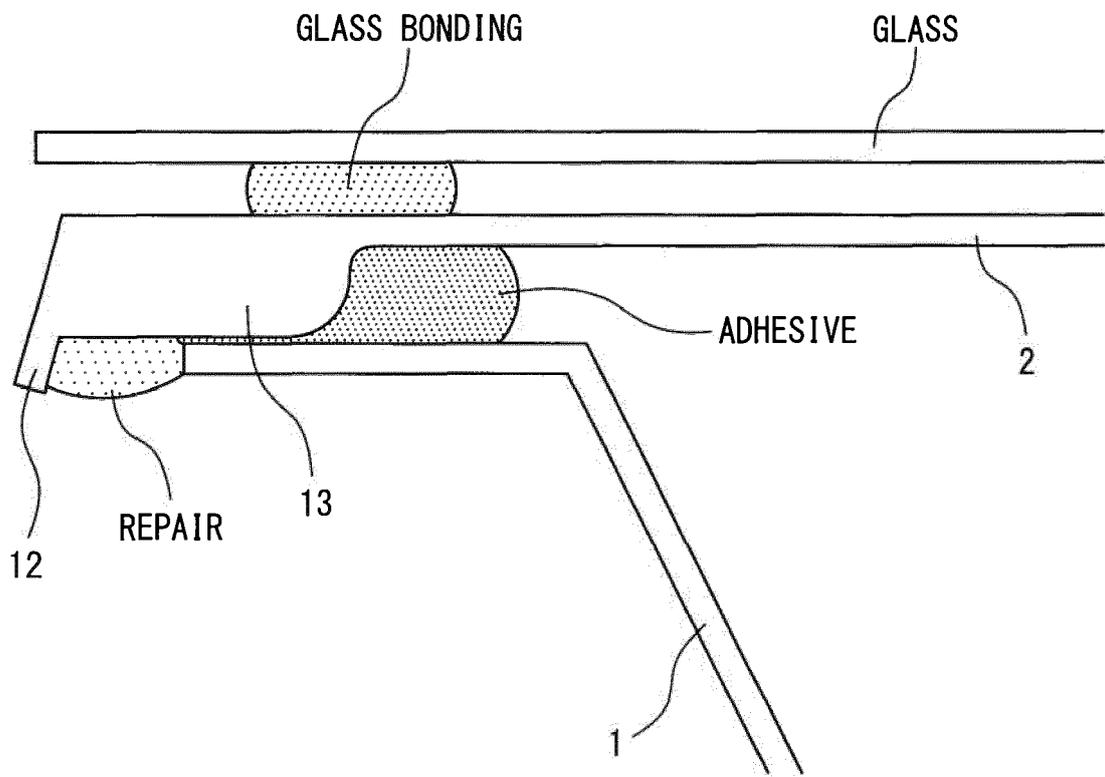
[FIG. 10] FIG. 10 is a view showing simplified a peripheral edge part of an inner panel of a vehicle door according to a modification of one embodiment of the present disclosure.

[0058] For example, in the above embodiments, the inner panel 1 was formed with the flange 12 and ribs 13. However, like in the vehicle door 100 according to the modification of the present embodiment shown in FIG. 10, it is also possible to form the flange 12 and ribs 13 at the outer panel 2 and bond the outer panel 2 to the inner panel 1. By doing this as well, it is possible to obtain an effect similar to the present embodiment. Note that, in this case, in the claims, the first panel is the outer panel 2 and the second panel is the inner panel 1.

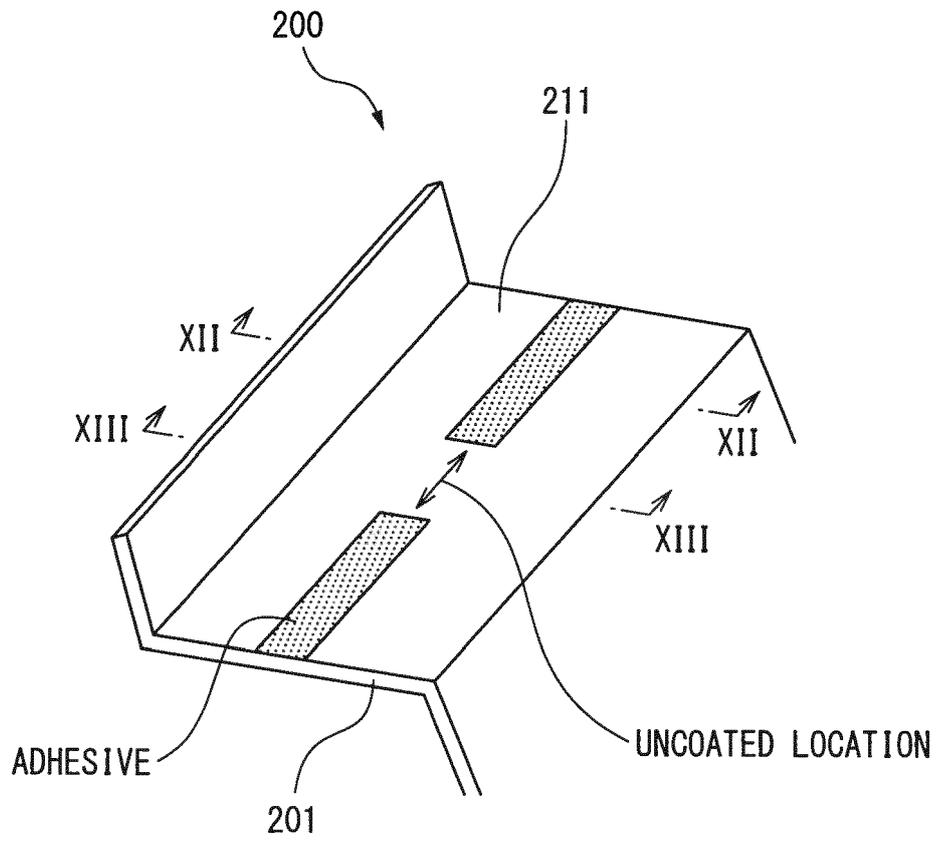
[FIG. 11] FIG. 11 is a view showing simplified a peripheral edge part of an inner panel of a vehicle door according to a comparative example different from the embodiment of the present disclosure.

[0019] FIG. 11 is a view showing simplified a peripheral edge part 211 of an inner panel 201 of a vehicle door 200 according to a comparative example different from the present embodiment and shows the part corresponding to the part surrounded by the broken line in FIG. 2. FIG. 12 is a cross-sectional view of the vehicle door 200 according to the comparative example along the line XII-XII of FIG. 11 in the state when bonding an outer panel 202. FIG. 13 is a cross-sectional view of the vehicle door 200 according to the comparative example along line XIII-XIII of FIG. 11 in the state when bonding the outer panel 202.

[0020] If bonding the outer panel 202 to the peripheral edge part 211 of the inner panel 201, for example, as shown in FIG. 11, the peripheral edge part 211 of the inner panel 201 is coated with the adhesive along the peripheral direction of the peripheral edge part 211 or the facing surface of the outer panel 202 facing the peripheral edge part 11 is coated with the adhesive. The adhesive is coated for example by discharging from a nozzle the adhesive pumped in through piping.

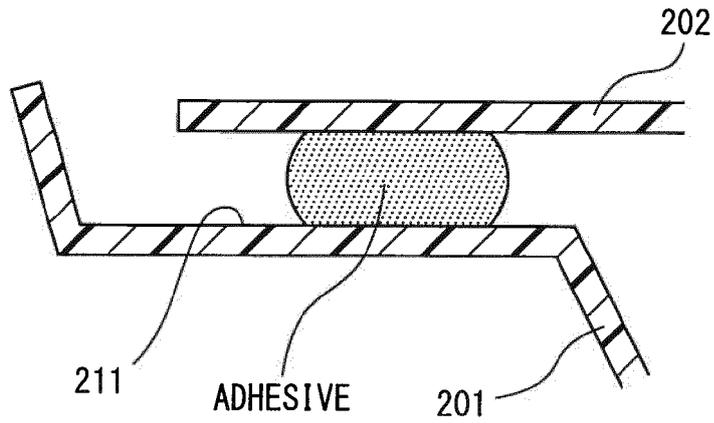
[FIG. 12] FIG. 12 is a cross-sectional view of a vehicle door according to a comparative example along line XII-XII of FIG. 11 in the state when bonding the outer panel.

[0022] As shown in FIG. 12, the adhesive performs the role as a seal for sealing the clearance formed between the inner panel 201 and the outer panel 202 after curing (below, referred to as the "clearance between panels") and preventing water from entering from the clearance between panels to the vehicle compartment. For this reason, if an uncoated location ends up being formed, as

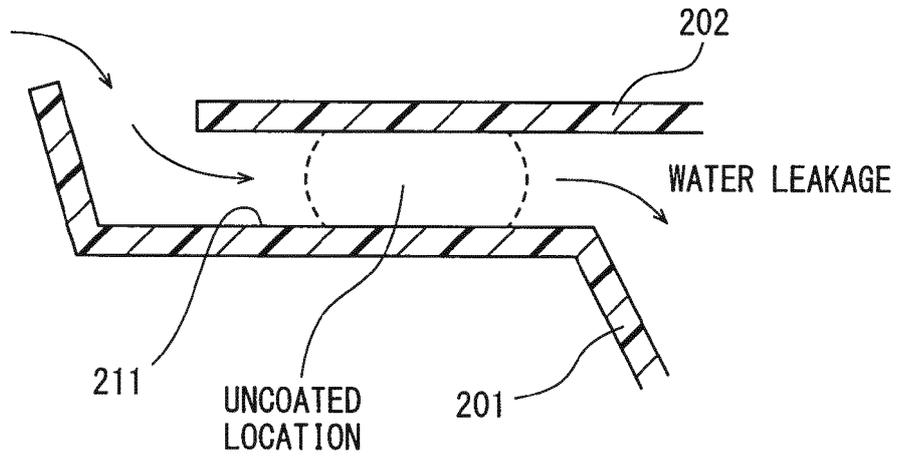
[FIG. 13] FIG. 13 is a cross-sectional view of a vehicle door according to a comparative example along line XIII-XIII of FIG. 11 in the state when bonding the outer panel.

shown in FIG. 13, it ends up becoming no longer possible to seal the clearance between panels by the adhesive, the seal becomes insufficient, and water leakage to the inside of the vehicle compartment is liable to occur.

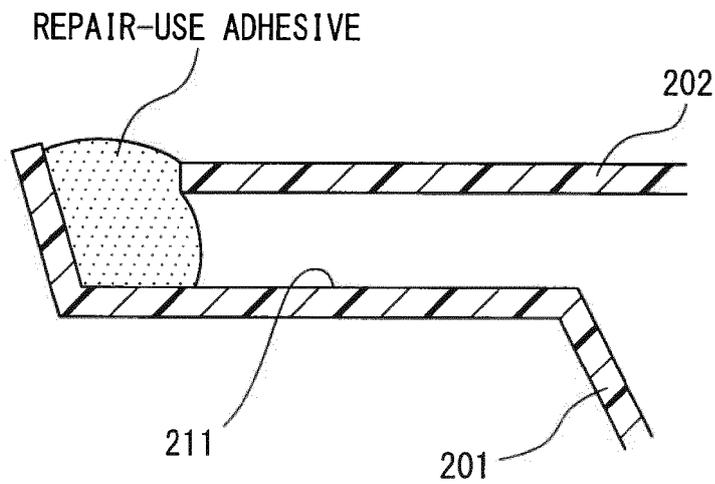
[FIG. 14] FIG. 14 is a view for explaining a repair method in the case where water leakage has occurred in a vehicle door according to a comparative example different from an embodiment of the present disclosure.

[0024] Here, in the state after bonding the outer panel 202 to the inner panel 201, it is difficult to recoat a repair-use adhesive to repair water leakage in a pinpoint manner at the uncoated location formed inside the clearance between panels. For this reason, for example, as shown in FIG. 14, the water leakage is repaired by recoating a repair-use adhesive at the entrance to the clearance between panels along the peripheral direction.

[0025] However, in the state after bonding the outer panel 202 to the inner panel 201, the repair worker cannot directly view the uncoated location from the outside, so from where to where along the peripheral direction at the entrance to the clearance between panels to make the repair (recoat the repair-use adhesive) so that water leakage no longer occurs is difficult to judge and the range of repair easily becomes unclear.
