(12) **EUROPEAN PATENT APPLICATION**

(21) Application number: **19167061.1**

(54) **CONVEYOR INSPECTION WITH UNMANNED VEHICLE CARRYING SENSOR STRUCTURE**

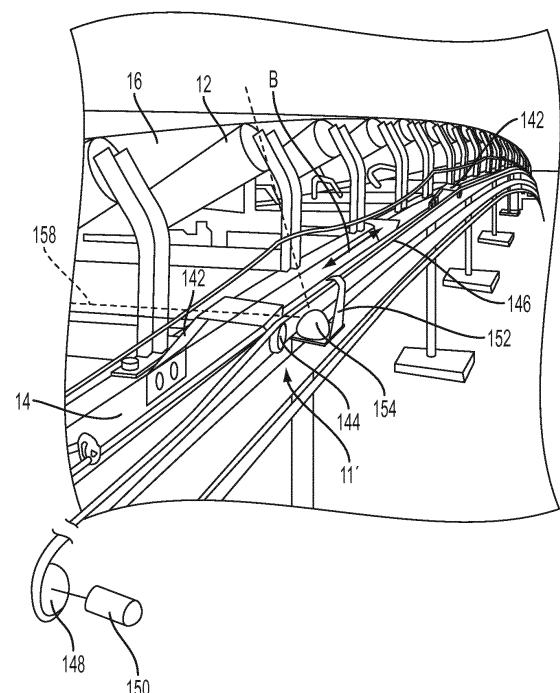
**FIG. 8**

FIG. 8 is a view of a portion of the guide structure, in the form of a cable, which carries the sensor structure in accordance with an embodiment.

**[0033]** The guide structure 122 includes a plurality of supports 142 that are fixed to at least one side of the frame 14 of the conveyor 10' and spaced along a length of the frame 14. In the embodiment of FIGs. 6-8, each support 142 includes a roller 144 for supporting a cable 146 that extends along the length L of the conveyor 10'. The cable 146 is moved by a pulley 148 driven by a motor 150 or by other systems for moving a cable.

**[0034]** The sensor structure 124 includes a vehicle or carrier 152 that moves together with the cable 146 in a guided manner in the directions B of FIG. 8. The sensor structure 124 also includes an imaging sensor 154 disposed on the carrier 152 for movement therewith. The imaging sensor can be mounted to the carrier 152 using a conventional pan and tilt mechanism so as to be capable of motion in two degrees of freedom: rotation in a horizontal plane and in a vertical plane. The imaging sensor 154 is preferably a thermal imaging camera (capable of zooming) aimed at the roller structure 126 to capture visual and thermal images of the rollers 12, 12' of each roller structure 126 and underside of the belt 16 as the carrier, with sensor 154, travels along a side of the operating conveyor 10'. The imaging sensor 154 of FIG. 5 can be used to capture a thermal image (such as shown in FIG. 3) that indicates a hot spot 36 of a roller 12. The hot spot 36 indicates heat generated by friction which may indicate that the bearing of the roller 12 is damaged. The field of view 158 of the sensor 154 is such that the roller structures 126 and at least a portion of the underside of the belt 16 (see FIG. 7) can be monitored to determine if there are defects in the monitored belt portion, particularly at the bent areas 160 of the belt 16. Instead of or in addition to a thermal image camera, the imaging sensor 154 can be a visual image camera or a camera with sensitivity in the near infrared. In addition, or in the alternative, the sensor structure 124 can include a microphone such as a directional microphone for obtaining acoustic signals from the conveyor 10'. More than one sensor structure 124 can be provided on the cable 146. Also, it can be appreciated that a guide structure 122 and associated sensor structure(s) 124 can be provided on each side of the conveyor. Furthermore, instead of moving the cable 146, the cable can be static and the carrier 152 can be self-propelled.

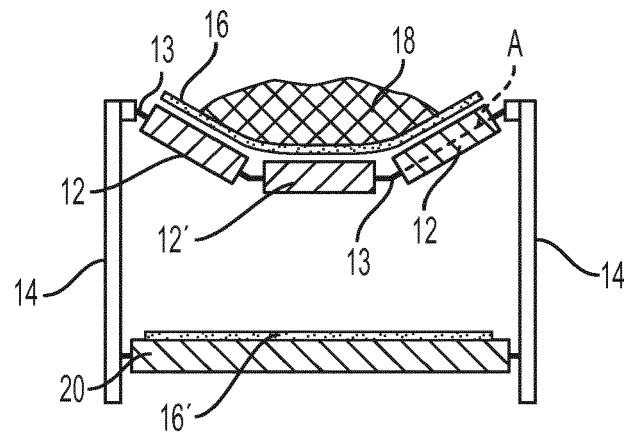
FIG. 1  
(PRIOR ART)

FIG. 1 is a sectional view of a portion of a conventional conveyor showing the belt and upper and lower rollers thereof.

**[0002]** FIG. 1 shows a sectional view of a portion of a conventional large conveyor, generally indicated 10, which is typically used in mining operations. A set of idlers or upper rollers is carried by a frame 14 and include outer rollers 12 and a central roller 12'. The rollers 12, 12' rotate with respect to the moving, endless belt 16 that carries the material 18. The rollers 12, 12' are provided to ensure that the belt 16 defines a trough for the material 18. A plurality of sets of the rollers is spaced to support the belt 16 along the length of the conveyor 10. Lower rollers 20 support the returning portion of the belt 16'.

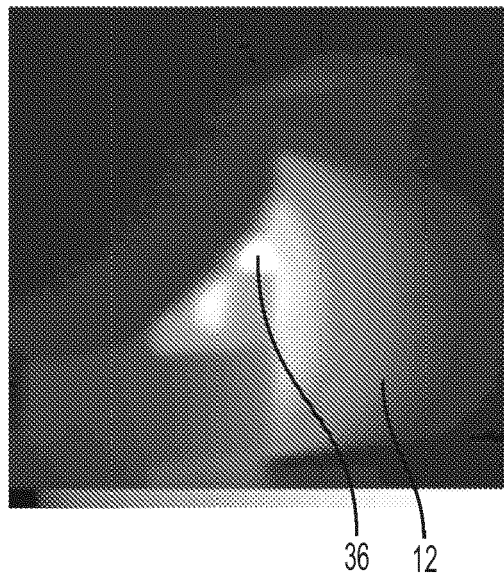
FIG. 3 is a thermal scan of a roller of the conveyor of FIG. 2 using the sensor structure.

ably a thermal imaging camera aimed at the roller structure 24 to capture visual and thermal images of the rollers 12, 12' of each roller structure 24 as the vehicle 22 travels along a side 34 of the operating conveyor 10. FIG. 3 is a thermal image captured by the imaging sensor 30 of FIG. 2, showing a hot spot 36 of a roller 12. The hot spot 36 indicates heat generated by friction which may indicate that the bearing of the roller 12 is damaged. A viewing angle of the imaging sensor 30 can be such that at least a portion of the underside of the belt 16 can be monitored to determine if there are defects in this belt portion.

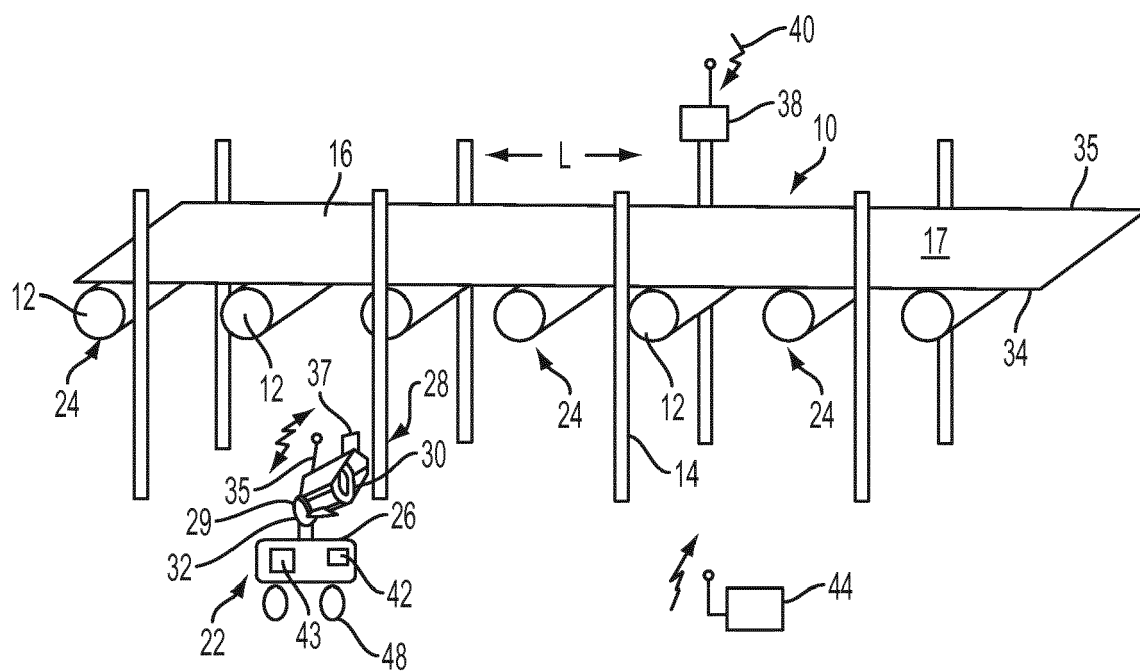
FIG. 2 is a schematic view of a portion of a forward flight of a conveyor with an unmanned vehicle, carrying sensor structure in a pan and tilt arrangement, to inspect rollers at a side of the conveyor in accordance with an embodiment.

**[0018]** With reference to FIG. 2, a schematic view of a portion of a forward flight of a conveyor is shown, generally indicated at 10, being inspected by an unmanned vehicle, generally indicated at 22. The conveyor 10 is conventional and is preferably of the type shown in FIG. 1, having a plurality of roller sets or roller structures 24 carried by the frame 14 under a top flight 17 of the belt 16. Each roller structure 24 preferably includes the two outer rollers 12 and the central roller 12' of FIG. 1. Each roller 12, 12' rotates about an axis A via bearings 13 as the endless belt 16 is conveyed along with material 18. The return flight of the belt 16, the lower rollers 20, and the material 18 being conveyed are not shown in FIGs. 2 and 4. Alternatively, the roller structure can comprise two or four rollers.

**[0020]** The unmanned vehicle 22 may be conventional, such as of the type disclosed in U.S. Patent No. 7,784,570 B2, having a platform 26 carrying sensor structure, generally indicated at 28. In the embodiment of FIG. 2, the sensor structure 28 includes an imaging sensor 30 disposed on mounting structure 29. In the embodiment of FIG. 2, the mounting structure 29 is a conventional pan and tilt mechanism 32 so as to be capable of motion in two degrees of freedom: rotation in a horizontal plane and in a vertical plane. The imaging sensor 30 is prefer-

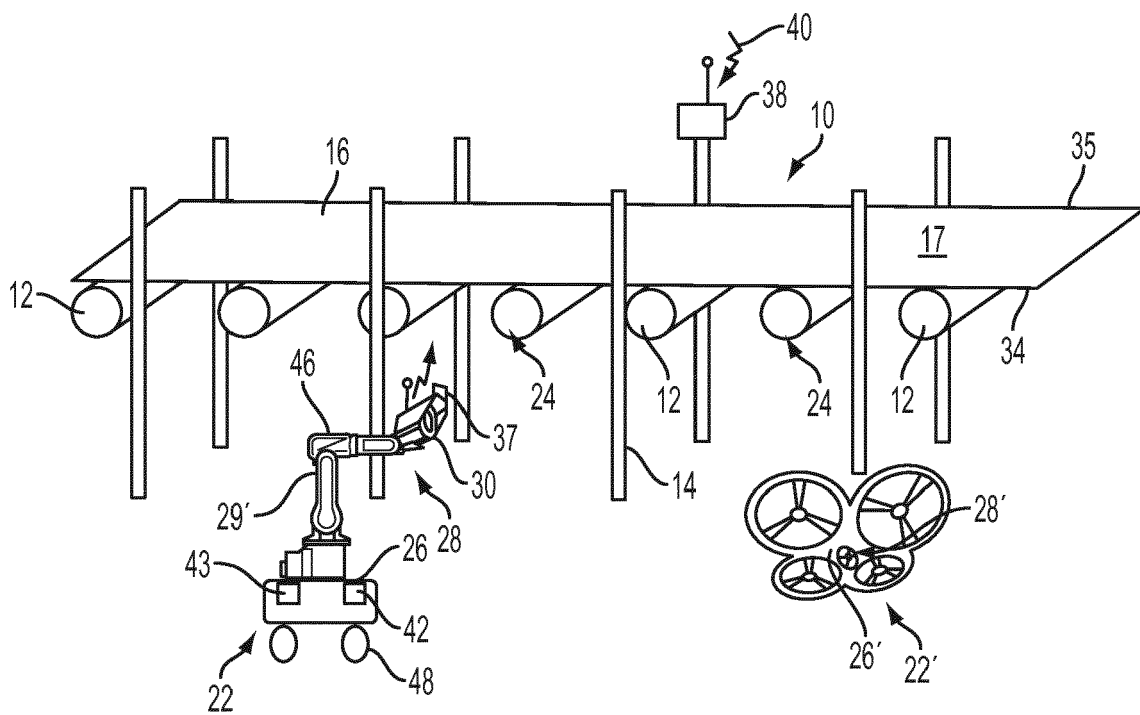
FIG. 4 is a schematic view of a portion of a forward flight of a conveyor with an unmanned vehicle having a robotic arm carrying sensor structure to inspect rollers at a side of the conveyor in accordance with another embodiment.

**[0024]** With reference to FIG. 4, instead of mounting the imaging sensor 30 and the acoustic sensor 37 on the two degree of freedom pan and tilt mechanism 32, the mounting structure 29' comprises a robot 46 that carries the sensors 30 and 37 for movement in more than two degrees of freedom. In the embodiment, the robot 46 has

six degrees of freedom. This provides more mobility so as to move the sensors 30, 37 to ensure they are adjacent to the roller sets 24 as the vehicle 22 traverses changing terrain. Instead of providing the robot, the sensors 30 and 37 can be mounted on an extendable arm such as the Packbot ® from iRobot Corp®. Preferably, the arm can be extended only when the vehicle 22 is stopped to closely monitor a point of interest on the conveyor 10. If desired, the arm can be extended to reach under the belt.

**[0026]** Any other unmanned vehicle capable of moving along rough terrain can be used to carry the sensor structures 28 or 28'. Alternatively, with reference to FIG. 4, a remote controlled flying vehicle such as a miniature helicopter or drone, generally indicated at 22', including the sensor structure 28 on platform 26', can be used instead of the vehicle 22 that has ground-engaging structure such as tracks or wheels 48. The vehicle 22' can be controlled to fly adjacent to the conveyor 10 near the outer rollers 12. The sensor structure 28' can be mounted on the platform 26' in the manner discussed above using regard to mounting structure 29 or 29'. Furthermore, if the vehicle 22 is controlled by the remote control unit 44, the unit 44 can also control movement of the pan and tilt mechanism 32 or the robot 46.

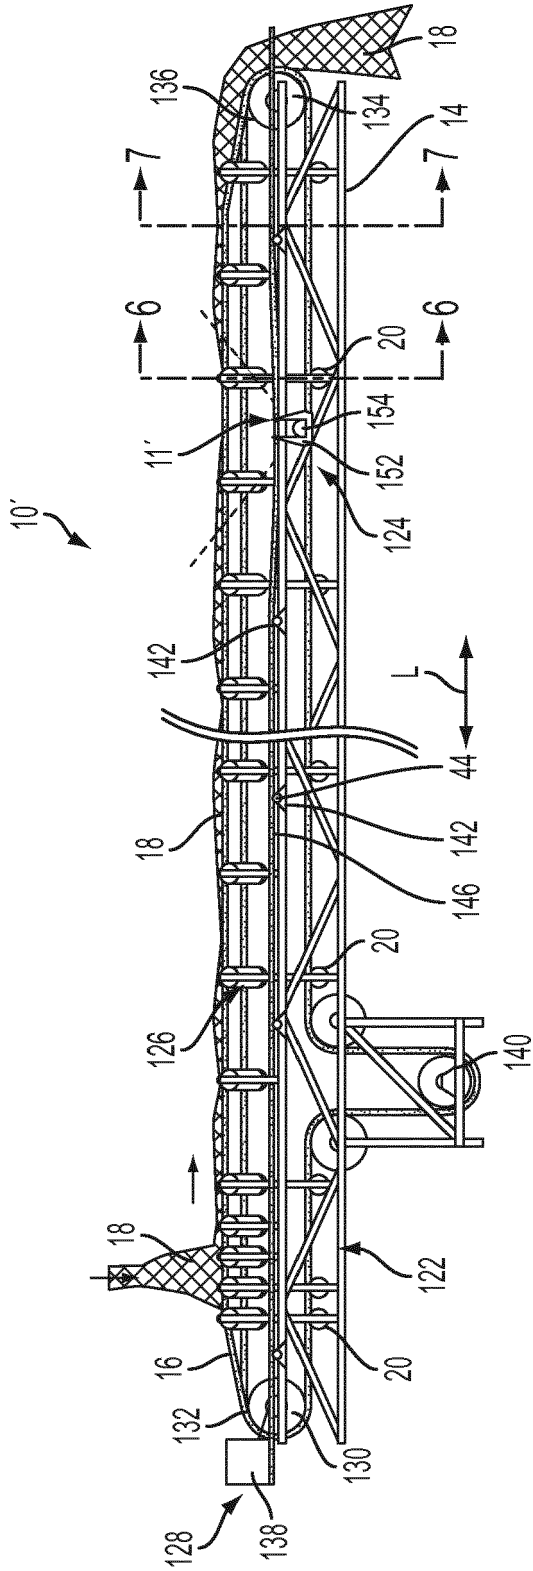
FIG. 5 is side schematic view of a conveyor with guide structure, in the form of a cable carrying sensor structure, at a side of the conveyor to inspect rollers and an underside of the conveyor belt, in accordance with another embodiment.

**[0030]** With reference to FIG. 5, a schematic view of a conveyor, generally indicated at 10, is shown with an associated inspection system, generally indicated at 11', to inspect rollers and an underside of the conveyor belt, in accordance with an embodiment. The inspection system 11' comprises guide structure 122, carrying sensor structure generally indicated at 124, disposed adjacent to at least one side of the conveyor 10'. The conveyor 10' is conventional and is preferably of the type shown in FIG. 1, having a plurality of roller sets or roller structures 126 carried by the frame 14 under a top flight 15 of the endless belt 16. Each roller structure 126 preferably includes the two outer rollers 12 and the central roller 12' as shown in FIG. 6. Each roller 12, 12' rotates about an axis A via bearings 13 as the endless belt 16 is conveyed along with material 18. The return flight of the belt 16' is supported by the lower rollers 20 (FIG. 4). Alternatively, the roller structure 126 can comprise two or more rollers.

**[0031]** Drive structure, generally indicated at 128, is provided for moving the belt 16. In the embodiment, the drive structure includes a first pulley 130 at a first end 132 and a second pulley 134 at the second end 136 of the conveyor 10'. At least one of the pulleys is powered. In the embodiment, a motor 138 drives the first pulley 130. A conventional belt tensioning roller 140 engages the return flight of the belt 16'. The roller 140 is adjustable to adjust the tension in the belt 16'.

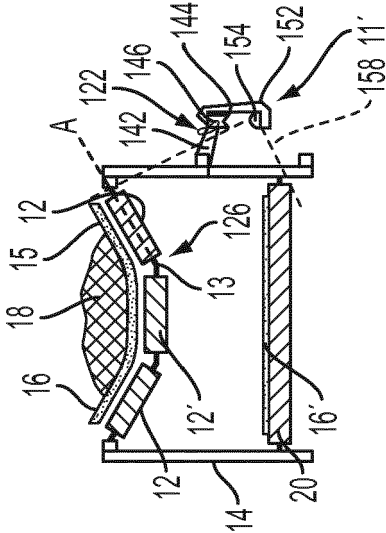
FIG. 6 is a sectional view taken along the line 6-6 in FIG. 5.

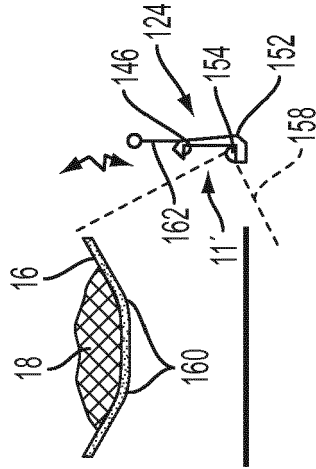
FIG. 7 is a sectional view taken along the line 7-7 in FIG. 5.

**[0035]** Preferably, a wireless transceiver 162 (FIG. 7) on the sensor structure 124 permits the transfer of data to and from the sensor structure 124. The transceiver 162 receives signals to thereby associate data that is captured by the imaging sensor 154 with position, so as to determine what part of the belt 16 or which roller 12, 12, of a set 126 is damaged or not functioning properly. Instead of transmitting the images or data, they can be stored in memory that is provided on the sensor structure 124 for later downloading.

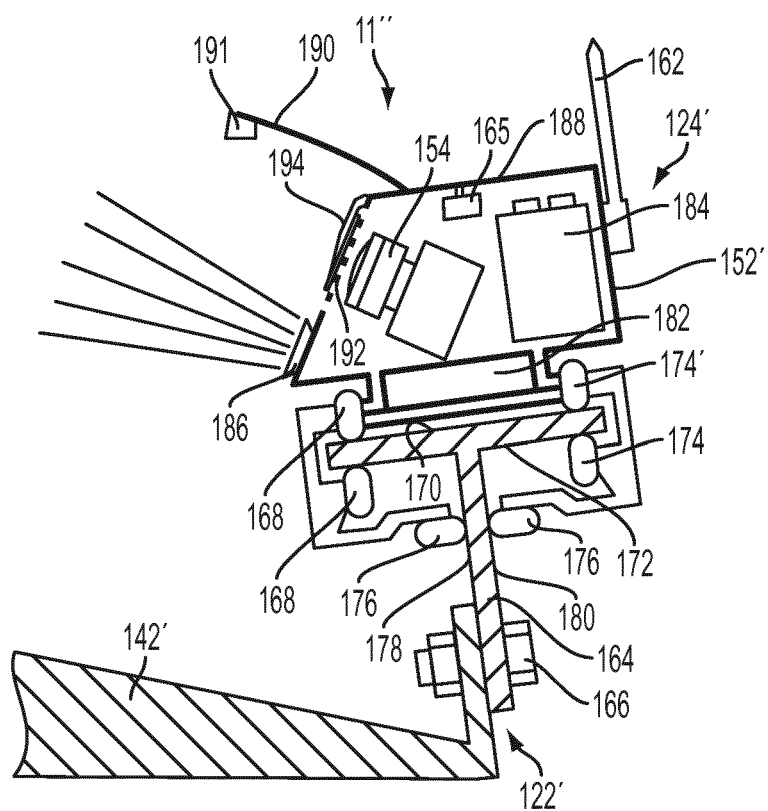
FIG. 9 is a schematic sectional view of a portion of the guide structure, in the form of a track, which carries the sensor structure in accordance with another embodiment.

**[0036]** With reference to FIG. 9, another embodiment of an inspection system is shown generally indicated at 11". The system 11" comprises guide structure 122' and

sensor structure 124'. The guide structure 122' includes a plurality of supports 142' that are fixed to at least one side of the frame 14 of the conveyor 10' and spaced along a length of the frame 14 (similar to supports 142 in FIG. 5). A guide rail 164 is fixed by bolts 166 or the like to the supports 142' and extends along at least one side of the conveyor 10'. The guide rail 164 is a rigid track, preferably of T-shape. The sensor structure 124' includes a carrier 152' that moves along the guide rail 164 in a guided manner. In particular, the carrier 152' includes a first set of rollers 168 engaged with opposing surfaces 170, 172 at one end of the horizontal leg of the T-shaped rail 164, a second set of rollers 174 engaged with the opposing surfaces 170, 172 at the other end of the horizontal leg of the T-shaped rail 164, a third set of rollers 176 engaged with opposing surfaces 178, 180 of the vertical leg of the T-shaped rail 164. The sets of carrier rollers 168, 174, 176 permit guided movement of the carrier 152' along the guide rail 164. At least one of the rollers, e.g., roller 174' is driven by an electric motor 182 to propel the carrier 152' along the rail 164. A battery 184 powers the motor 182. Alternatively, a solar panel can provide power to the motor 182, or an electrical connector can be provided to connect the motor 182 to an external power supply. Other ways to move the carrier 152' along the rail 164 are possible, such as air propulsion, or a motor driven pulley system.

**[0037]** The imaging sensor 154 is mounted on the carrier 152'. A battery-powered light source 186 can be provided on the carrier 152' to create defined lighting conditions at the underside of the belt 116. A pan and tilt unit can be provided for the imaging sensor 154 and/or the light source 186. The wireless transceiver 162 on the sensor structure 124' permits the transfer of data to and from the sensor structure 124' and can control the motor 182 remotely for moving the carrier 152'. A housing 188 of the carrier 152' provides an enclosure for the imaging sensor 154 so as to protect the imaging sensor 154 from harsh outdoor conditions. Heating or cooling systems can be provided in the housing 188. A sunshield 190 can be provided to ensure that the imaging sensor 154 operates under the most optimum lighting conditions. An acoustic sensor or microphone 191 can be mounted on the sunshield 191 or other part of the sensor structure 124'. A viewing window 192 is provided in the housing 188, through which the imaging camera obtains images. A wiper 194 with a spray cleaner can be provided to clean the window 192. Also, while moving alongside the conveyor, the acoustic sensor 191 can also be used to detect any other unusual sound or image not originating from the rollers but from other parts of the installation.
