(12) **EUROPEAN PATENT APPLICATION**

(21) Application number: **22164225.9**

(71) Applicant: **Rohr, Inc.**  
**Chula Vista, CA 91910-2098 (US)**

(54) **MACHINE VISION ACOUSTIC PANEL REPAIR WITH RETENTION OF ACOUSTIC PROPERTIES**

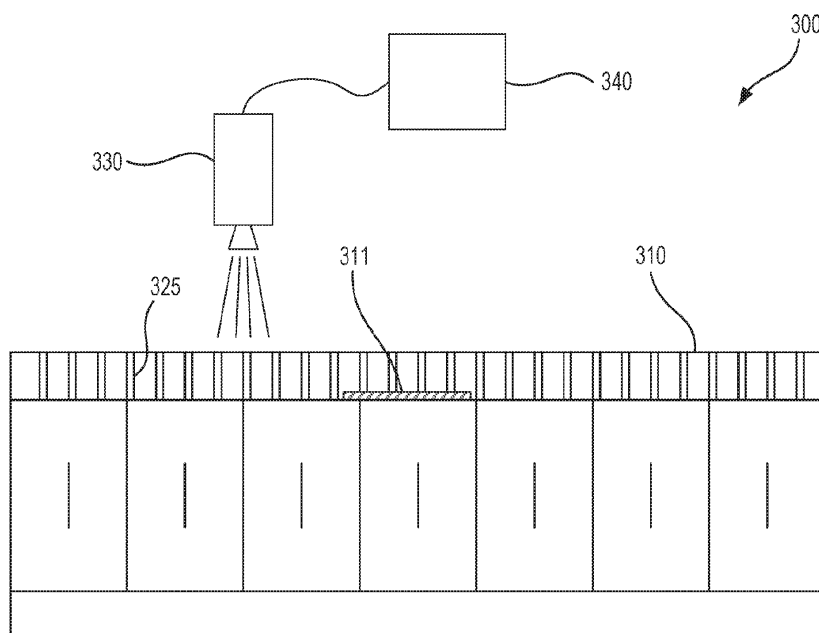
FIG. 3

(57) An acoustic panel (300) for an aircraft nacelle may comprise a perforated first skin (220), a second skin (230), and a core (210) sandwiched between them. A camera system (330) may scan a perforation pattern of a damaged portion (311) of the perforated first skin. The damaged portion of the perforated first skin may be re-

moved. A replacement patch (400) may be formed. A CNC machine (450) may drill the replacement patch according to the perforation pattern. The perforations in the replacement patch may be aligned with perforations in the perforated first skin.

40 **[0016]** Referring to FIG. 3, a schematic cross-section view of an acoustic panel 300 with a damaged portion 311 of a perforated top skin 310 is illustrated according to various embodiments. The damaged portion 311 may comprise a disbond or delaminated portion. A camera system 330 may scan the perforated top skin 310 to detect the locations of perforations 325. In various embodiments, the camera system 330 may comprise an optical camera, infrared camera, UV camera, X-ray camera, or any other camera capable of detecting the locations of perforations 325. In various embodiments, the camera system 330 may emit light onto the top skin 310 and detect the reflected light to detect the locations of the perforations 325. The camera system 330 may capture one or more images of the perforated top skin 310. A computer 340 may store the locations and perforation pattern of the perforations 325. The computer 340 may comprise a processor and a tangible, nontransitory memory. The computer 340 may instruct a computer numeric

control ("CNC") machine to create perforations in a repair laminate which match the locations of perforations 325 in the perforated top skin 310.

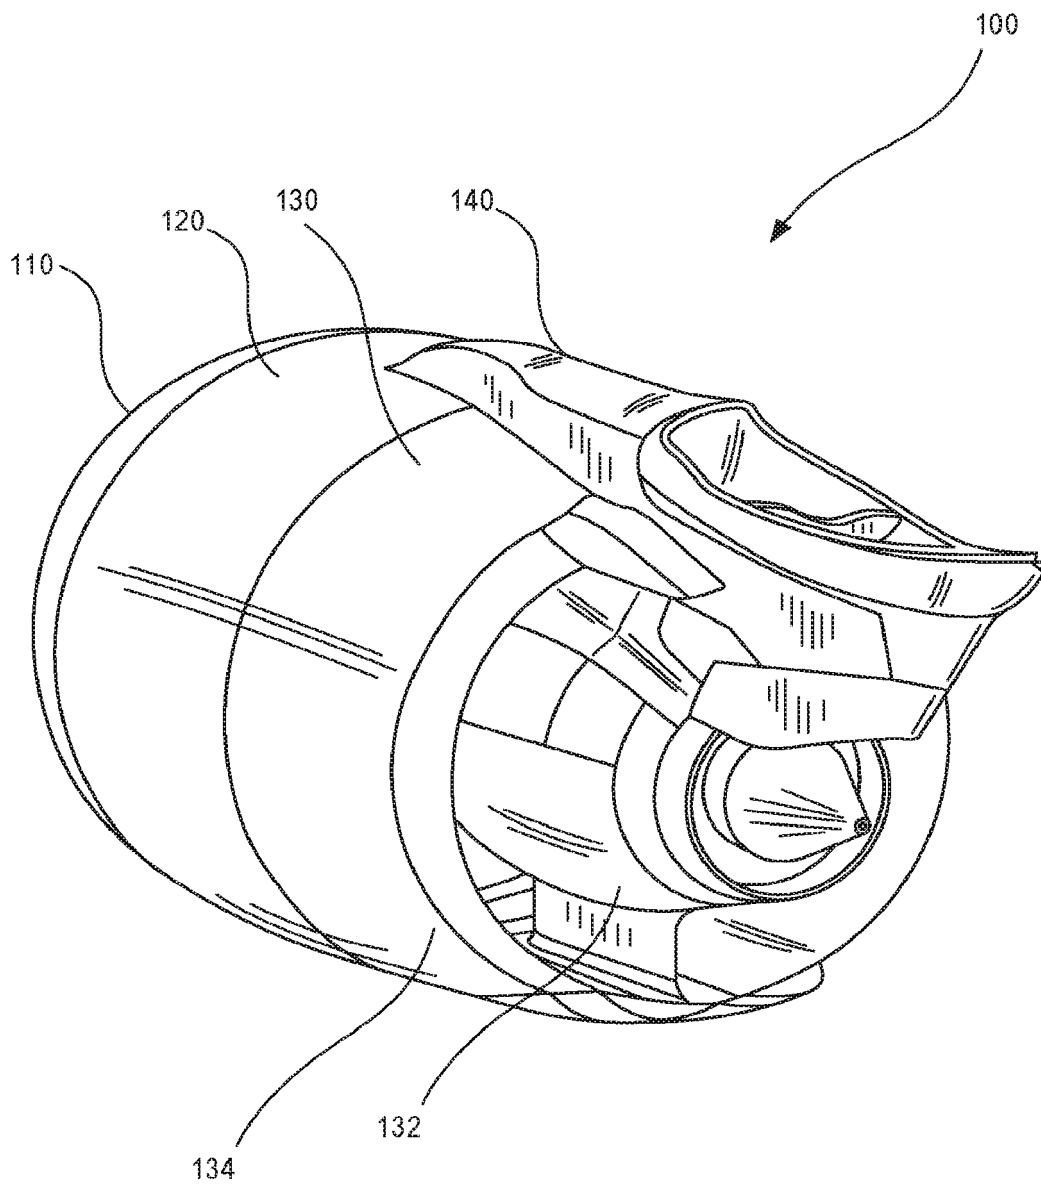
**[0013]** Referring to FIG. 1, a nacelle 100 for a gas turbine engine is illustrated according to various embodiments. Nacelle 100 may comprise an inlet 110, a fan cowl 120, and a thrust reverser 130. Nacelle 100 may be coupled to a pylon 140, which may mount the nacelle 100 to an aircraft wing or aircraft body. Thrust reverser 130 may comprise an inner fixed structure ("IFS") 132, an outer fixed structure ("OFS"), and a translating sleeve 134. Bypass air from an engine fan may flow in a generally annular bypass air duct defined between the IFS 132 and the translating sleeve 134. Portions of the inner fixed structure 132, the translating sleeve 134, and the inlet 110 may be commonly formed using acoustic panels.

FIG. 1 illustrates a perspective view of a nacelle for an aircraft in accordance with various embodiments; FIG. 2 illustrates a perspective view of an acoustic panel in accordance with various embodiments; FIG. 3 illustrates a schematic cross-section view of an acoustic panel with a damaged portion of a perforated top skin in accordance with various embodiments; FIG. 4 illustrates a schematic cross-section view of

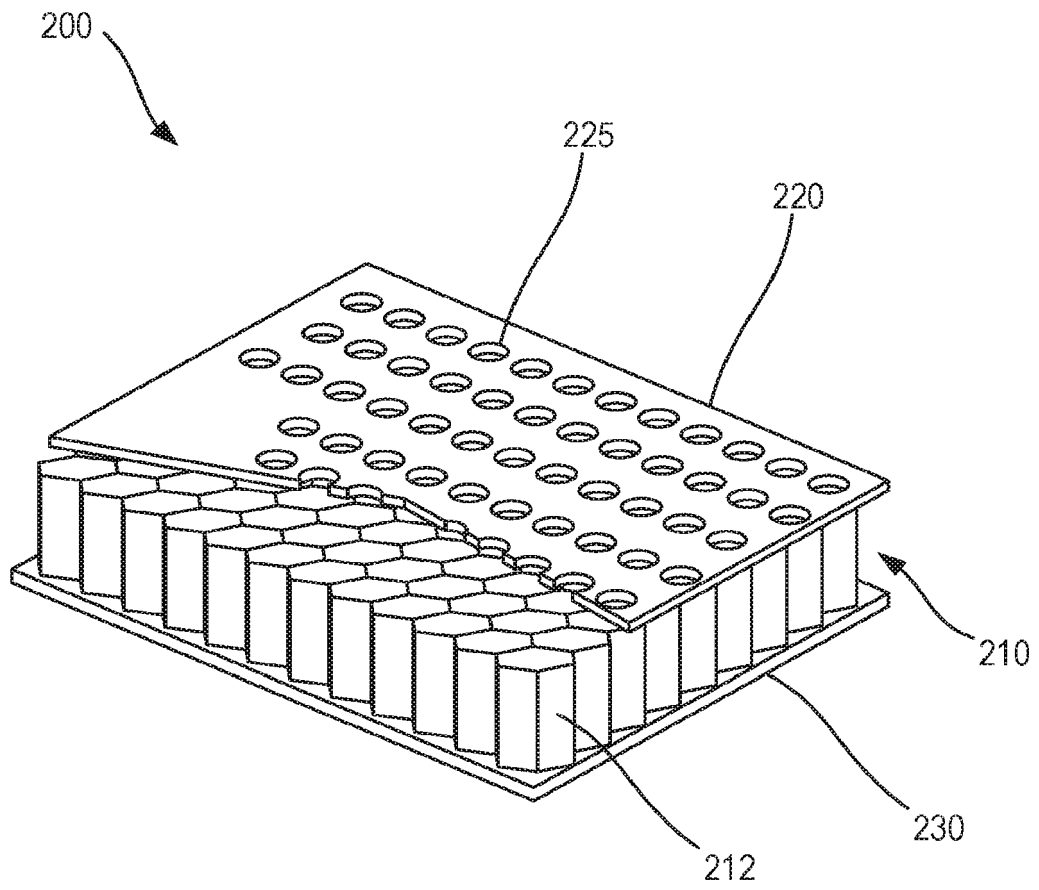
FIG. 2

**[0014]** Referring to FIG. 2, an acoustic panel 200 is illustrated according to various embodiments. The acoustic panel 200 may comprise perforations 225, and could be used to form portions of a nacelle for an aircraft engine, as described above. The acoustic panel 200 may

comprise a core 210, positioned between a first skin 220 and a second skin 230. The core 210 may have walls extending generally in a normal direction from the first skin to the second skin that form a plurality of cells 212.

5 The cells 212 may be hexagonal in shape in which case the core 210 is then commonly referred to as honeycomb core. In various embodiments, however, the cells 212 could have any of a number of different geometries. Core walls could be made from various metals such as titanium or aluminum, or composites, or hardened paper or other plastics, according to the particular application of the panel and the desired material properties. Adjacent core walls may be bonded to each other with glue or may be welded, or other methods may be used to join core walls together to form the cellular structure. The first skin 220, 10 core 210, and second skin 230 combine to form closed cells that may become acoustic resonating chambers after one of the skins is perforated. Such configuration works to attenuate acoustic waves, such as noise from an aircraft engine, in a known fashion. The first skin 220 and second skin 230 may be formed of laminar plies of fiber reinforcement joined together with a matrix. The fibers may be carbon, glass, aramid or other known types. The matrix may be thermoset polymers such as epoxies, 25 thermoplastics, or other known materials. The acoustic panel 200 is formed by joining together the first skin 220, second skin 230, and core 210, which may be done with adhesive, co-curing, mechanical fastening, or through other means. In the case of an adhesively bonded acoustic panel, the edges of the core walls adjacent to each skin are bonded to the inner surface of the respective skin to form a rigid, high strength structure.

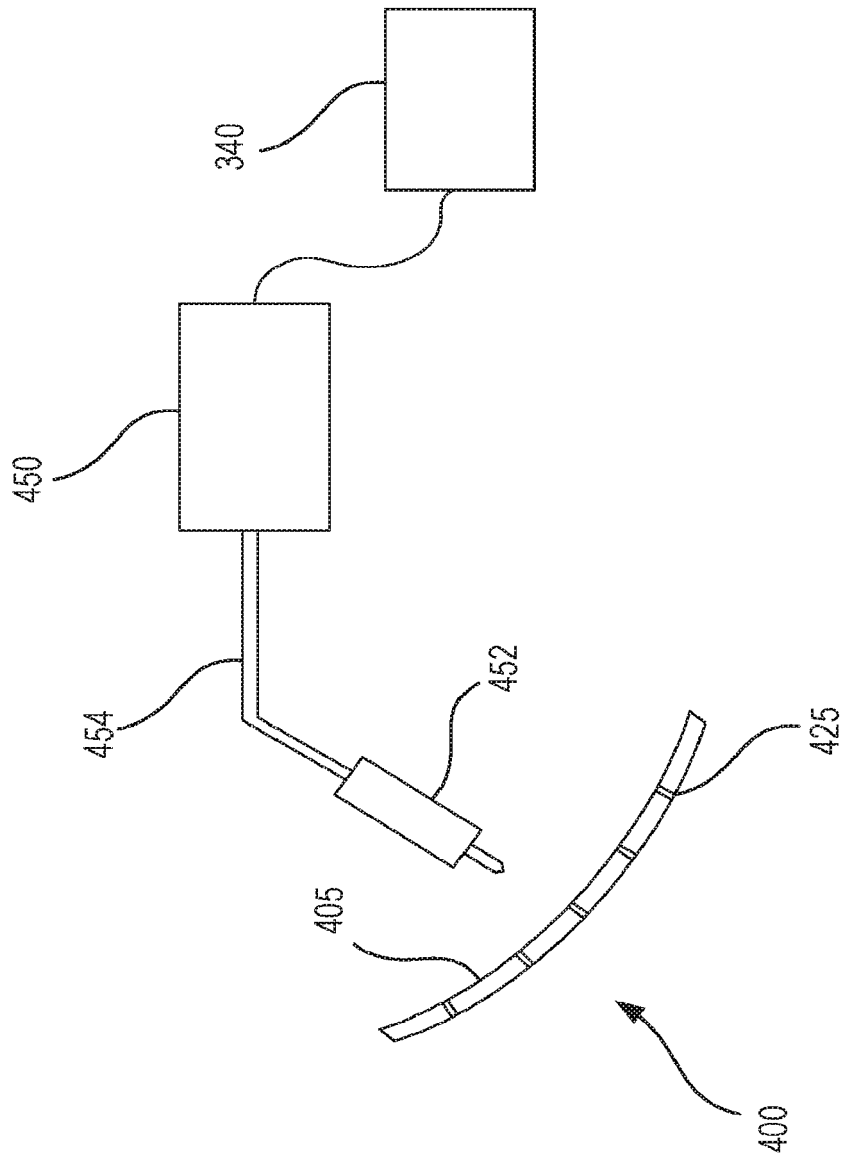
FIG. 4

**[0017]** Referring to FIG. 4, a schematic view of a repair laminate 400 and a CNC machine 450 is illustrated according to various embodiments. The repair laminate 400 may comprise a plurality of composite plies cured in the shape of a component to be repaired. As illustrated, the repair laminate 400 may comprise a complex 3-dimensional shape. The shape of the repair laminate 400 may match the shape of a repair area of a damaged component. The CNC machine 450 may command a drill 452 to drill perforations 425 in the repair laminate 400 in accordance with the pattern stored by computer 340. Various types of drills may be utilized, such as a mechanical drill, laser drill, electron beam, water jets, or any other suitable drill. The CNC machine 450 may comprise one or more drills 452. The drill 452 may be on an axis system 454. The axis system 454 may move the drill 452 to the desired location and angle. In various embodiments, the axis system 454 may comprise a five or six-axis system. However, the axis system 454 may comprise any suitable number of axes to move the drill 452 in a desired manner. In various embodiments, the drill 452 may be positioned normal to the surface 405 of the repair laminate 400. Thus, each perforation 425 may be drilled perpendicular to the repair laminate 400 in its local area.

a repair laminate in accordance with various embodiments

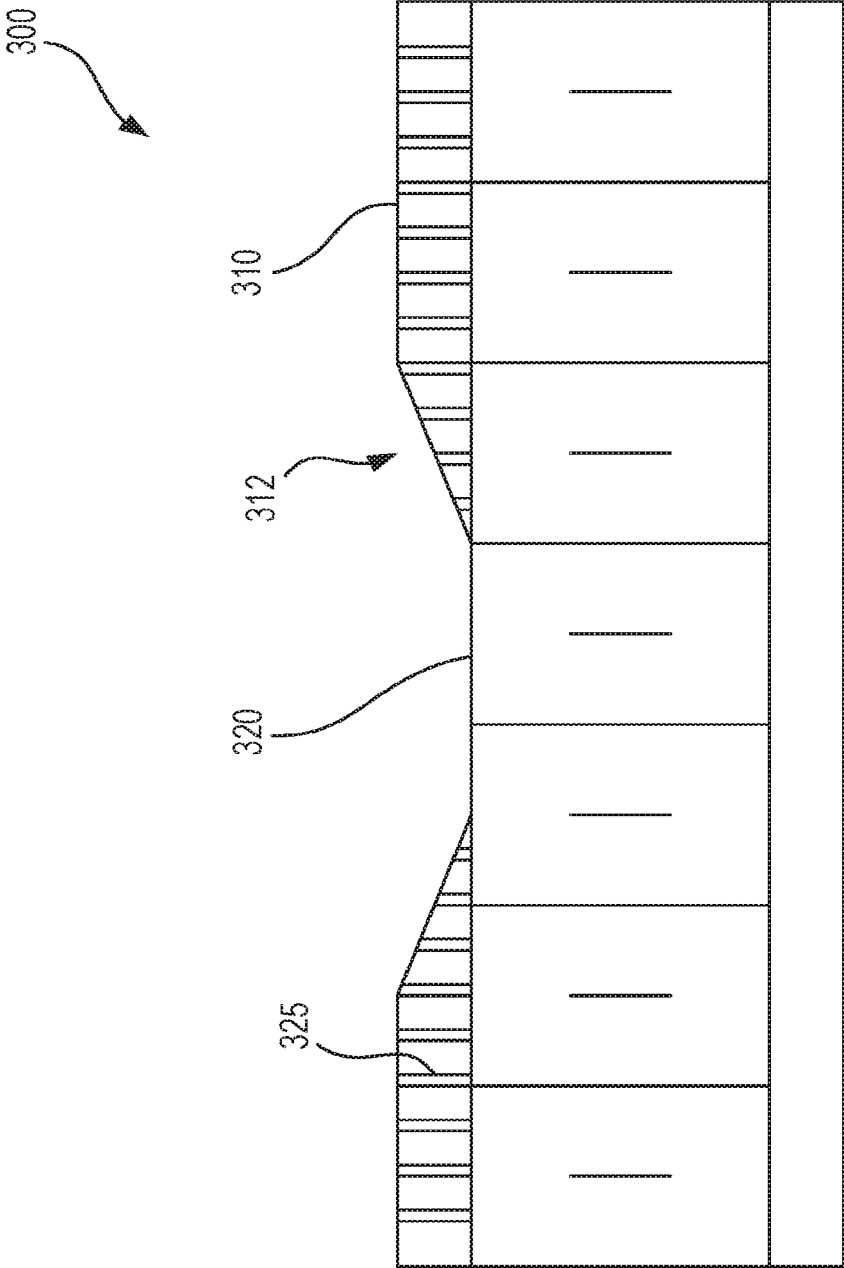
**[0018]** Referring to FIG. 5, a schematic cross-section view of the acoustic panel 300 with the damaged portion of the perforated top skin 310 removed is illustrated according to various embodiments. The damaged portion may be cut with a continuously sloped ramp portion 312 between the top of the top skin 310 and the core section 320 where the top skin 310 is completely removed. However, in various embodiments, the damaged portion may be cut with a stepped profile. In various embodiments, the acoustic panel 300 may be curved in two or three dimensions. The curved shape may make it difficult to align perforations 325 between the remaining top skin 310 and a replacement patch using a pre-drilled flat panel. However, referring back to FIG. 4, by drilling the repair laminate 400 in the curved shape with the CNC machine 450 and stored perforation pattern, the perforations 325 may align with the perforations 425 in the repair laminate 400.

FIG. 5 illustrates a schematic cross-section view of the acoustic panel with the damaged portion of the perforated top skin removed in accordance with various embodiments;

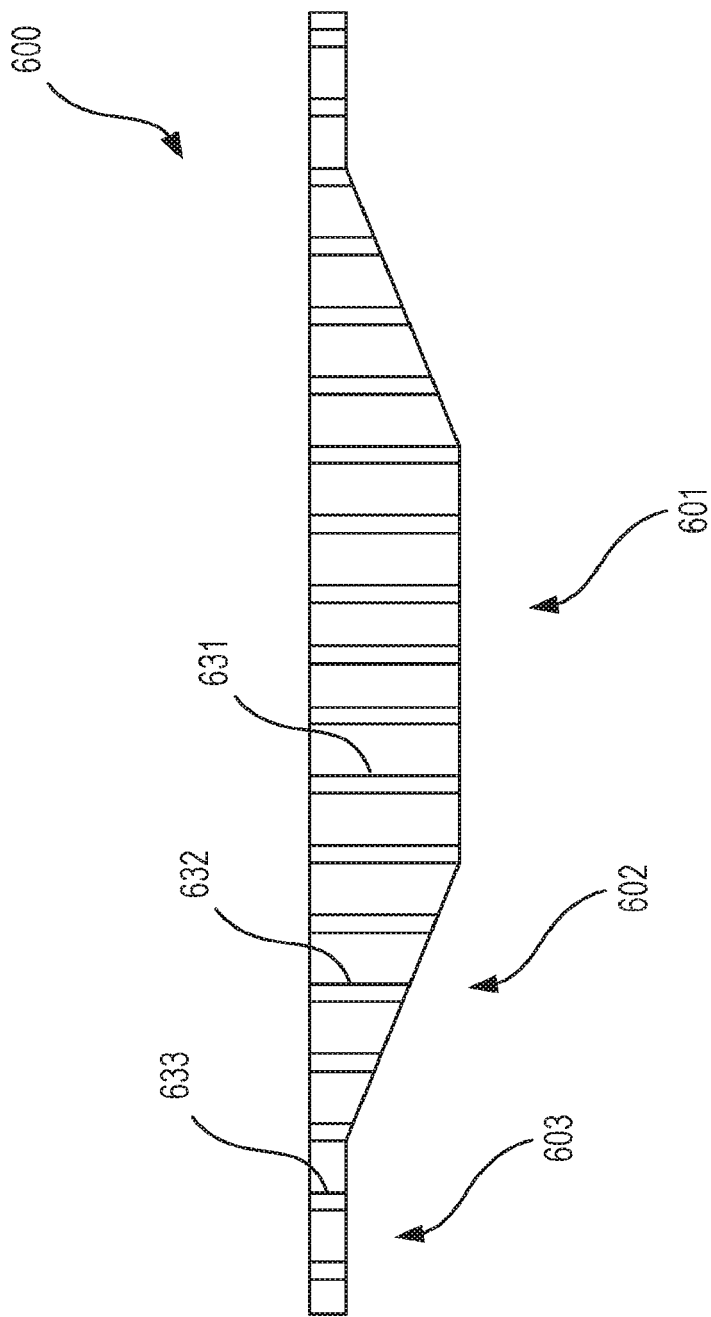
**[0019]** Referring to FIG. 6, a schematic cross-section view of a replacement patch 600 is illustrated according to various embodiments. The replacement patch 600 may comprise a plurality of composite plies. The plies may be laid up on a bond tool which matches the shape of the component which is being repaired. The replacement patch 600 may be cut from the repair laminate 400 shown in FIG. 4 after the perforations 425 are drilled in the repair laminate 400. However, in various embodiments, the replacement patch 600 may be cut from the repair laminate 400 prior to the perforations 425 being drilled in the repair laminate 400. The replacement patch 600 may comprise a core portion 601 which is configured

to be placed directly over the core of an acoustic panel where the original top skin is completely removed. The replacement patch 600 may comprise a ramp portion 602 which is configured to be placed where the original top skin is partially removed. The replacement patch 600 may comprise an overlap portion 603 which is configured to be placed over the original top skin. The replacement patch 600 may comprise perforations 631 in the core portion 601, perforations 632 in the ramp portion 602, and perforations 633 in the overlap portion 603.

FIG. 6 illustrates a schematic cross-section view of a replacement patch in accordance with various embodiments;

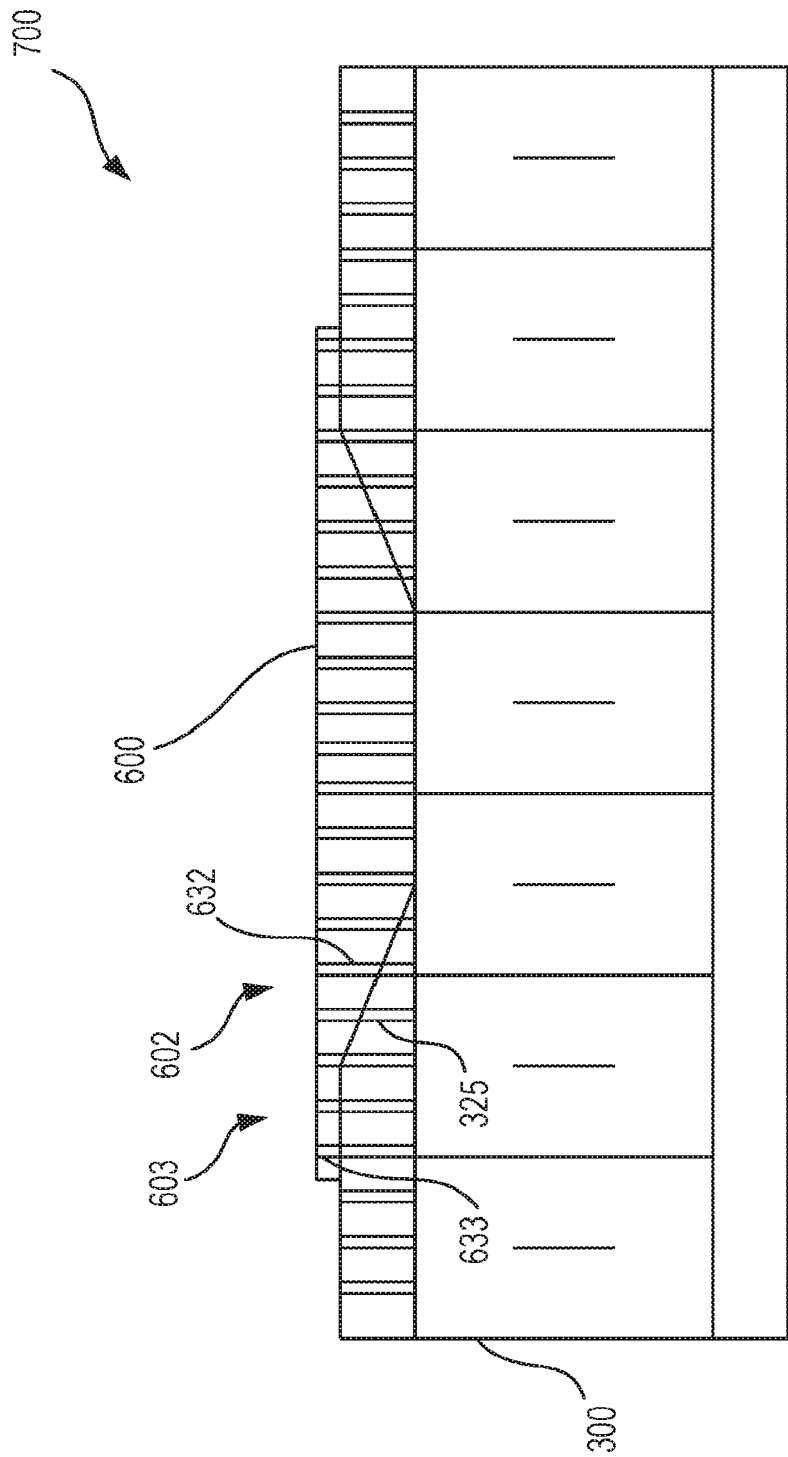
**[0020]** Referring to FIG. 7, a repaired acoustic panel 700 is illustrated according to various embodiments. The replacement patch 600 may be bonded to the acoustic panel 300. The perforations 632, 633 in the ramp portion 602 and the overlap portion 603 of the replacement patch 600 may align with the perforations 325 in the acoustic panel 300. One or more pins may be inserted through the perforations 325, 632, 633 to keep the replacement patch 600 in place during curing. An adhesive may be placed on the replacement patch 600 and/or the acoustic panel 300 between the replacement patch 600 and the acoustic panel 300. An articulation reticulation process may be used to remove adhesive from the perforations 325, 632, 633, wherein hot air is blown through the perforations 325, 632, 633 to remove excess adhesive. The acoustic panel 300 with the replacement patch 600 may be cured in an autoclave. The repaired acoustic panel 700 may then be ready for operational use.

FIG. 7 illustrates a repaired acoustic panel in accordance with various embodiments; and

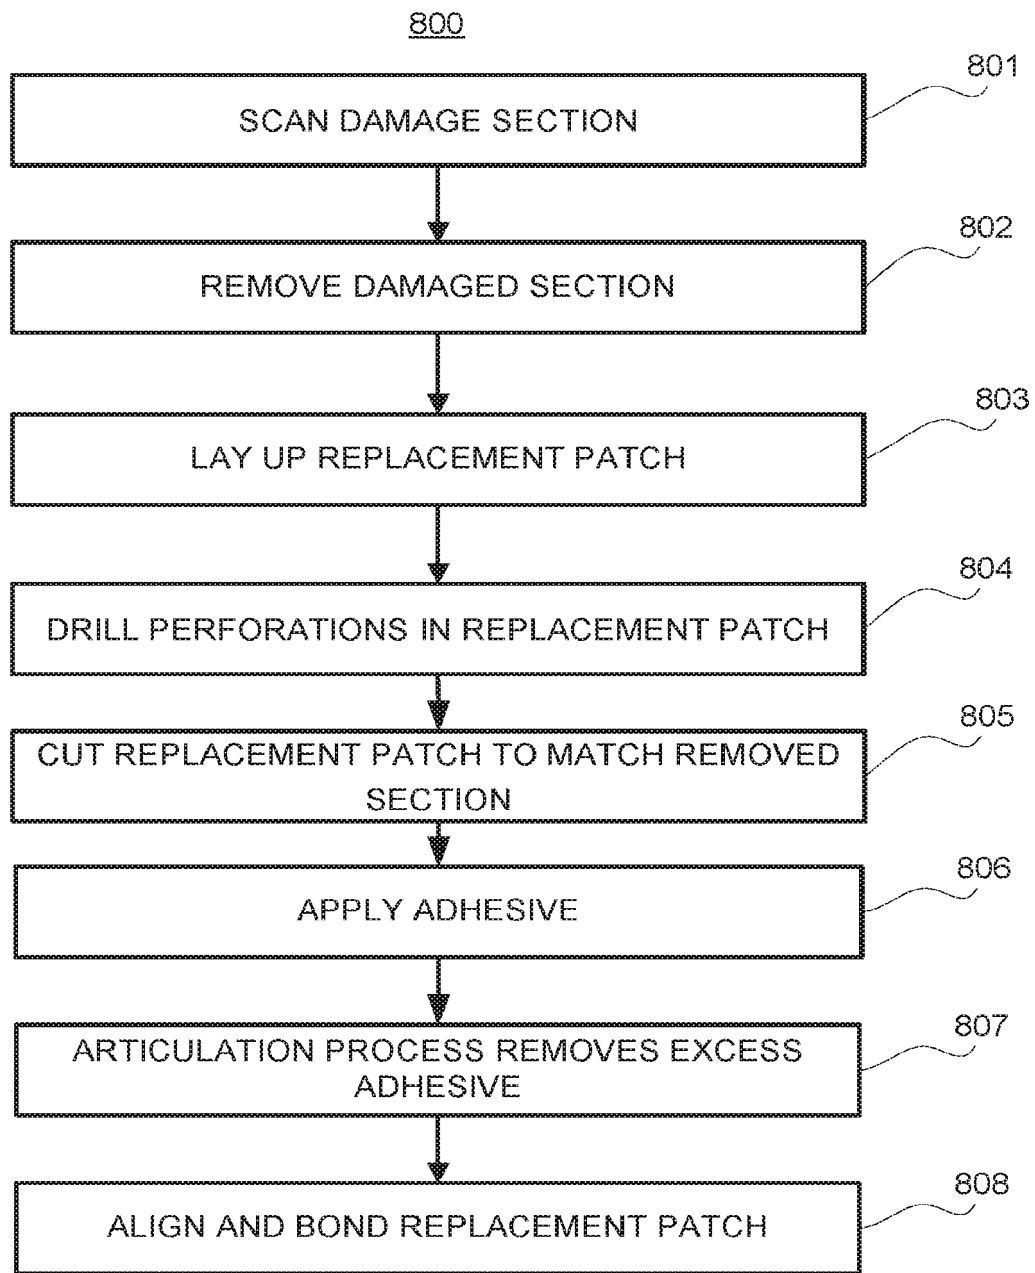
**[0021]** Referring to FIG. 8, a flowchart 800 of a process for repairing an acoustic panel is illustrated according to various embodiments. Damage may be detected in an acoustic panel. A camera system may scan the perforation pattern in the damaged section (step 801). The damaged section may be removed from the acoustic panel (step 802). A replacement patch may be laid up using a bond tool matching the shape of the acoustic panel (step 803). A CNC machine may drill perforations in the replacement patch matching the perforation pattern in the damaged section (step 804). The replacement patch may be cut to match the removed section (step 805). An adhesive may be applied to the replacement patch and/or the acoustic panel (step 806). An articulation reticulation process may remove adhesive from the perforations (step 807). The replacement patch may be aligned with the acoustic panel and bonded to the acoustic panel (step 808). In various embodiments, pins may be placed in perforations to align the replacement patch with the acoustic panel.

FIG. 8 illustrates a flowchart of a process for repairing an acoustic panel in accordance with various embodiments.
