(12) **EUROPEAN PATENT APPLICATION**

(21) Application number: **23161316.7**

(54) **ACOUSTIC PANEL REPAIR WITH RETENTION OF ACOUSTIC PROPERTIES**

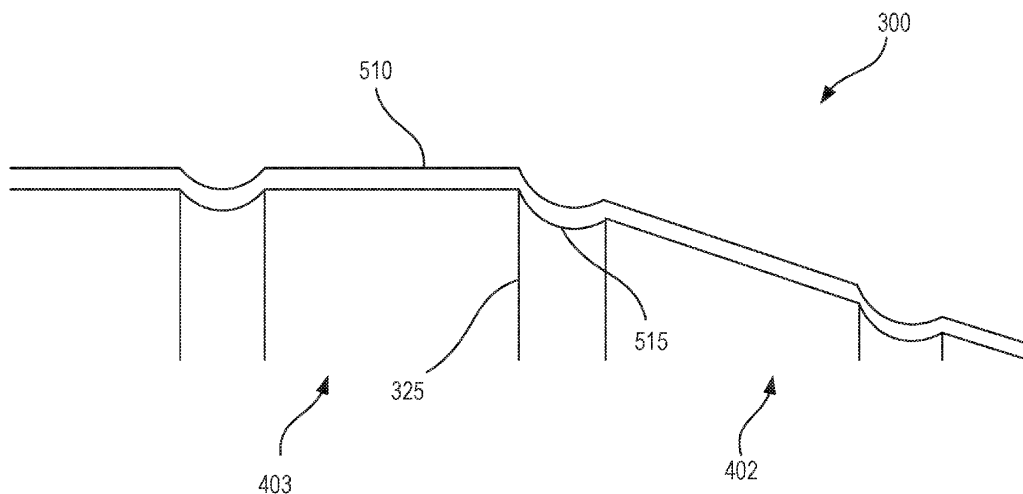
sure differential may cause the fiberglass ply to form dimples (515) within the perforations of the first skin. The fiberglass ply may be used as a template to drill holes in a replacement patch (400).

FIG. 5B illustrates a schematic cross-section view of an acoustic panel with a fiberglass ply with dimples in accordance with various embodiments

**[0020]** Referring to FIG. 5B, the acoustic panel 300 and the fiberglass ply 510 may be vacuum bagged, and a pressure differential may force the fiberglass ply 510 to droop into the perforations 325 in the ramp portion 402 and the overlap portion 403, creating dimples 515 within the perforations 325.

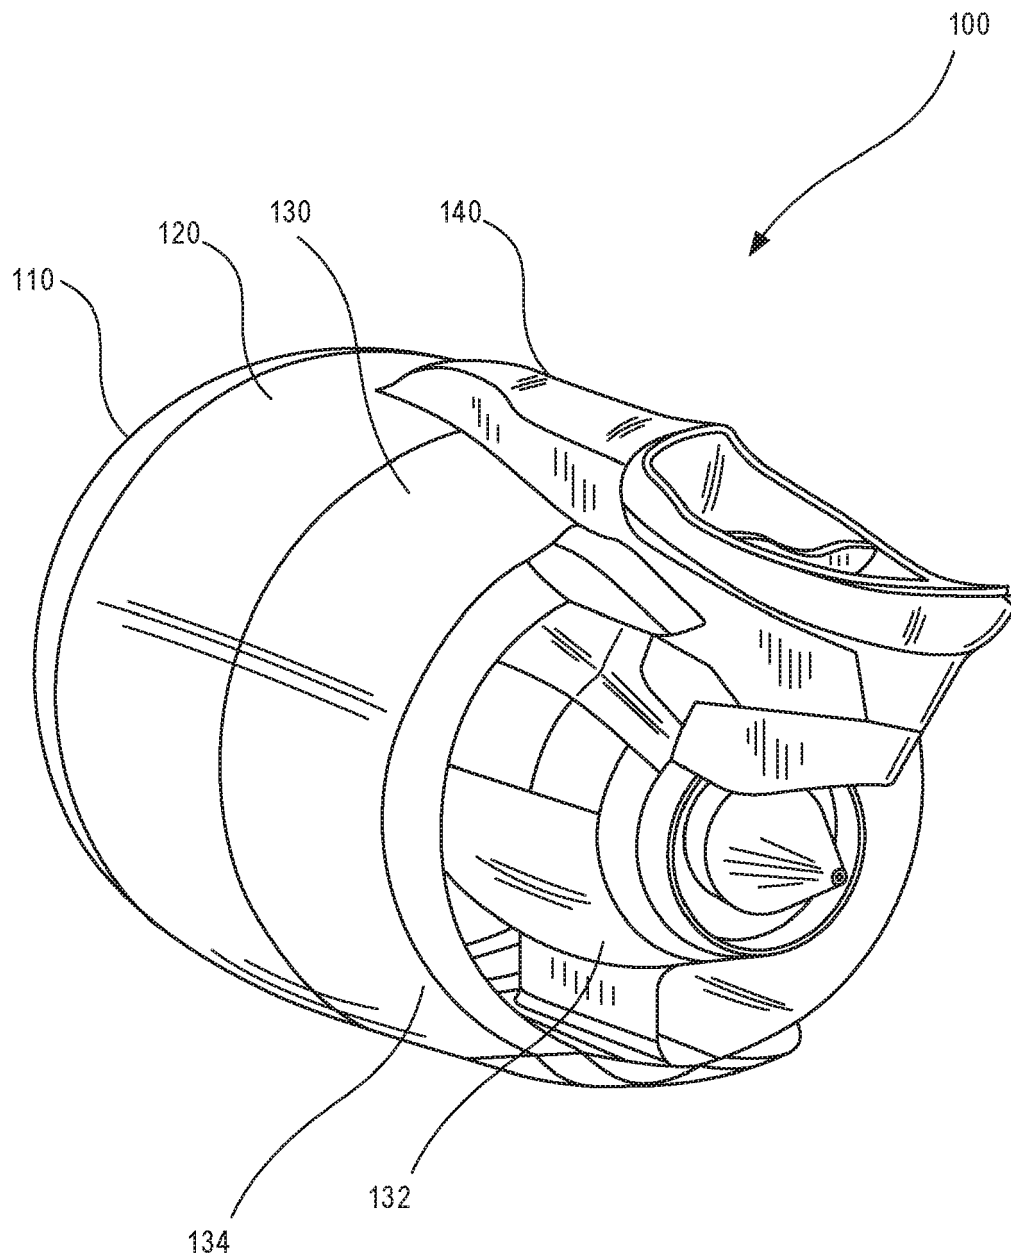
FIG. 1 illustrates a perspective view of a nacelle for an aircraft in accordance with various embodiments; FIG. 2 illustrates a perspective view of an acoustic panel in accordance with various embodiments; FIG. 3 illustrates a schematic cross-section view of an acoustic panel with a damaged portion of a perforated top skin removed in accordance with various embodiments; FIG. 4A illustrates a schematic cross-section view of a replacement patch in accordance with various embodiments; FIG. 4B illustrates a schematic cross-section view of a replacement patch with a maskant in accordance

**[0013]** Referring to FIG. 1, a nacelle 100 for a gas turbine engine is illustrated according to various embodiments. Nacelle 100 may comprise an inlet 110, a fan cowl 120, and a thrust reverser 130. Nacelle 100 may be coupled to a pylon 140, which may mount the nacelle 100 to an aircraft wing or aircraft body. Thrust reverser 130 may comprise an inner fixed structure ("IFS") 132, an outer fixed structure ("OFS"), and a translating sleeve 134. Bypass air from an engine fan may flow in a generally an-

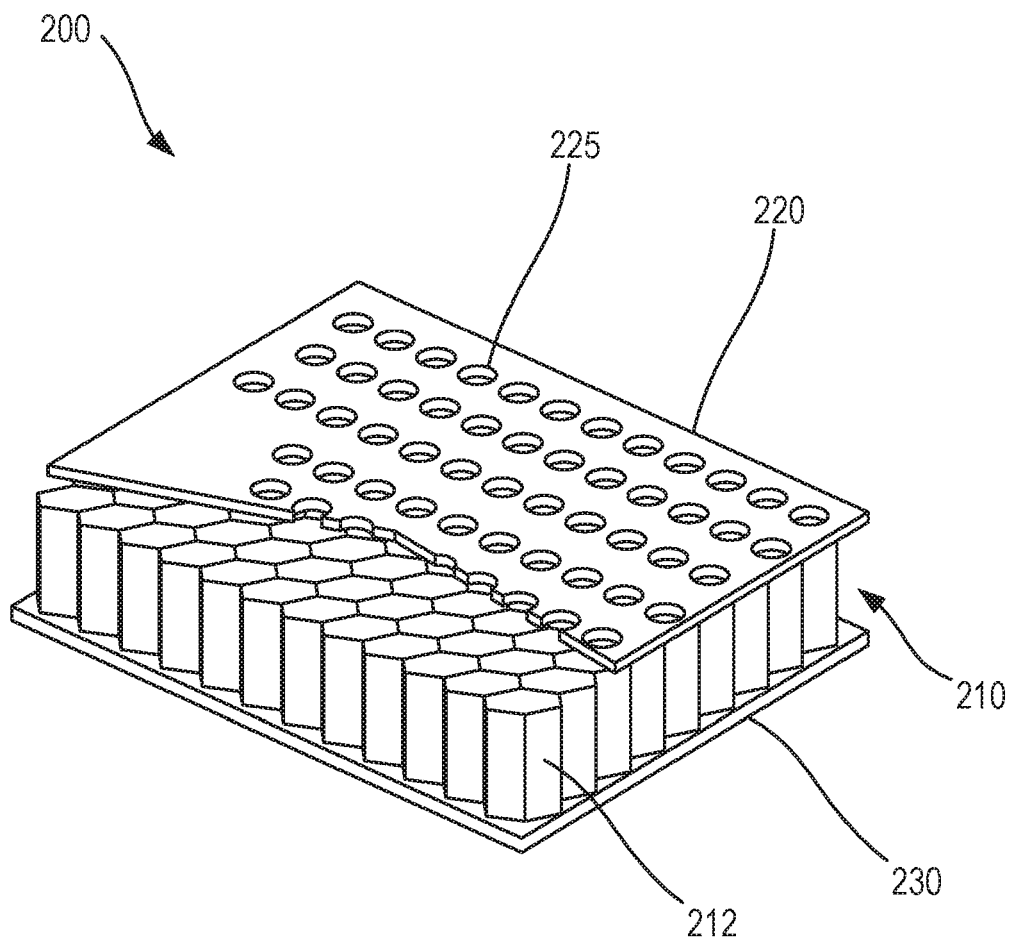
FIG. 2

**[0014]** Referring to FIG. 2, an acoustic panel 200 is illustrated according to various embodiments. The acoustic panel 200 may comprise perforations 225, and could be used to form portions of a nacelle for an aircraft engine, as described above. The acoustic panel 200 may comprise a core 210, positioned between a first skin 220 and a second skin 230. The core 210 may have walls extending generally in a normal direction from the first skin to the second skin that form a plurality of cells 212. The cells 212 may be hexagonal in shape and are then commonly referred to as honeycomb core. In various embodiments, however, the cells 212 could have any of a number of different geometries. Core walls could be made from various metals such as titanium or aluminum, or composites, or hardened paper or other plastics, according to the particular application and material properties. Adjacent core walls may be bonded to each other with glue or may be welded, or other methods may be used to join core walls together to form the cellular structure. The first skin 220, core 210, and second skin 230 combine to form closed cells that may become resonator chambers when one of the skins is perforated and work to attenuate acoustic waves, such as noise from an aircraft engine, in a known fashion. The first and second skins 220, 230 may be formed of laminar plies of fiber reinforcement joined together with a matrix. The fibers may be carbon, glass, aramid or other known types. The matrix may be thermoset polymers such as epoxies, thermoplastics, and other known materials. The acoustic panel 200 is formed by joining together the first skin 220, second skin 230, and core 210, which may be done with adhesive, co-curing, mechanical fastening, or through other means. In the case of an adhesively bonded acoustic panel, the edges of the core walls adjacent to each skin are bonded thereto to form a rigid, high strength structure.

In various embodiments, a portion of the first skin 220 may not be fully attached to the core 210 during manufacture of the acoustic panel 200, or the portion may delaminate from the core 210, resulting in a void, or the first skin 220 may become damaged during operation. It may be desirable to repair the first skin 220 by replacing a portion of the first skin 220 with a patch.

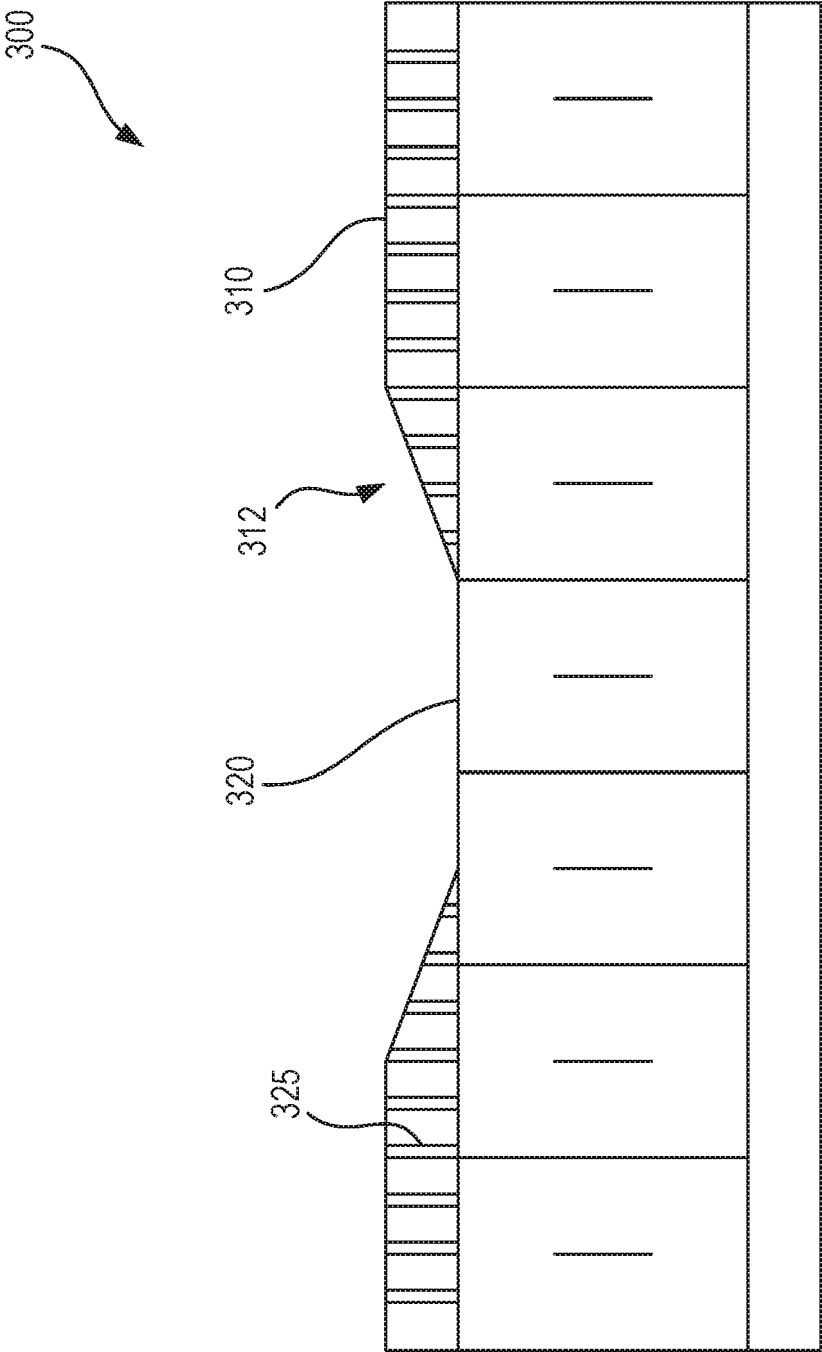
FIG. 3

**[0015]** Referring to FIG. 3, a schematic cross-section view of an acoustic panel 300 with a damaged portion of a perforated top skin 310 removed is illustrated according to various embodiments. The damaged portion may be cut with a continuously sloped ramp portion 312 between the top of the top skin 310 and the core section 320 where the top skin 310 is completely removed. However, in various embodiments, the damaged portion may be cut with a stepped profile. In various embodiments, the acoustic panel 300 may be curved in two or three dimensions. The curved shape may make it difficult to align perfora-

tions 325 between the remaining top skin and a replacement patch.

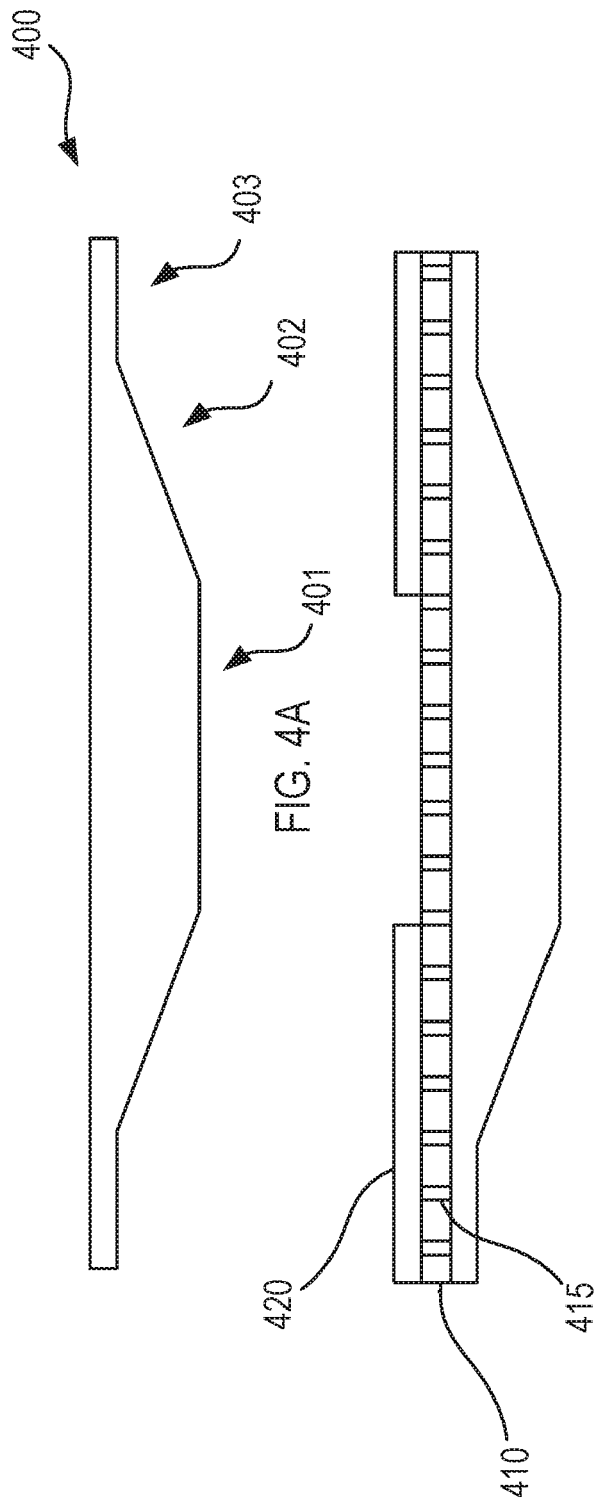
FIG. 4B

**[0017]** Referring to FIG. 4B, a maskant 410 may be coupled to the replacement patch 400. The maskant 410 may be a polymeric material. The maskant 410 may comprise a plurality of apertures 415 matching a perforation pattern of an acoustic panel. A tape 420 may be coupled to the replacement patch 400 or the maskant 410 over the ramp portion 402 and the overlap portion 403.

**[0016]** Referring to FIGs. 4A-4C, a schematic cross-section view of a replacement patch 400 is illustrated according to various embodiments. The replacement patch 400 may comprise a plurality of composite plies. The plies may be laid up on a bond tool which matches the shape of the component which is being repaired. The replacement patch 400 may comprise a core portion 401 which is configured to be placed directly over the core of an acoustic panel where the original top skin is completely removed. The replacement patch 400 may comprise a ramp portion 402 which is configured to be placed where the original top skin is partially removed. The replacement patch 400 may comprise an overlap portion 403 which is configured to be placed over the original top skin.

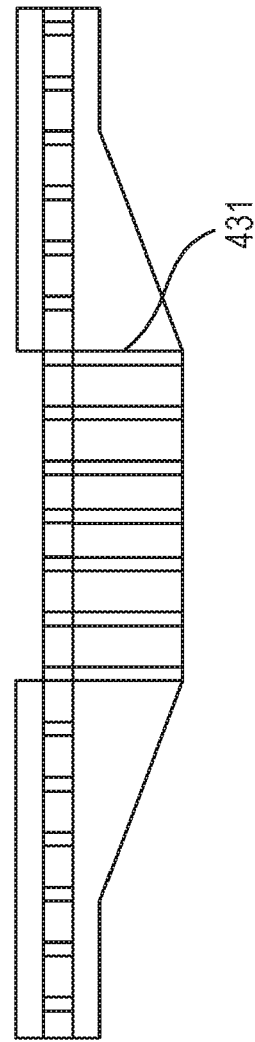
FIG. 4C illustrates a schematic cross-section view of a replacement patch with perforations in a core portion in accordance with various embodiments

**[0018]** Referring to FIG. 4C, perforations 431 may be created in the core portion 401 with a blasting process. An abrasive material may be blasted at the replacement patch 400. In various embodiments, the abrasive material may comprise aluminum oxide, silicon carbide, or any other suitable abrasive material. The maskant 410 and the tape 420 may prevent the abrasive material from removing material from the replacement patch 400, other than through the apertures 415 in the maskant 410. The blasting may create the perforations 431 in the core portion 401.

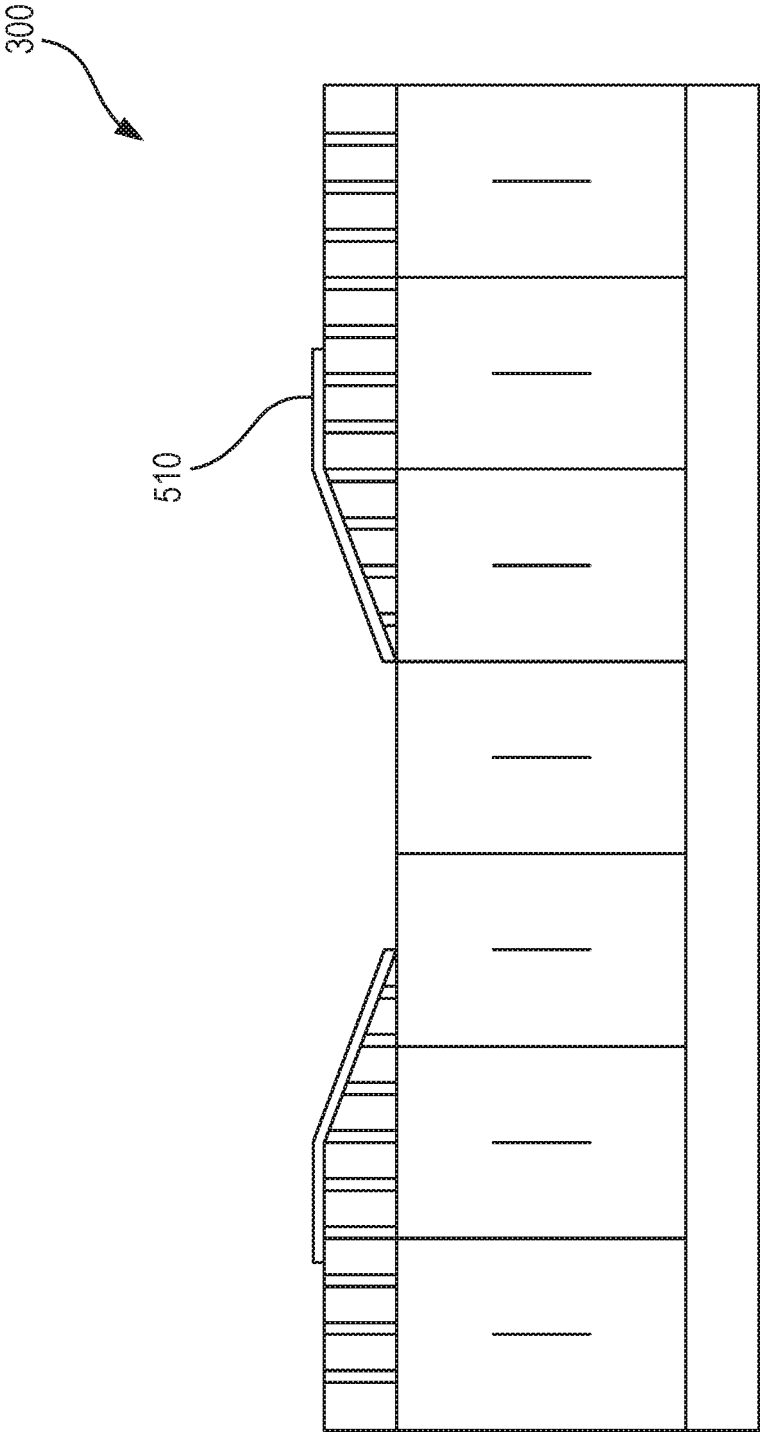
FIG. 5A illustrates a schematic cross-section view of an acoustic panel with an uncured fiberglass ply in accordance with various embodiments;

**[0019]** Referring to FIG. 5A, an uncured fiberglass ply 510 may be coupled to the acoustic panel 300. In various embodiments, a single ply may be used. However, in various embodiments, a plurality of plies may be used.

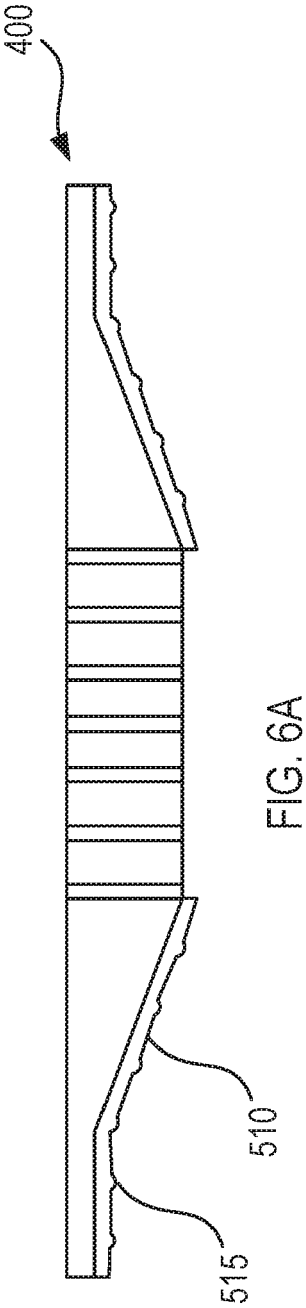
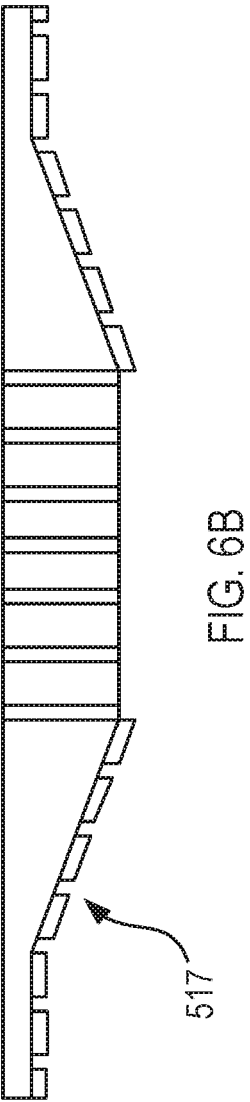
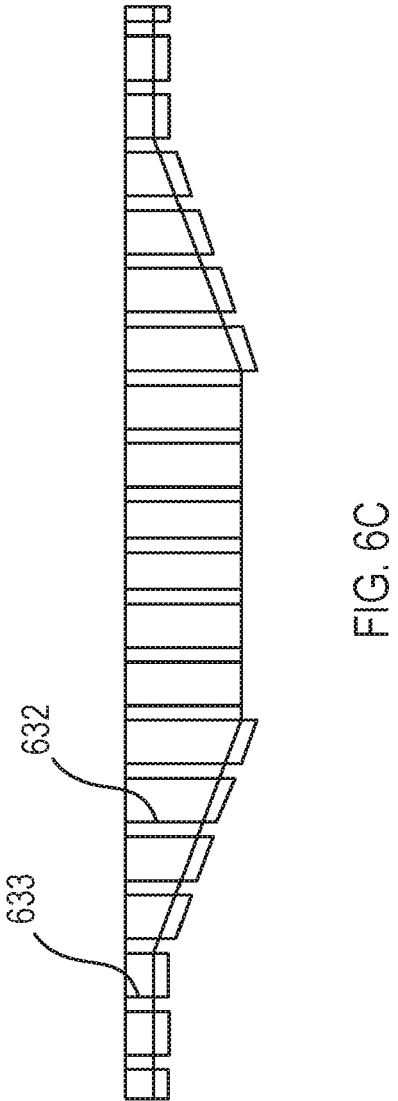
FIG. 6A illustrates a fiberglass ply coupled to a replacement patch in accordance with various embodiments;

FIG. 6B illustrates a fiberglass ply coupled to a replacement patch after the dimples have been sanded off in accordance with various embodiments;

FIG. 6C illustrates a replacement patch with perforations drilled in the overlap portion and the ramp portion in accordance with various embodiments; and

**[0021]** Referring to FIGs. 6A-6C, the fiberglass ply 510 may be removed from the acoustic panel and coupled to the replacement patch 400. The dimples 515 corresponding to the perforations in the acoustic panel may remain present as raised bubbles relative to the flat portions of the fiberglass ply 510.

**[0022]** Referring to FIG. 6B, the fiberglass ply 510 may be sanded. The sanding may remove the dimples 515 from the fiberglass ply 510. The fiberglass ply 510 may be left with apertures 516 where the dimples were formerly located which correspond to the perforations in the acoustic panel. Thus, the fiberglass ply 510 may provide a perforation template matching the acoustic panel.

**[0023]** Referring to FIG. 6C, perforations 632, 633 may be drilled in the ramp section 402 and the overlap section 403 of the replacement patch. The perforations 632, 633 may be drilled through the apertures 517 in the fiberglass ply 510. Thus, the perforations 632, 633 may match the perforation pattern of the acoustic panel. In various embodiments, the perforations 632, 633 may be laser drilled or drilled with a mechanical drill.

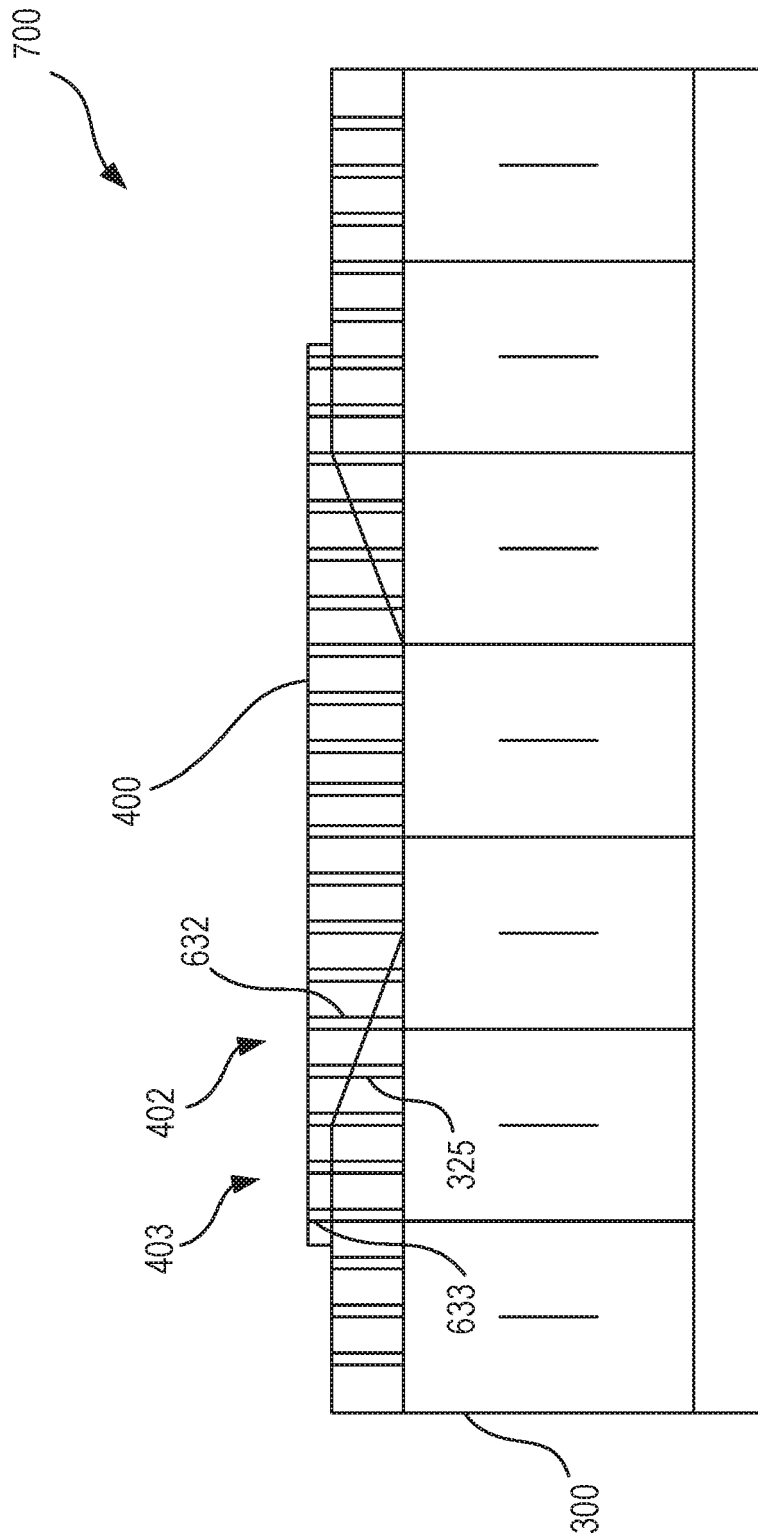
Fig. 7

**[0024]** Referring to FIG. 7, a repaired acoustic panel 700 is illustrated according to various embodiments. The replacement patch 400 may be bonded to the acoustic panel 300. The perforations 632, 633 in the ramp section 402 and the overlap section 403 of the replacement patch 400 may align with the perforations 325 in the acoustic panel 300. One or more pins may be inserted through the perforations 325, 632, 633 to keep the replacement patch 400 in place during curing. An adhesive may be placed on the replacement patch 400 and/or the acoustic panel 300 between the replacement patch 400 and the acoustic panel 300. The acoustic panel 300 with the replacement patch 400 may be cured in an autoclave. The repaired acoustic panel 700 may then be ready for operational use.

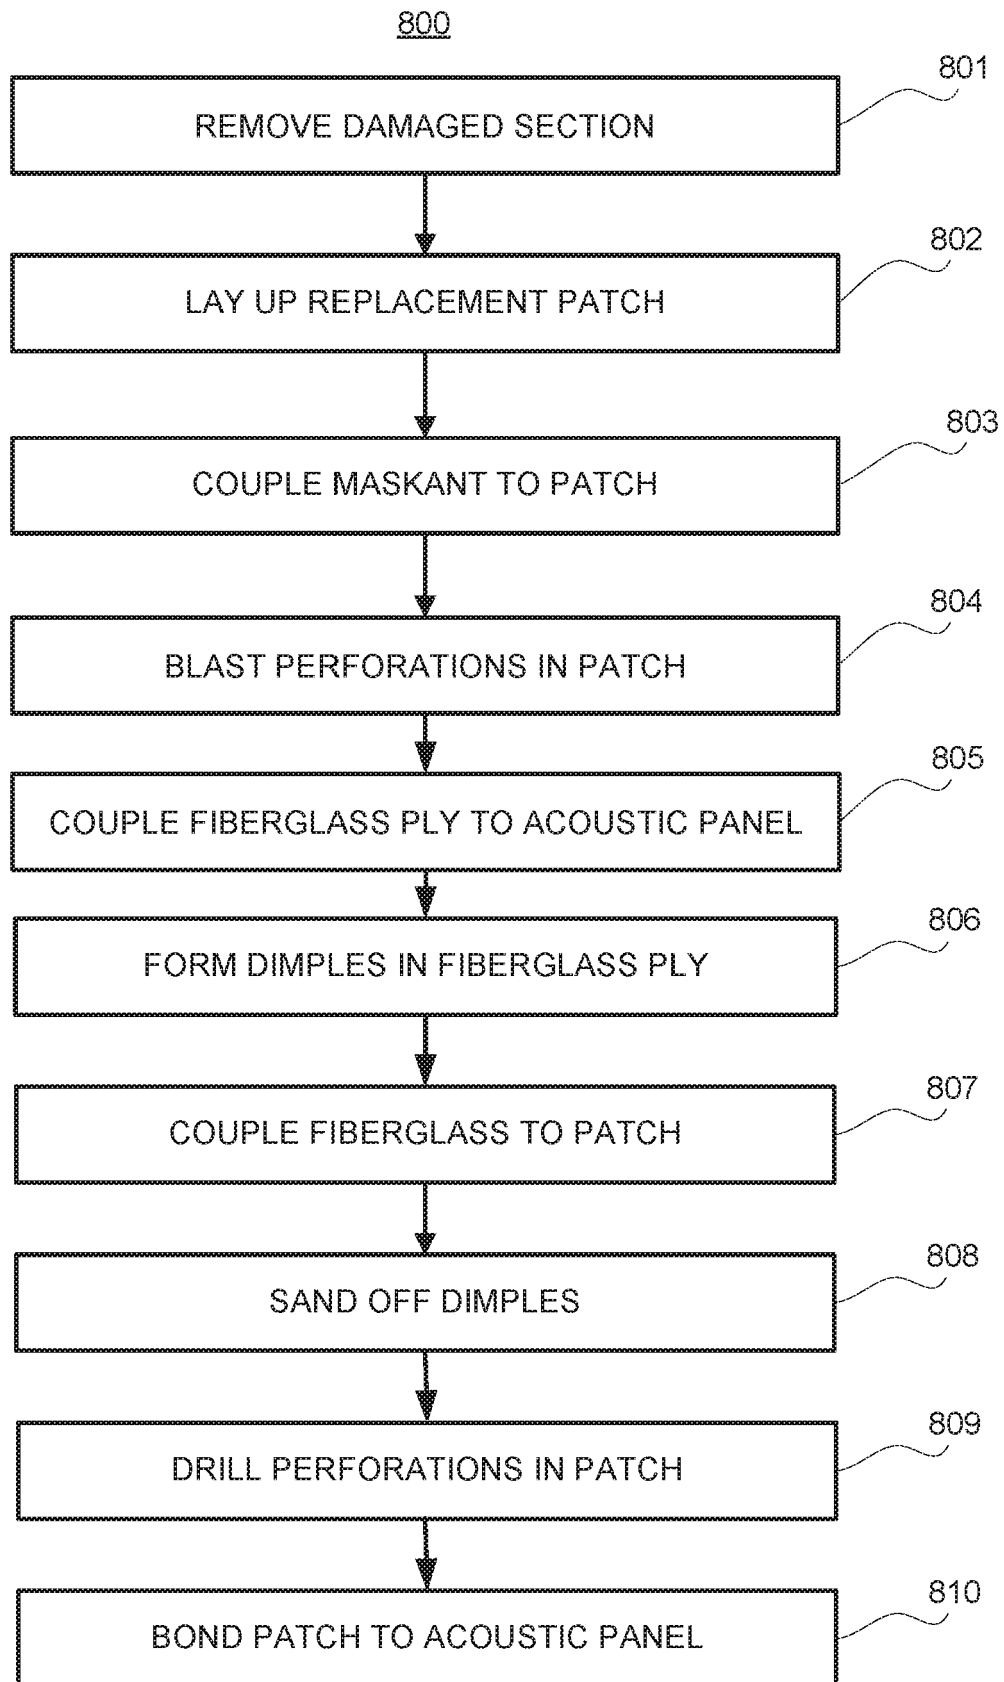
**FIG. 8**

**[0025]** Referring to FIG. 8, a flowchart 800 of a process for repairing an acoustic panel is illustrated according to various embodiments. Damage may be detected in an acoustic panel. The damaged section may be removed from the acoustic panel (step 801). A replacement patch may be laid up using a bond tool matching the shape of the acoustic panel (step 802). A perforated maskant may be coupled to the replacement patch (step 803). Perforations may be blasted in the replacement patch (step 804). The perforations may match the perforations in the maskant. A fiberglass ply may be coupled to the acoustic panel (step 805). The acoustic panel may be enclosed in a vacuum bag, such that the fiberglass ply droops into perforations in the acoustic panel, forming dimples in the fiberglass ply (step 806). The fiberglass ply may be removed from the acoustic panel and coupled to the replacement patch (step 807). The dimples in the fiberglass ply may be sanded off (step 808). Perforations may be drilled in the ramp section and overlap section of the replacement patch according to the pattern of the fiberglass ply (step 809). The replacement patch may be aligned with the acoustic panel and bonded to the acoustic panel (step 810).

FIG. 7 illustrates a flowchart of a process for repairing an acoustic panel in accordance with various embodiments.
