**EP 4 574 638 A1**

**EUROPEAN PATENT APPLICATION**

**(54) STRADDLED VEHICLE**

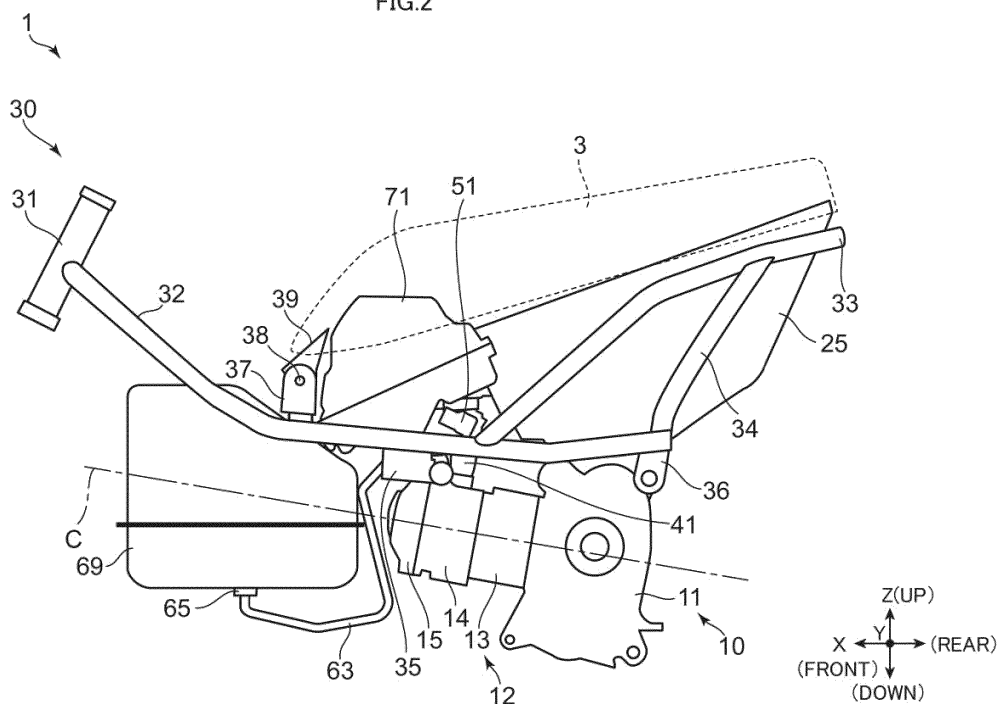
FIG.2

includes a cylinder head (14). The cylinder head (14) is connected to the intake pipe (41). At least a part of the cylinder head (14) overlaps the seat (3) in vehicle plan view. The air cleaner (71) is disposed above the cylinder head (14), below the seat (3), and in front of the storage box (25).

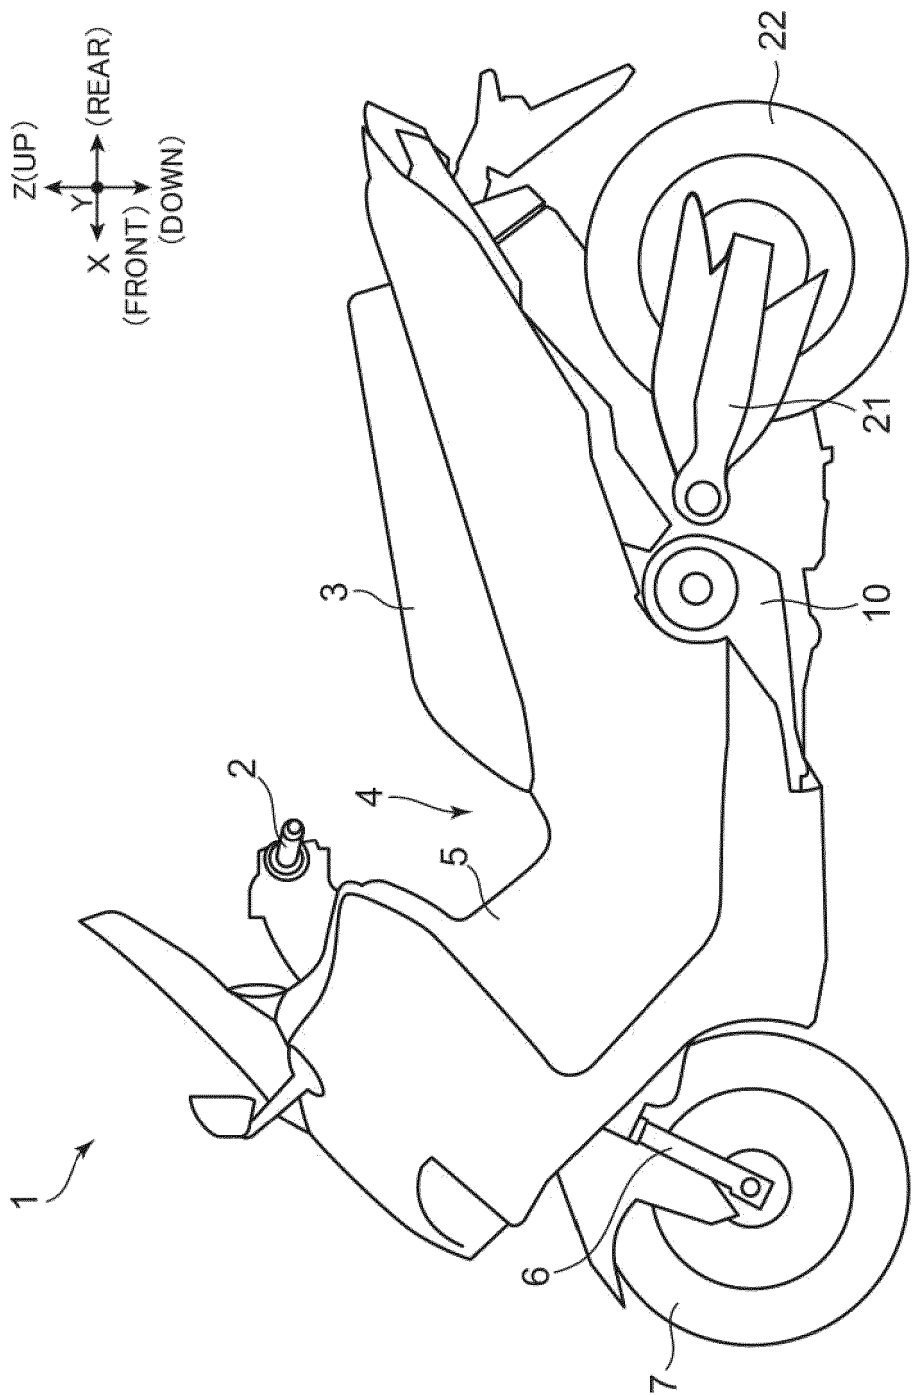
FIG.1

**[0065]** FIG. 1 is a left side view of a straddled vehicle 1 according to an embodiment. The straddled vehicle 1 is classified as, for example, a scooter-type vehicle.

**[0066]** FIG. 1 shows a longitudinal direction X, a transverse direction Y, and an up-down direction Z of the straddled vehicle 1. The longitudinal direction X, transverse direction Y, and up-down direction Z are defined with reference to a driver (also called a rider) riding the straddled vehicle 1. The longitudinal direction X, transverse direction Y, and up-down direction Z are perpendicular to one another. The longitudinal direction X and transverse direction Y are horizontal. The up-down direction Z is vertical.

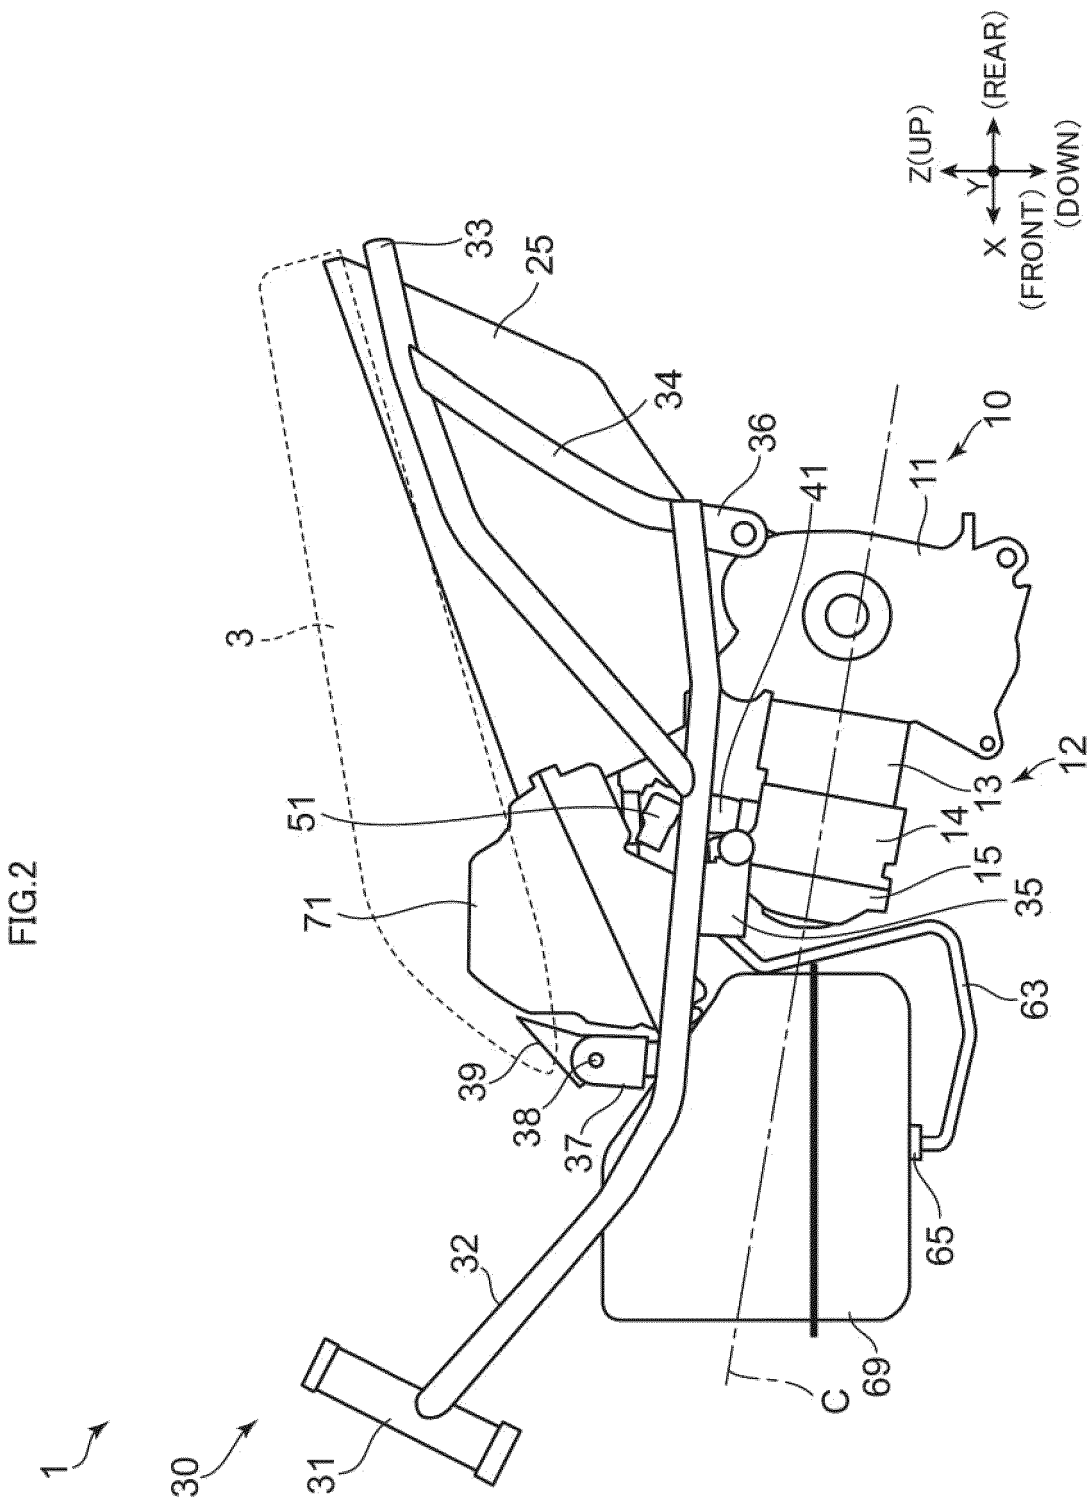
**[0074]** FIG. 2 is a left side view of the straddled vehicle 1. FIG. 2 omits illustration of the center cover 5 and the like. The straddled vehicle 1 includes a vehicle body frame 30. The vehicle body frame 30 supports the engine 10.

**[0083]** Refer to FIG. 2. The vehicle body frame 30 includes a head pipe 31, a main frame 32, a rear frame 33, and a back stay 34. The head pipe 31 is disposed at a front part of the straddled vehicle 1. The main frame 32 is connected to the head pipe 31. The main frame 32 extends rearward from the head pipe 31. The rear frame 33 and the back stay 34 are each connected to the main frame 32. The connection position between the main frame 32 and the back stay 34 is more rearward than the connection position between the main frame 32 and the rear frame 33. The rear frame 33 extends rearward and upward from the main frame 32. The back stay 34 extends rearward and upward from the main frame 32. The back stay 34 is connected to the rear frame 33. The connection position between the rear frame 33 and the back stay 34 is more rearward than and higher than the connection position between the main frame 32 and the back stay 34.

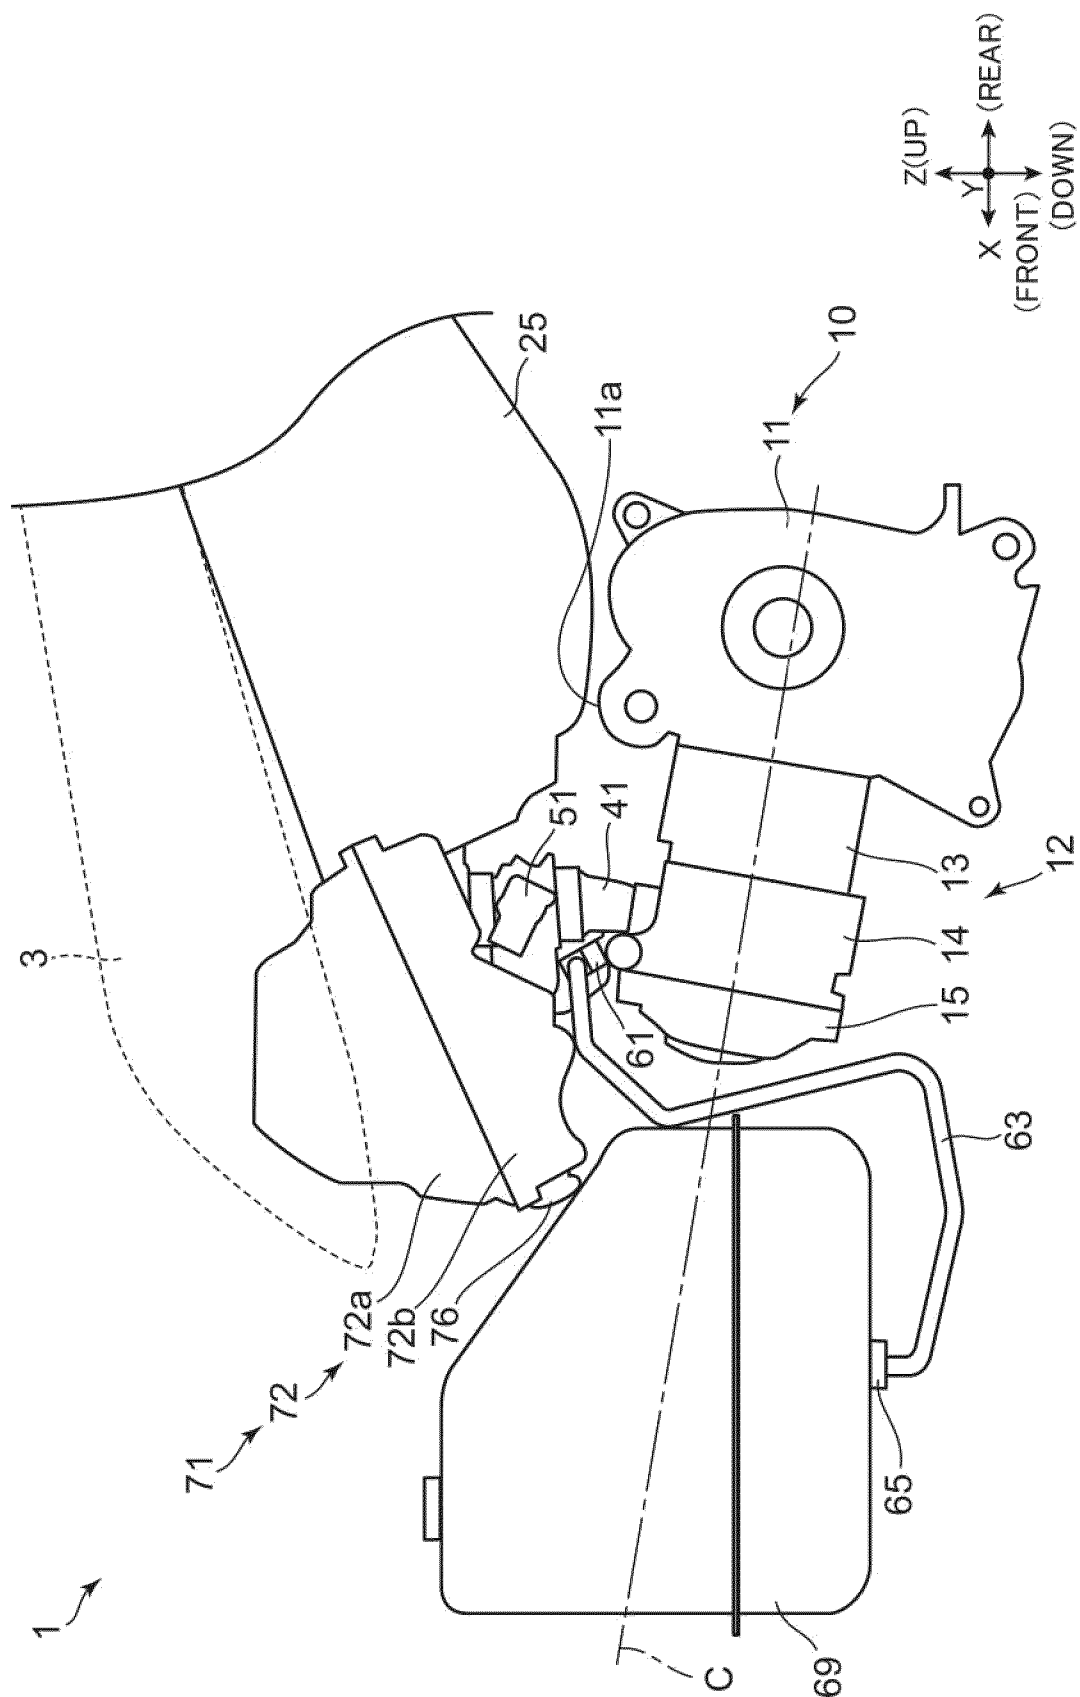
FIG.3

**[0078]** FIG. 3 is a left side view of the straddled vehicle 1. FIG. 3 omits illustration of the vehicle body frame 30 and the like. The straddled vehicle 1 includes a fuel injection device 61. The fuel injection device 61 is attached to the intake pipe 41. The fuel injection device 61 supplies fuel to the engine 10. The fuel injection device 61 supplies fuel to the engine 10 through the intake pipe 41.

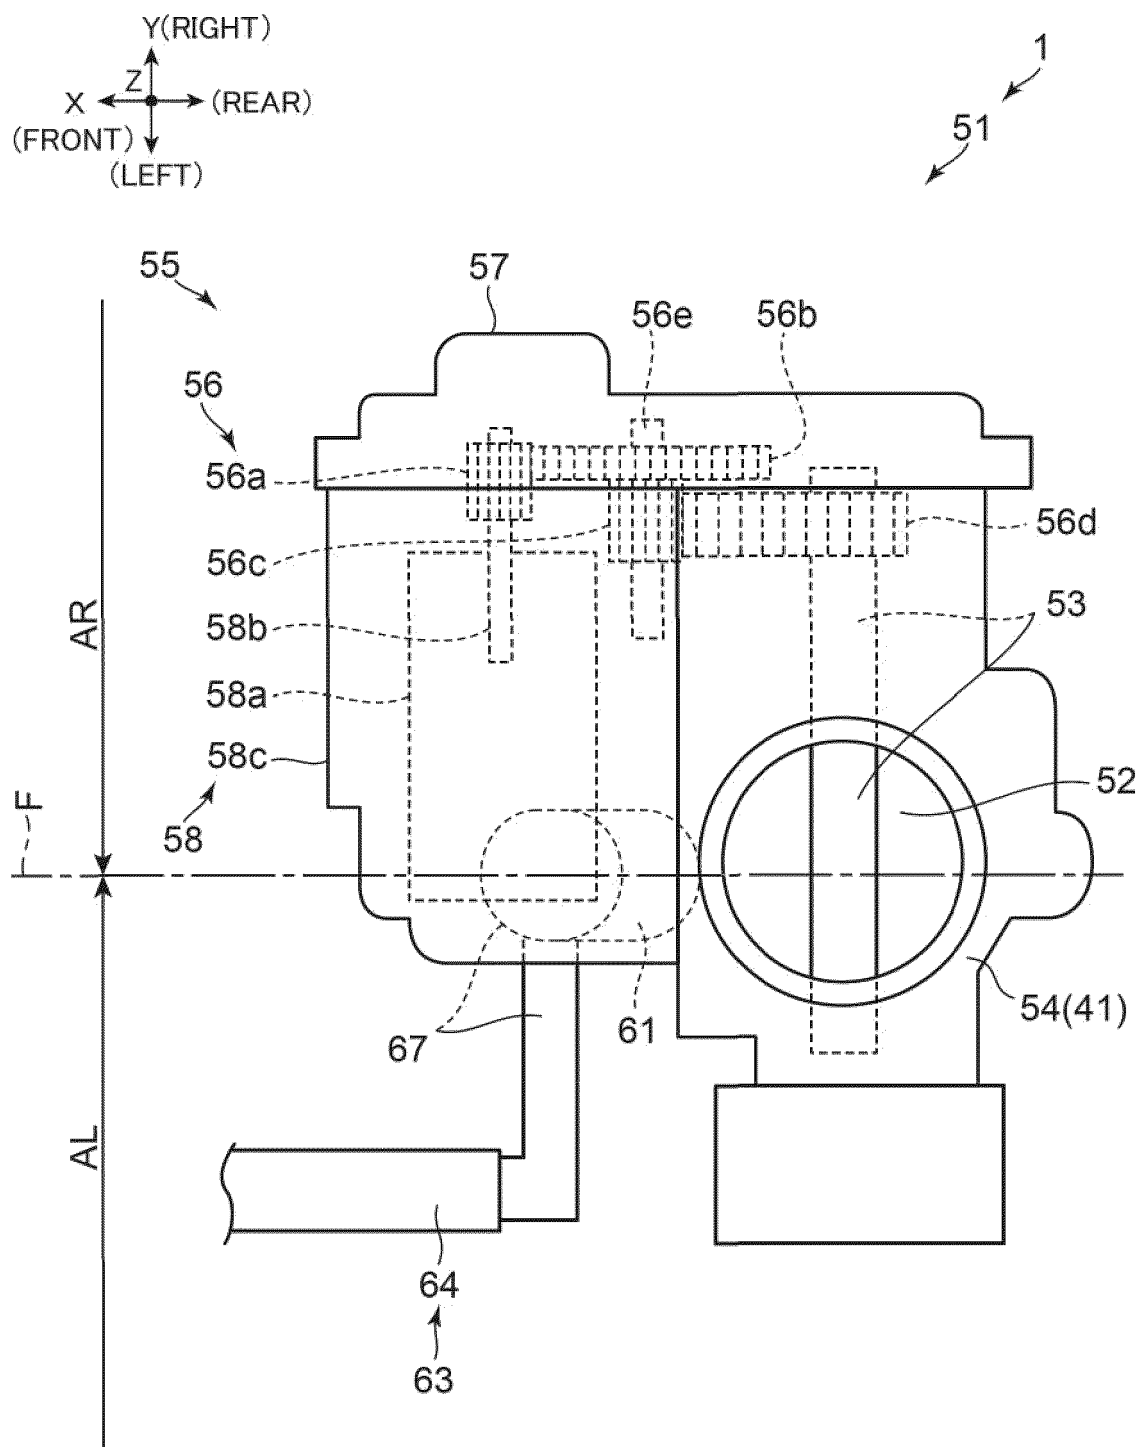
FIG.6

**[0641]** Refer to FIG. 6. FIG. 6 illustrates the fuel injection device 61 by a broken line. The fuel injection device 61 overlaps the throttle device 51 in vehicle plan view.

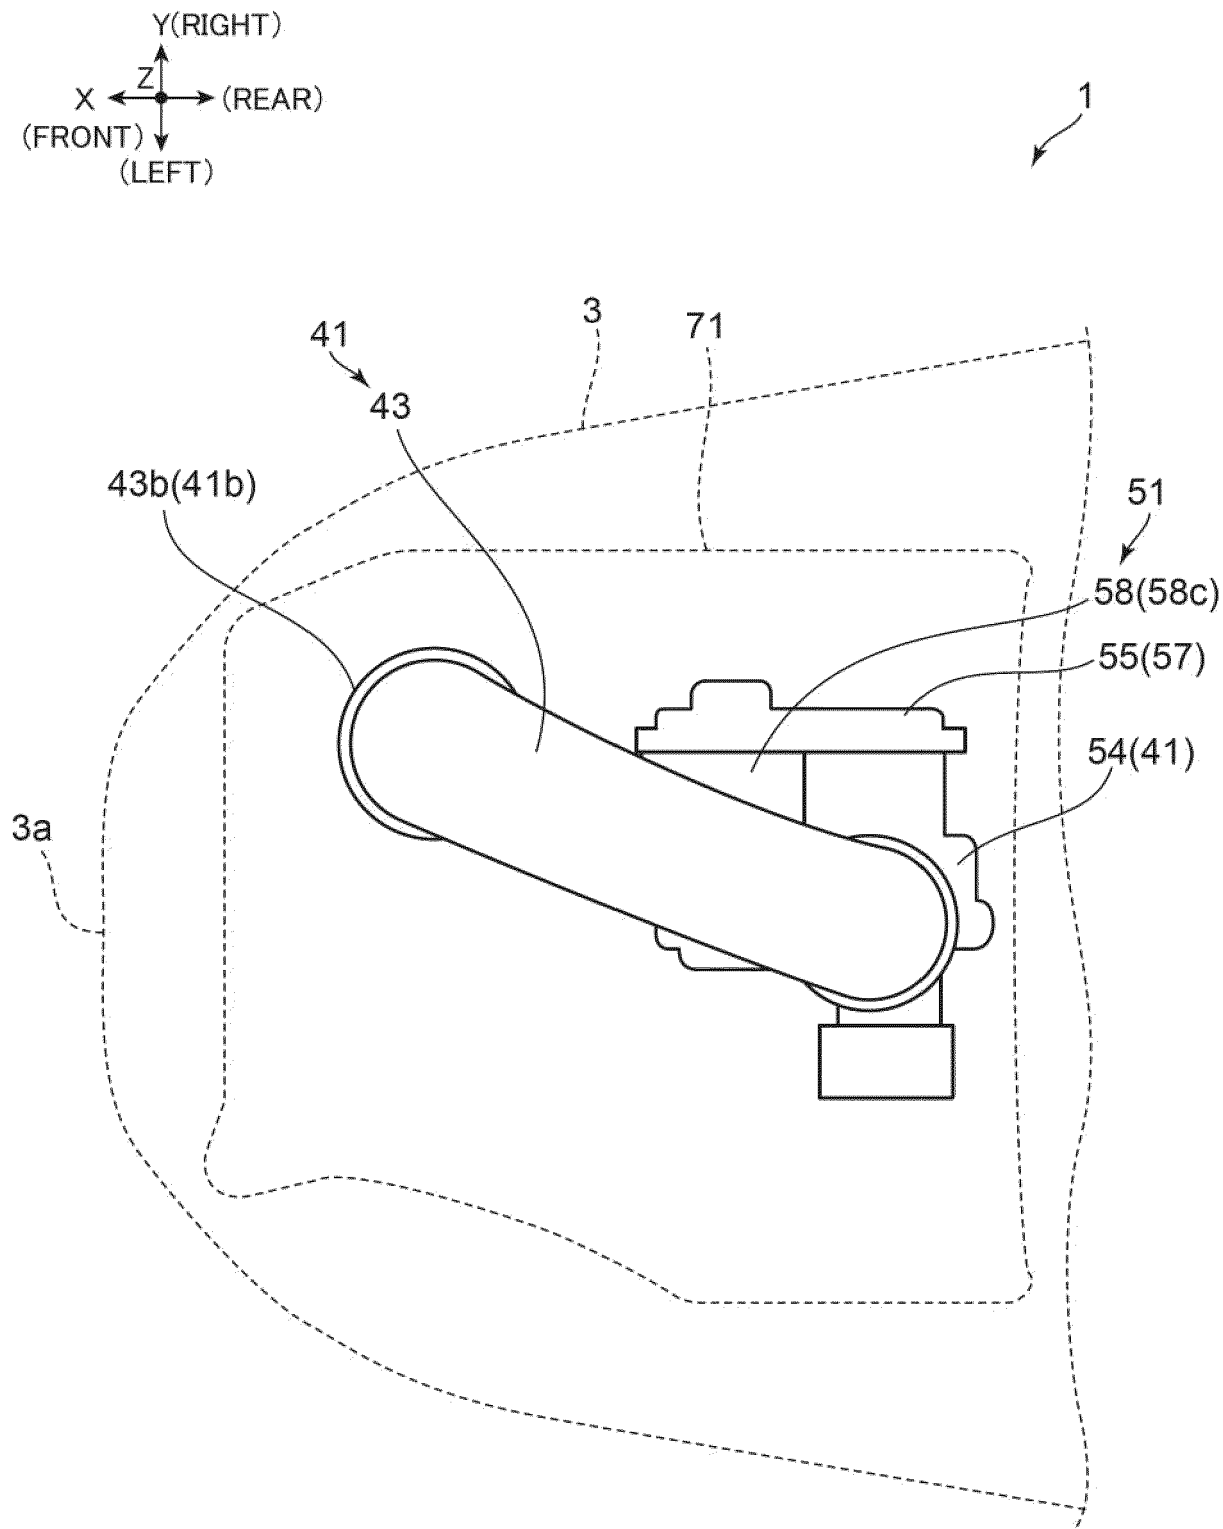
FIG.13

**[0548]** FIG. 13 is a plan view of the straddled vehicle 1. In FIG. 13, the seat 3 and the air cleaner 71 are indicated by broken lines. FIG. 13 clearly illustrates the intake pipe 41 and the throttle device 51.

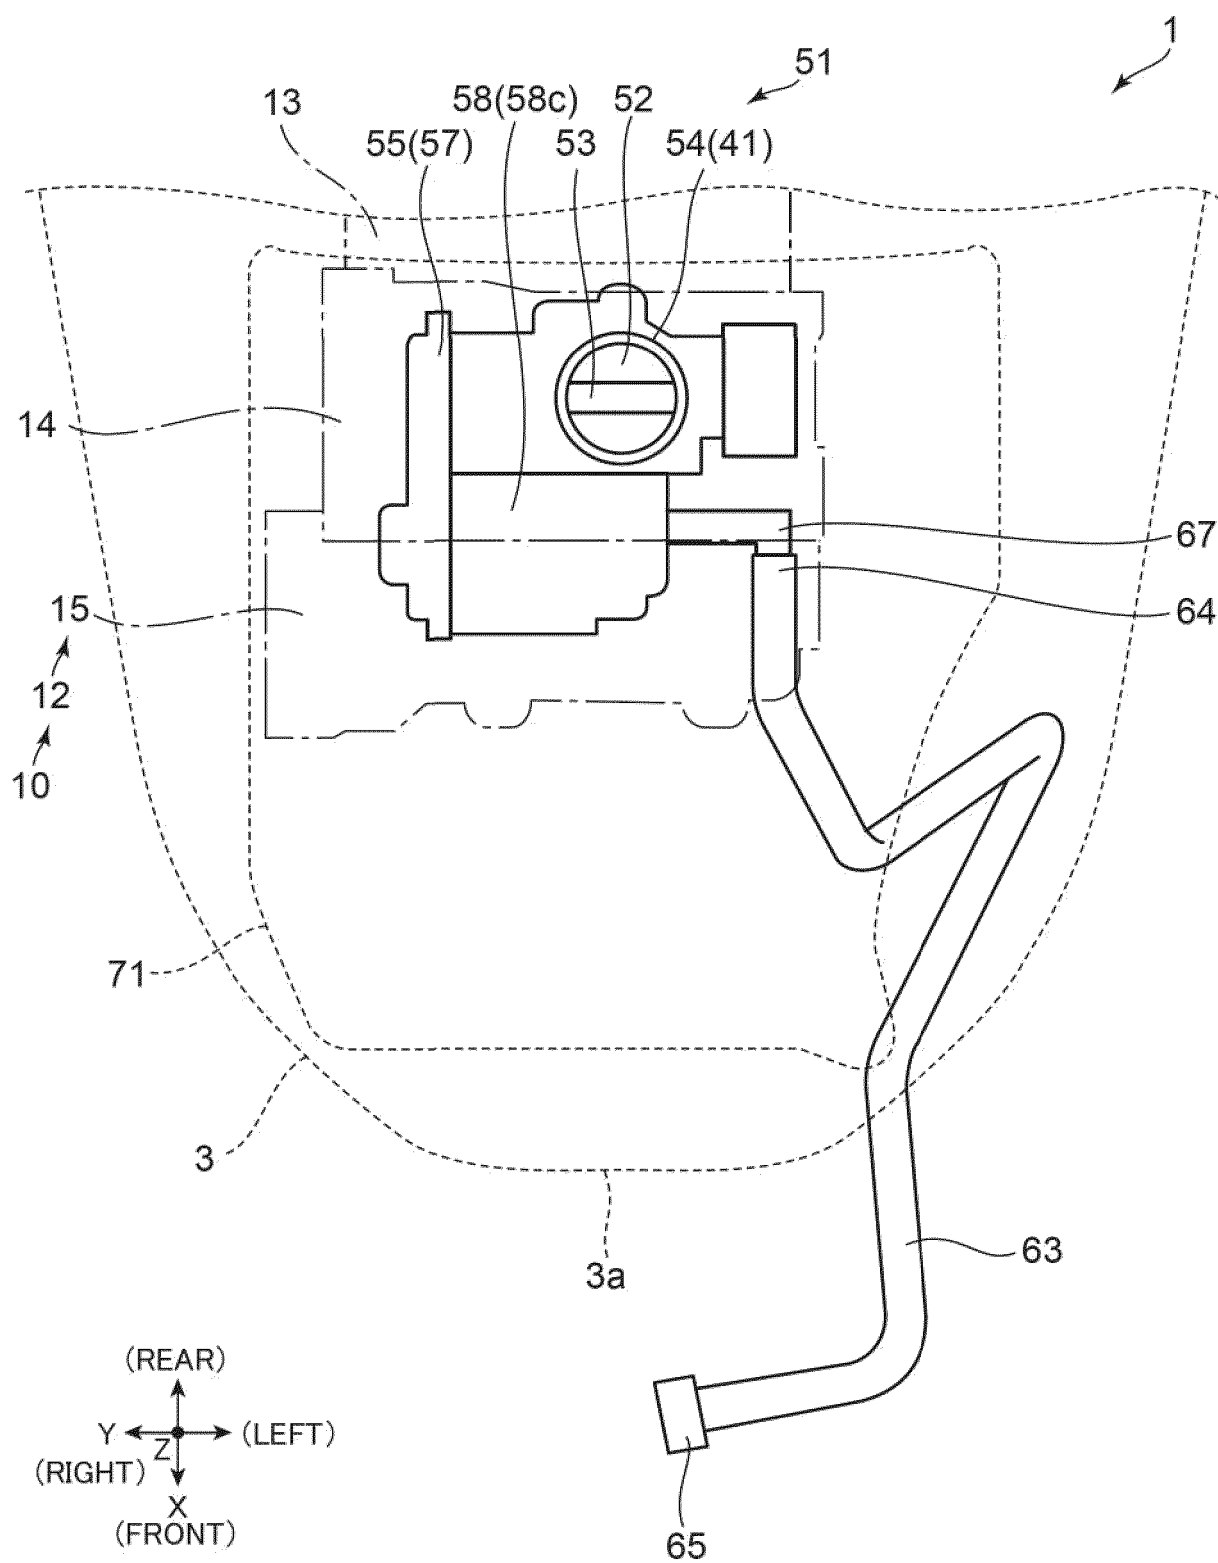
FIG.14

**[0565]** FIG. 14 is a plan view of the straddled vehicle 1. In FIG. 14, the seat 3 is indicated by a broken line. FIG. 14 clearly illustrates the throttle device 51.

**[0600]** In FIG. 14, the air cleaner 71 is indicated by a broken line. The throttle device 51 overlaps the air cleaner 71 in vehicle plan view. At least a part of the throttle device 51 overlaps the air cleaner 71 in vehicle plan view. For example, the entire throttle device 51 overlaps the air cleaner 71 in vehicle plan view.

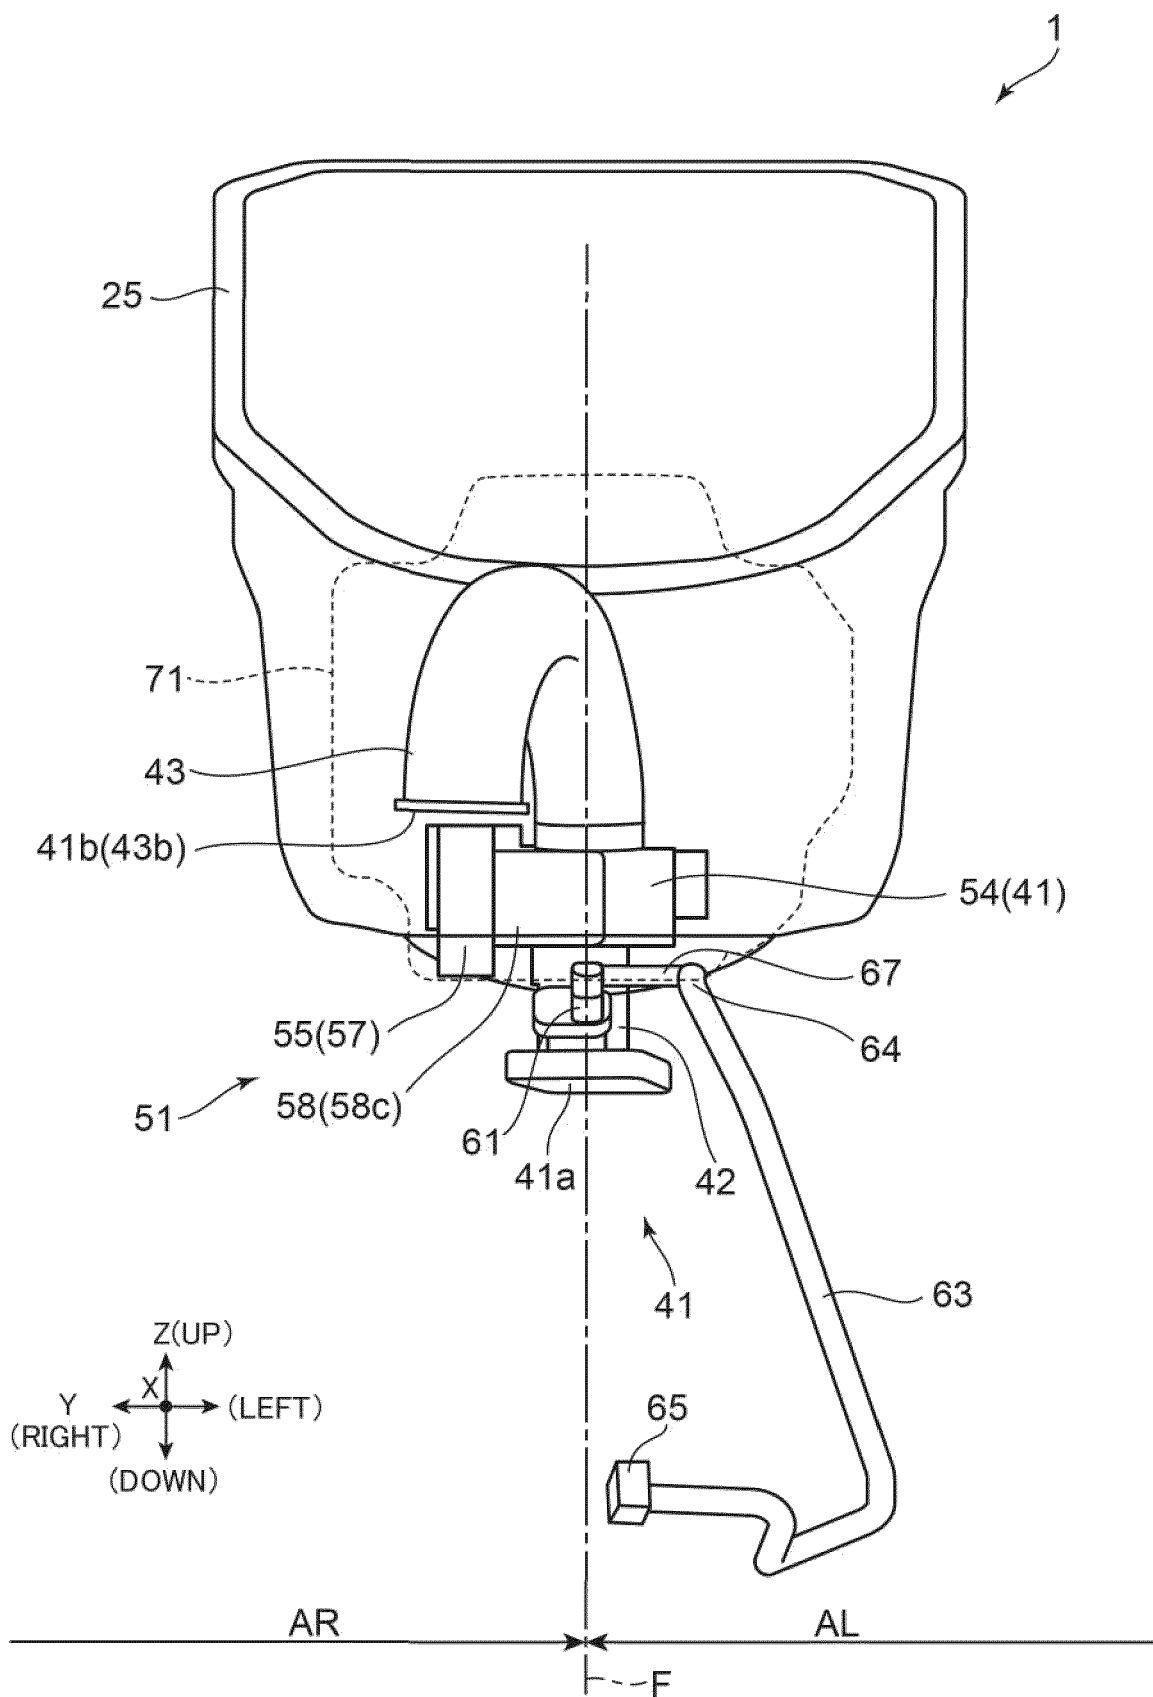
FIG.15

**[0672]** In FIG. 15, the air cleaner 71 is indicated by a broken line. The air cleaner 71 overlaps the storage box 25 in vehicle front view. At least a part of the air cleaner 71 overlaps the storage box 25 in vehicle front view.

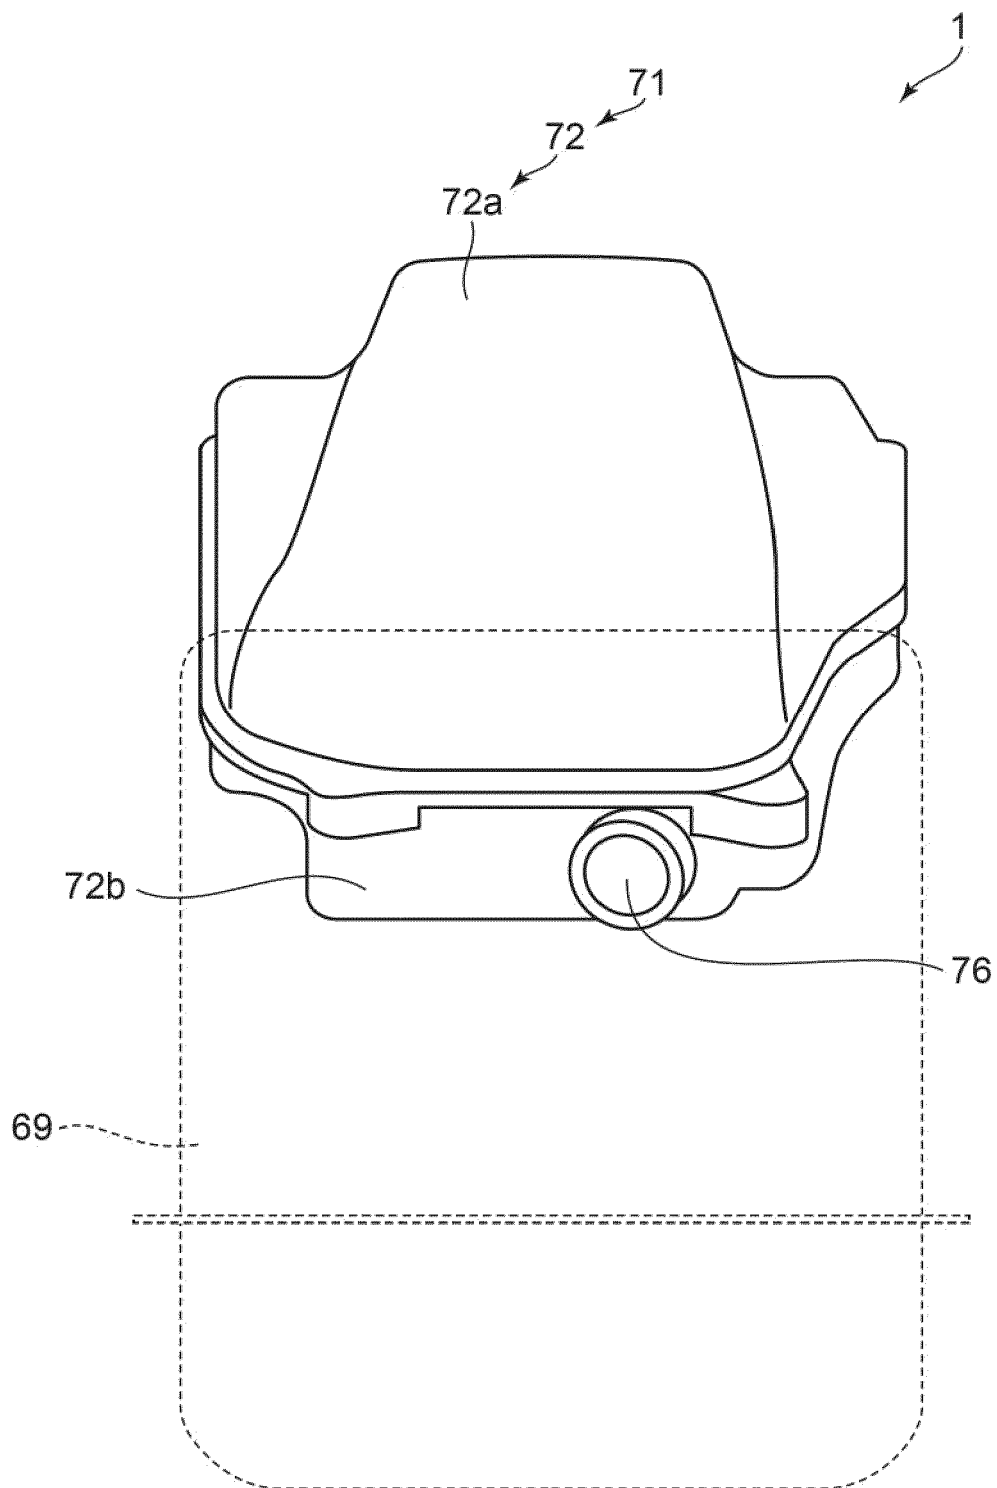
FIG.17

**[0727]** FIG. 17 is a front view of the air cleaner 71 and the fuel tank 69. In FIG. 17, the fuel tank 69 is indicated by a broken line. The air cleaner 71 overlaps the fuel tank 69 in vehicle front view. A part of the air cleaner 71 overlaps the fuel tank 69 in vehicle front view.
